Identification and Evaluation of Pavement-Bridge Interface Ride Quality Improvement and Corrective Strategies

Institute for Transportation

Report Number FHWA/OH-2011/1

January 2011

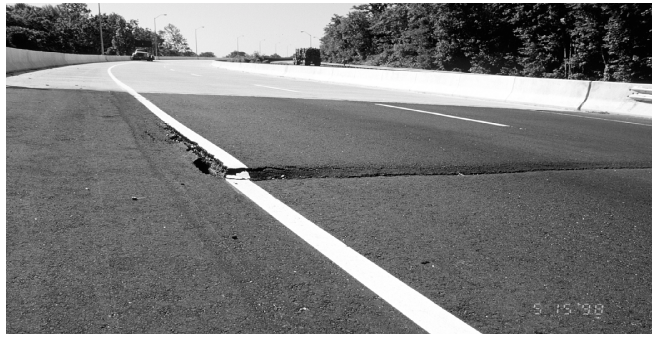
Figure 4.60. Approach slab distress attributable to foundation soil settlement (Route 10 westbound lane over the Appomattox River) (Hoppe, 1999)

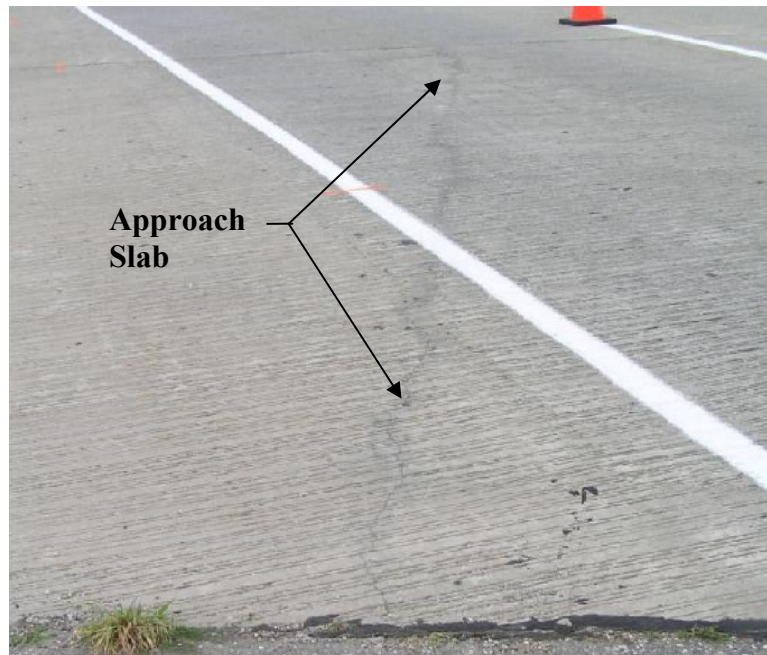
Figure 5.9. FAI 33-14.17 approach slab cracking

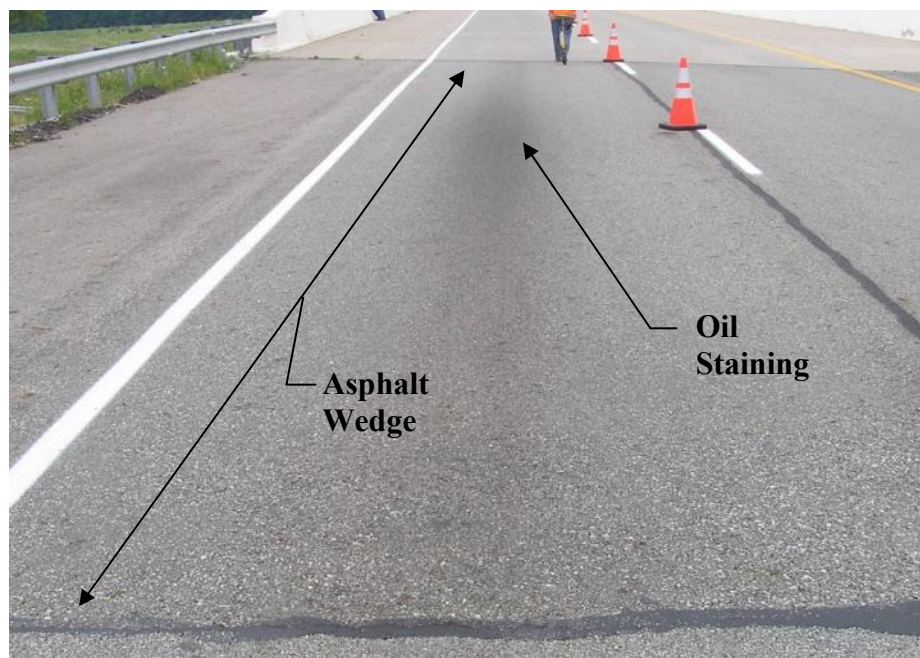
indicates a bump condition just prior to the stain. Oil staining can be caused by the bump exciting the vehicle vertically which in turn causes increased inertial forces on leaking engine oil droplets that then fall to the pavement on the downward portion of the excitation. Figure 5.10 shows the asphalt wedge and oil staining at the exit of the bridge.

Figure 5.10. FAI 33-14.17 asphalt wedge and oil staining located at exit of bridge

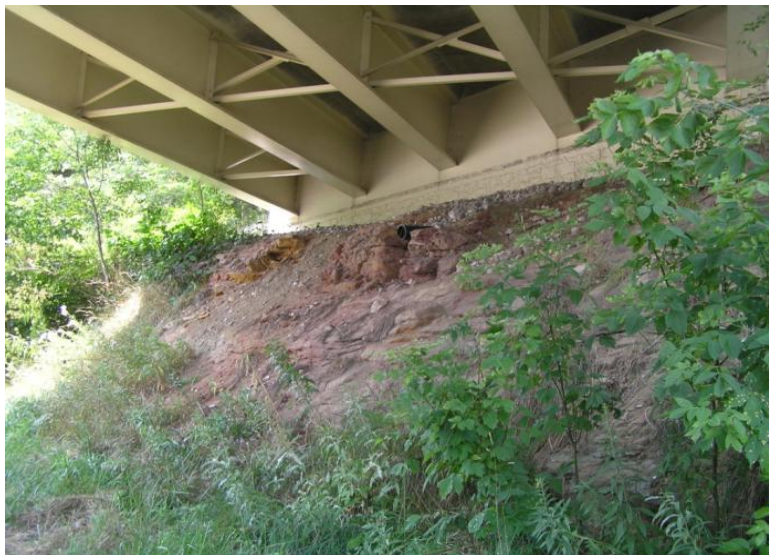
Figure 5.21. Abutment conditions at RIC 430-9.98

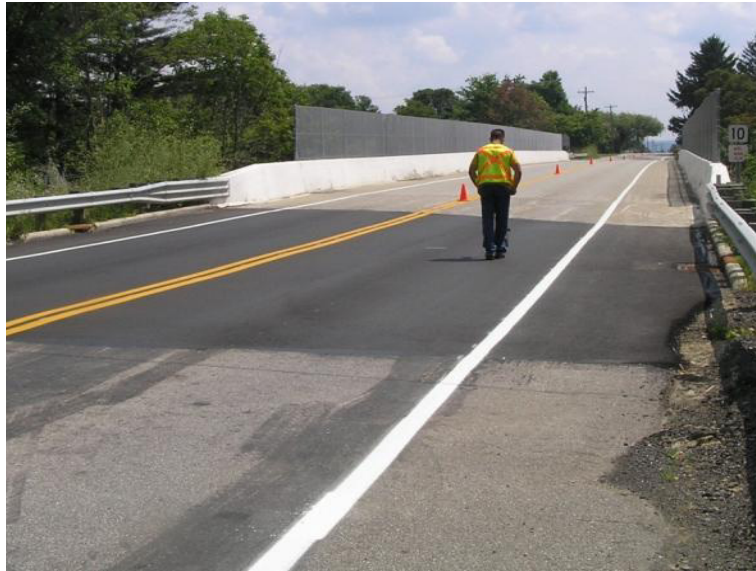
Figure 5.22. RIC 430-9.98 newly placed asphalt wedge and mud-jacked slab

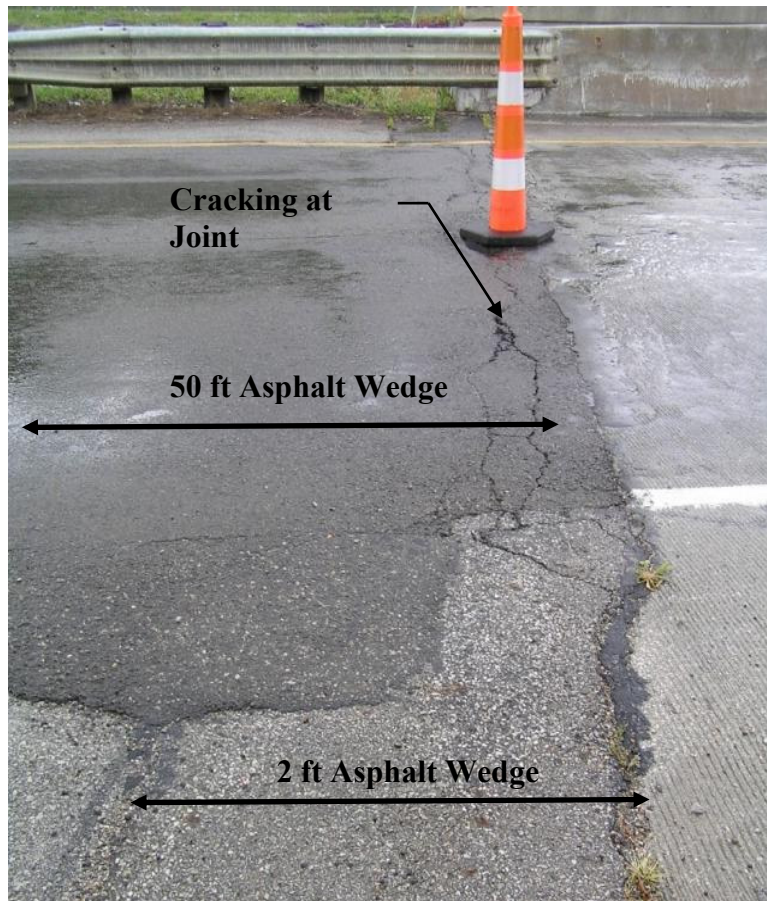
Figure 5.27. Asphalt wedges at bridge abutment

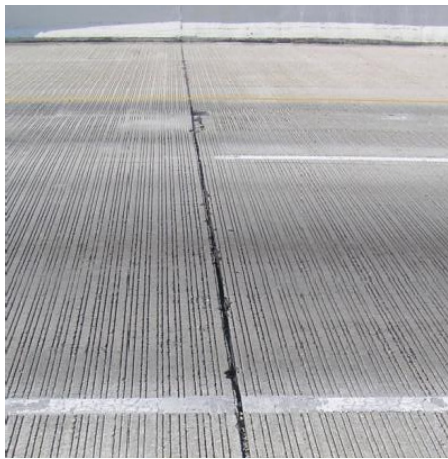
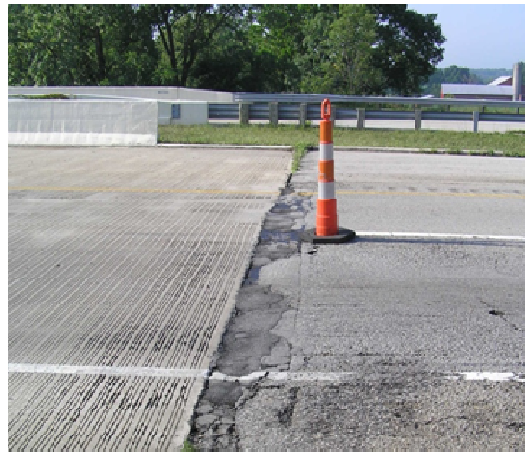
a. Approach-to-bridge joint

b. Approach-to-pavement joint

Figure 5.32. Condition of bridge and approach joints

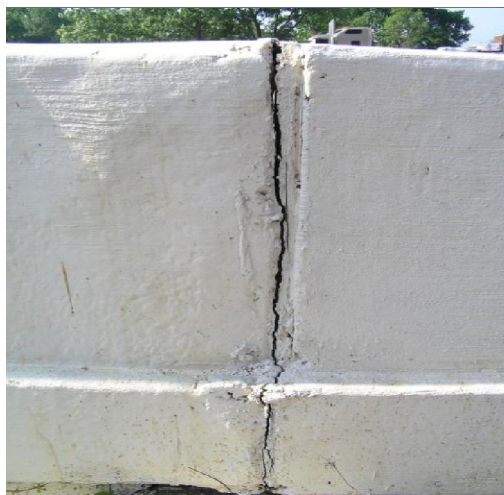
Figure 5.33. Barrier rail joint at approach slab showing settlement of approach slab

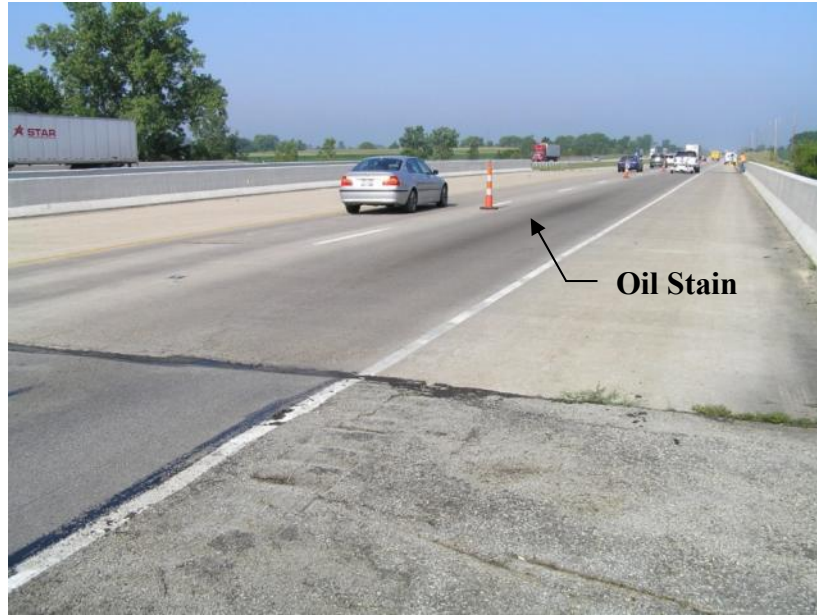
Figure 5.34. Oil staining on bridge surface caused by bump at pavement-to-approach joint

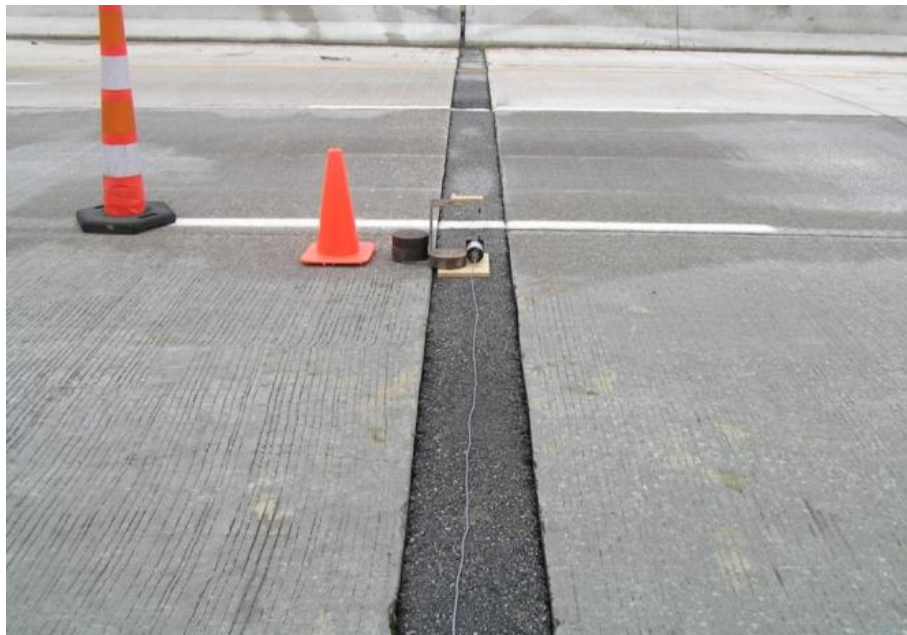
Figure 5.45. 12 in. pressure relief joint condition

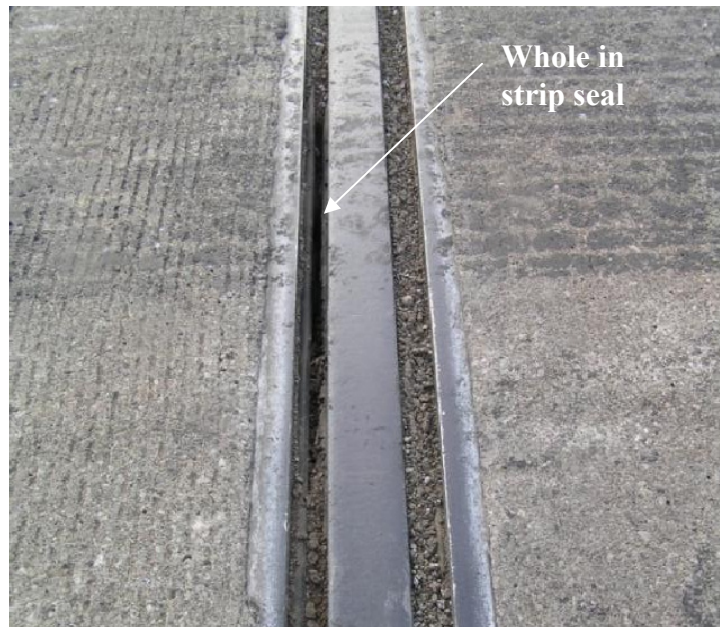
Figure 5.54. Deterioration of strip seal
