Low-Cost Rural Surface Alternatives Phase III: Demonstration Project

Final Report
April 2022

Sponsored by
Iowa Highway Research Board
(IHRB Project TR-721)
Iowa Department of Transportation
(InTrans Project 17-604)

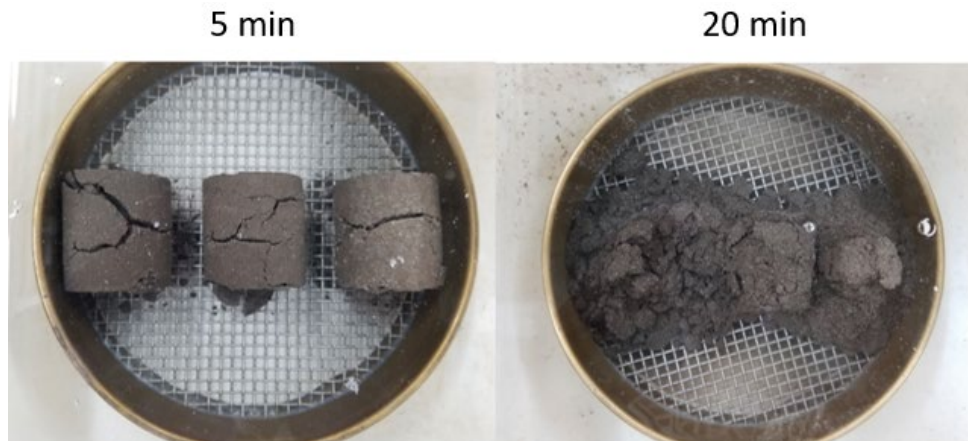
and compacted at optimum moisture content with standard Proctor energy. Each specimen was then placed on a #4 sieve and soaked under water at room temperature. The dissolution of each specimen with time was recorded (McMullen 2000). Figure 7 shows that the specimens of existing surface aggregates treated with the clay slurry in Washington County lost stability and broke into fragments after 20 minutes of soaking.

Figure 7. Slaking test for 2×2 specimens of existing surface aggregates from Washington County mixed with 7% clay slurry by dry weight

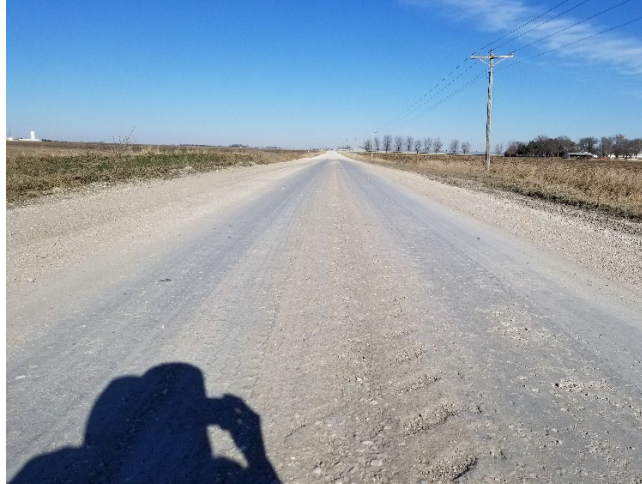
Figure 127. Rutting in EMC SQUARED section in Hamilton County during spring 2019

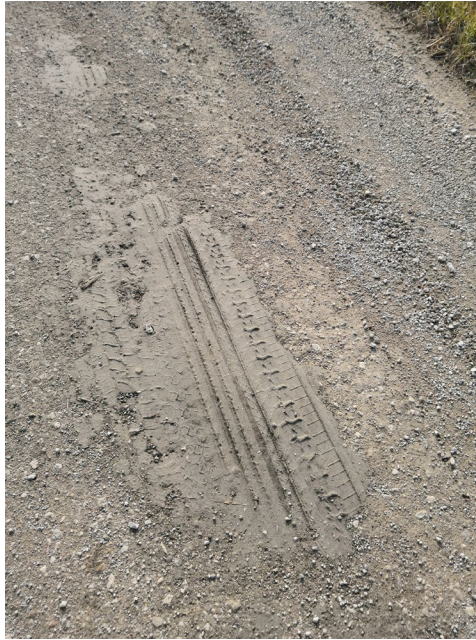
Figure 129. Clay on the surface in Hamilton County Claycrete section

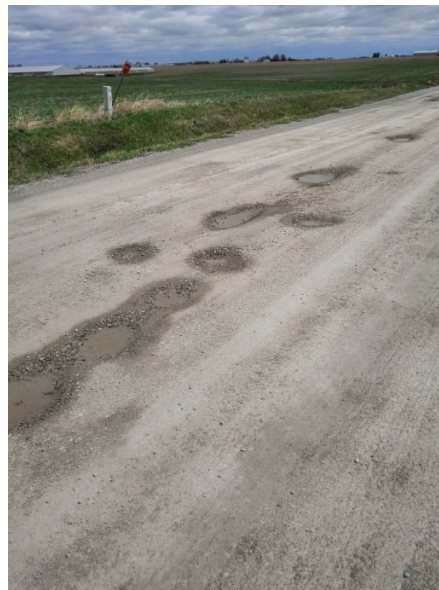
Figure 130. Potholes in control section in Washington County during spring 2020
