# Precast Concrete Elements for Accelerated Bridge Construction

## Volume 3. Laboratory Testing, Field Testing, and Evaluation of a Precast Concrete Bridge: Black Hawk County

**Final Report**  
**January 2009**

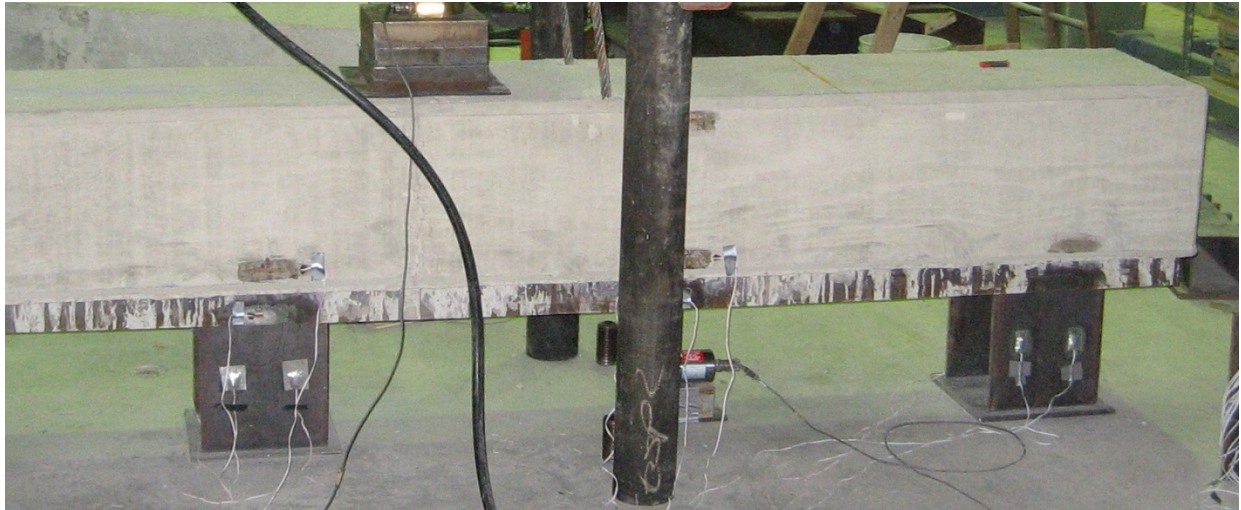
The abutment caps designed by Black Hawk County Engineering Department were fabricated at the Black Hawk County yard by county forces. After fabrication, the abutment caps were shipped to the ISU structures laboratory for service and ultimate strength testing. Two abutment caps were tested; the first abutment cap (Cap 1) was fabricated using a W12x65 steel section (Figure 2.1a), and the second abutment cap (Cap 2) was fabricated with a W12x26 section (Figure 2.1b).

a) Cap 1 fabricated with W12x65

**Figure 2.1. Precast abutment caps**

b) Cap 2 fabricated with W12x26

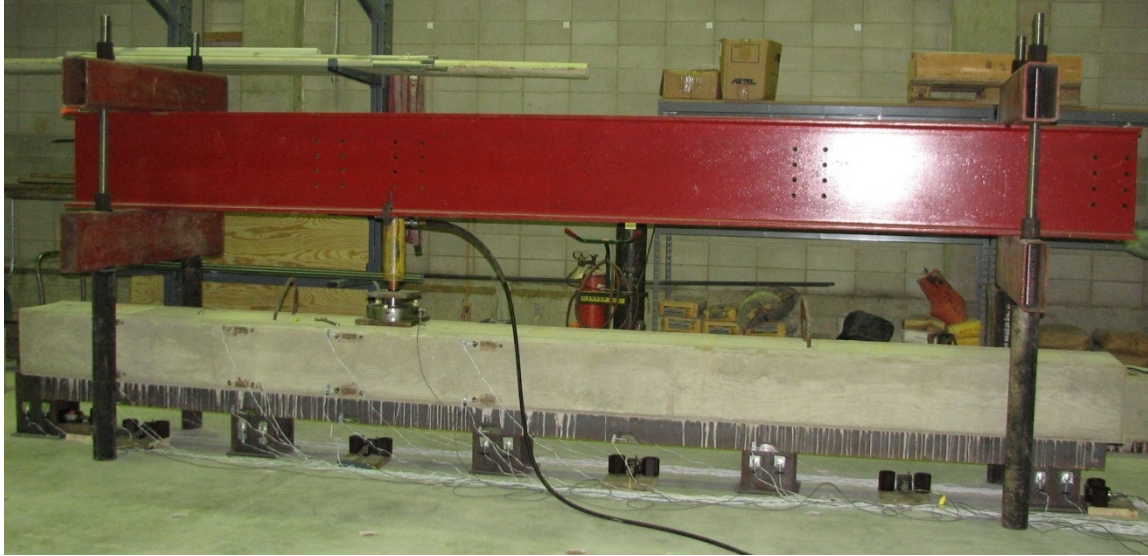
**Figure 2.4. Cap 1 service test set-up**

b) Photograph of service test

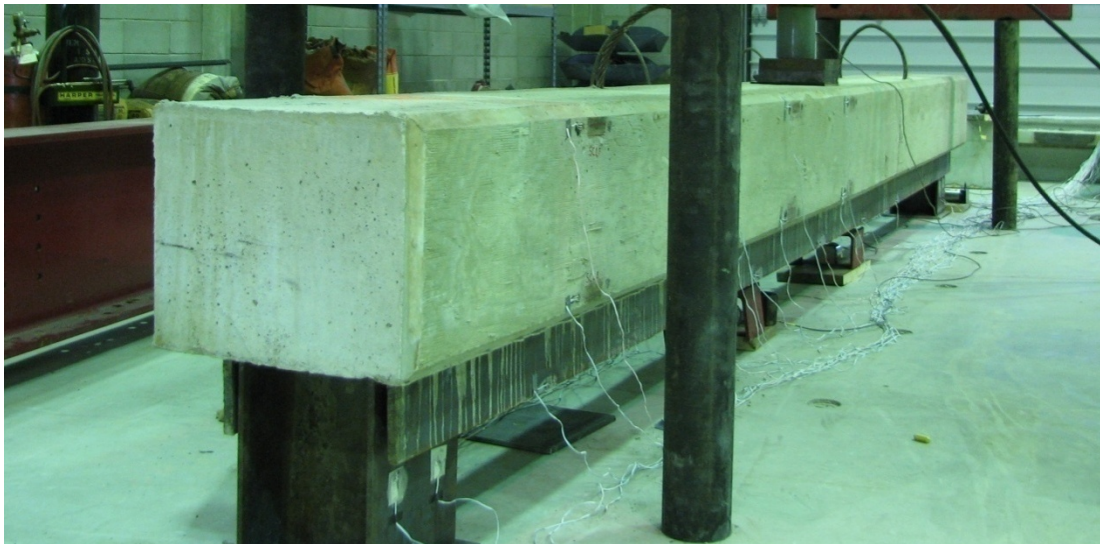
Due to a higher than anticipated capacity, the load frame for the positive ultimate strength test was not sufficient for failing the abutment cap. Thus, the negative ultimate bending strength was also investigated for Cap 1. The cap was placed within the load frame as shown in Figure 2.6. The actuator was placed on the floor, and pushed on the bottom of the cap, creating negative bending.

a) Positive strength test dimensions

**Figure 2.5. Positive ultimate strength bending test set-up**

b) Photograph of test

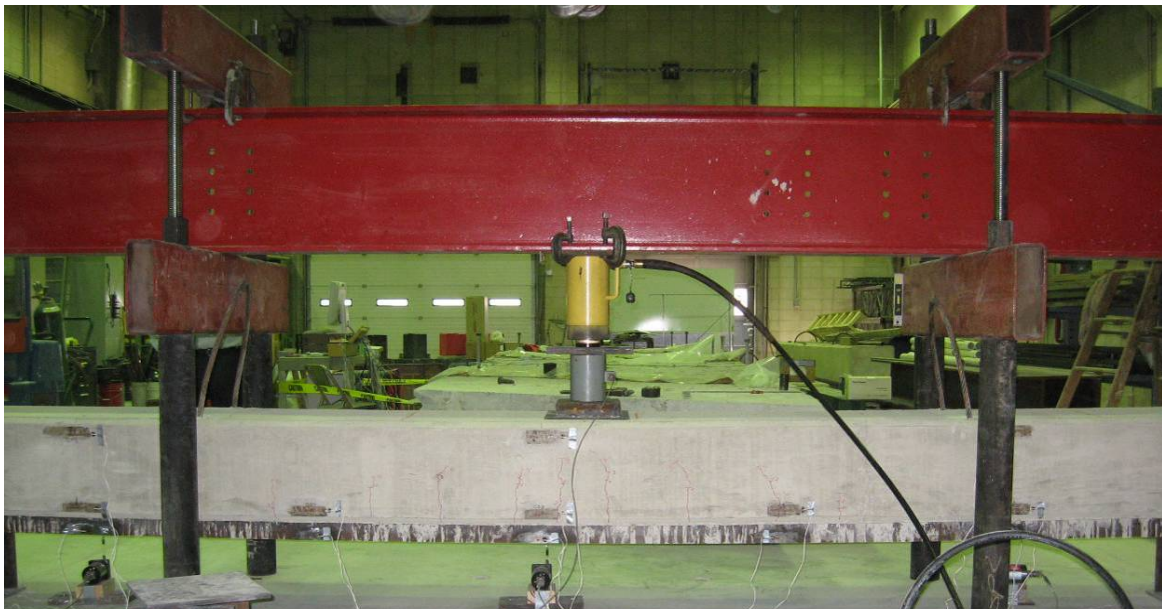
Cap 2 was tested for positive bending strength in the same manner as Cap 1. Two piles were used for supports, spaced at 15'-6". A single point load was applied at the midspan of the abutment cap to produce positive bending as shown in Figure 2.9. A negative strength bending test was not performed on Cap 2 as the abutment cap was failed during the positive strength bending test.

a) Strength test dimensions

b) Photograph of test

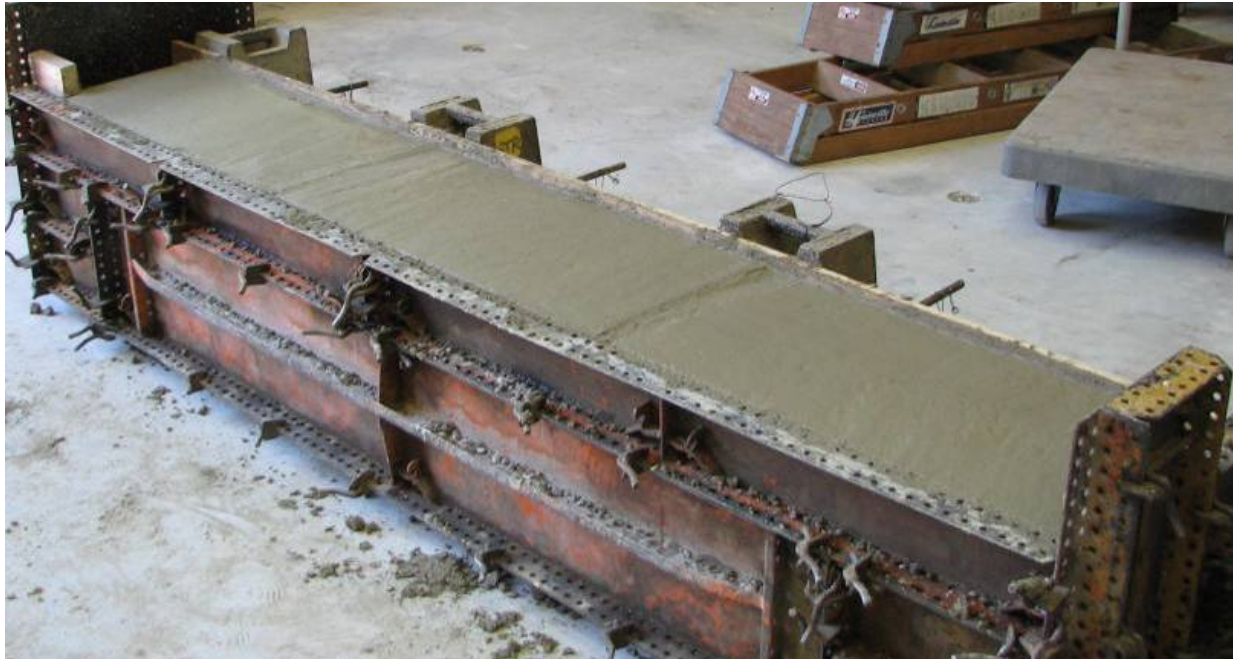
**Figure 2.15. Finished concrete surface of Type 1 Connection**

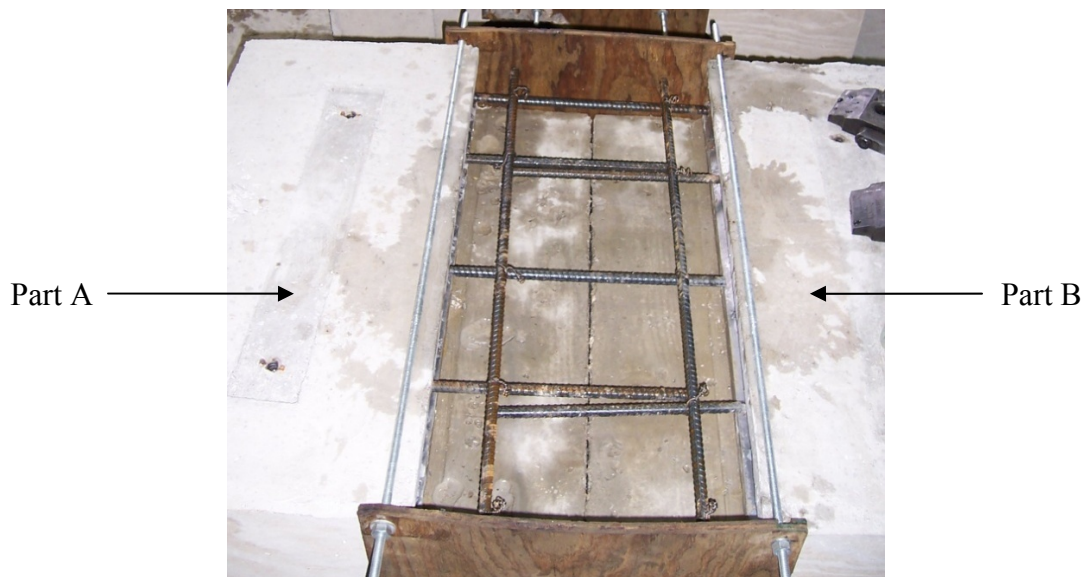
**Figure 2.16. Position of reinforcing bar before closure**

For the closure pour, the specimens (Parts A & B) were arranged as shown in Figure 2.12. Pieces of plywood, held in place with threaded rods, were used to cap the ends of each closure area. Six 30 in. long #4 bars (two for each specimen) and nine 14 in. long #4 bars (three for each specimen) were placed in the closure area. The 30 in. bars were placed longitudinally in the joint, one on each side, 3.25 in. from the center of the joint. The three 14 in. bars for each specimen were placed transversely across the joint. One bar was centered between the protruding bars and two bars were placed near the end of the closure area; this reinforcing is shown in Figure 2.16.

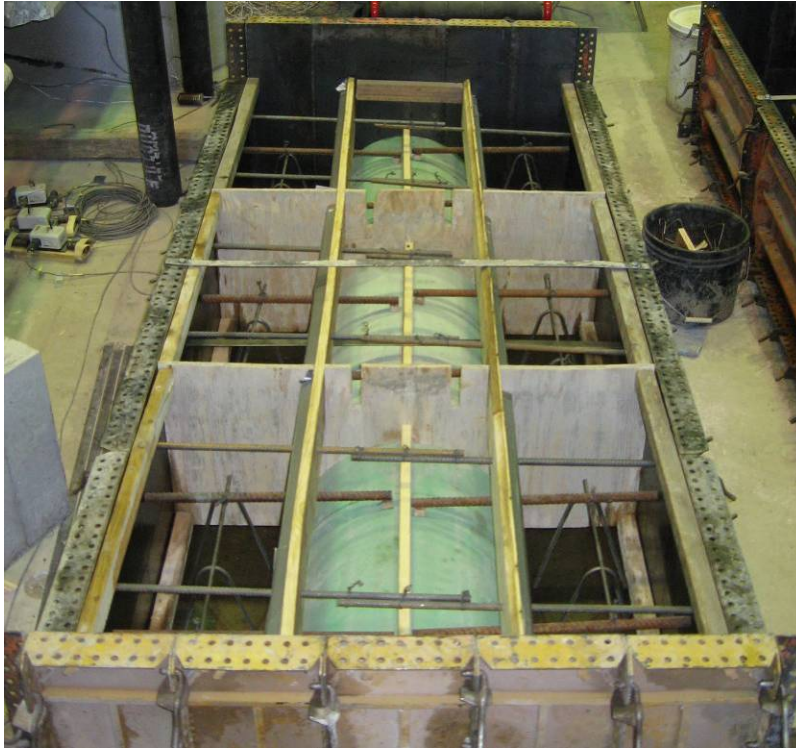
**Figure 2.23. Completed formwork for Type 3 Connection**

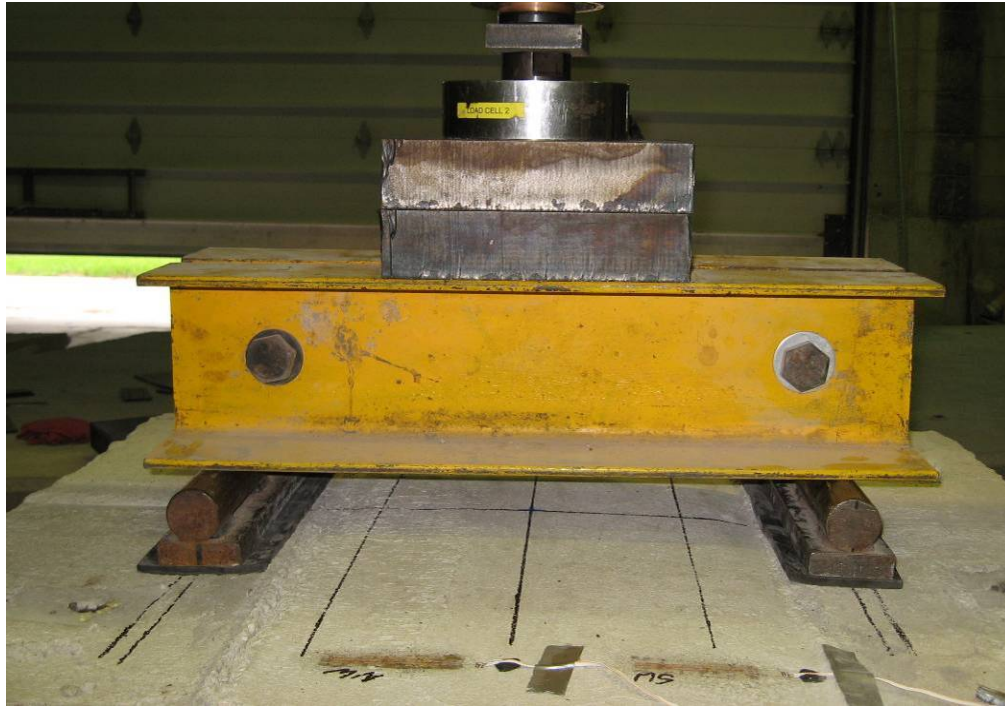
After a specimen was loaded at all five load positions, the specimen was set-up for ultimate load testing. To load the specimen at two locations, a beam was used to span the distance between the load points shown in Figure 2.31. By loading the midpoint of the span of the load beam, equal force was applied at each load position. Force was applied until failure of the specimen occurred. Strain and deflection data were recorded at 1000 pound increments. After failure, the broken specimen was examined, removed from the testing area, and then the next specimen was set in place.

**Figure 2.31. Ultimate load test set-up**

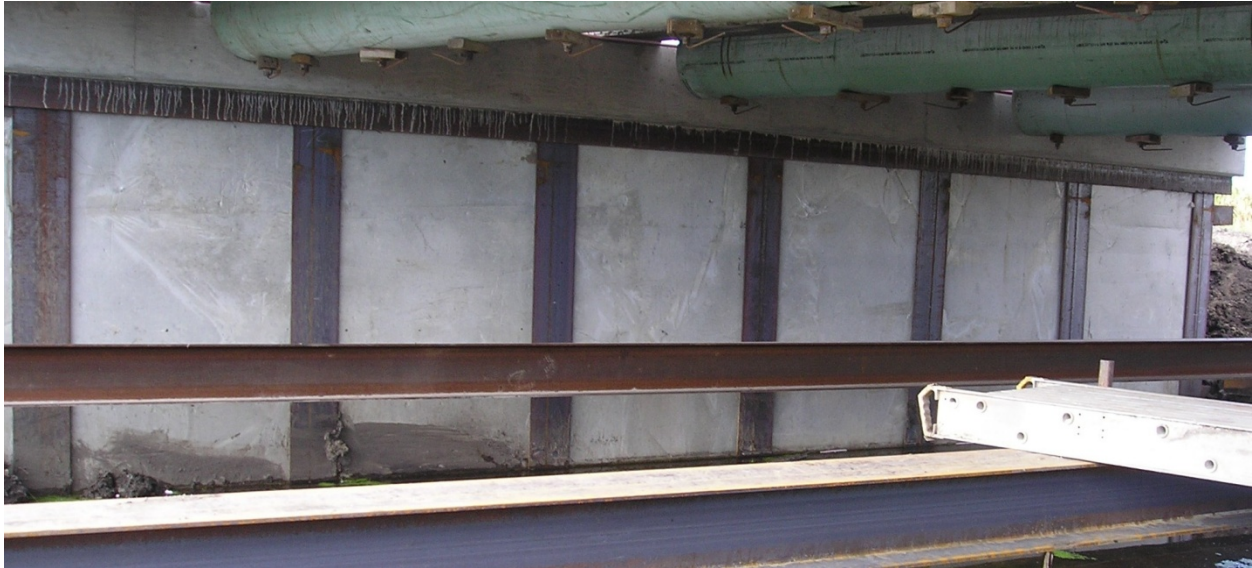
**Figure 2.33. Abutment backwalls in the field**

b) Photograph of backwalls in field

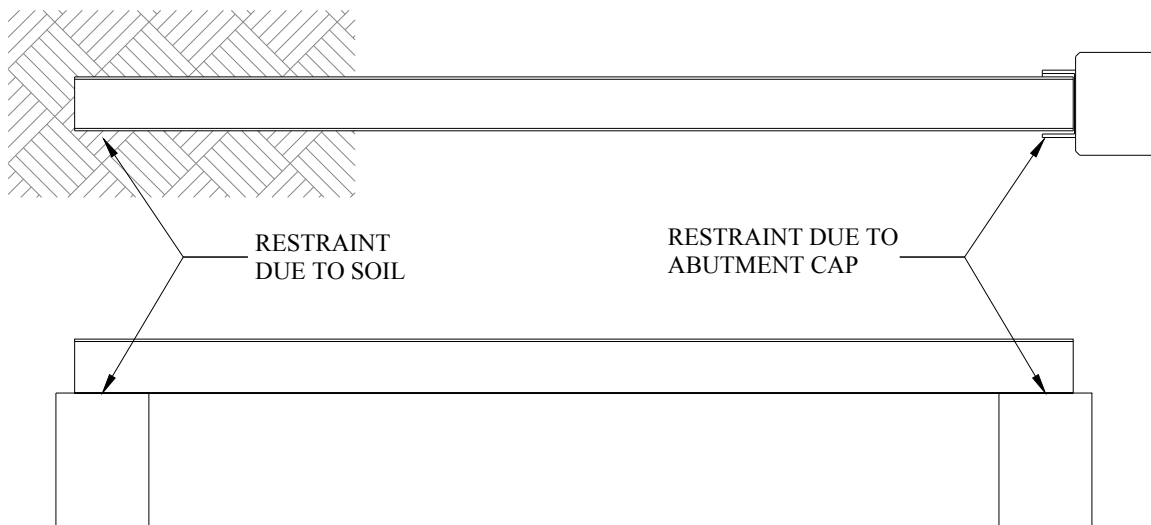
In the field, the backwall is restrained laterally at its top edge by the dead weight of the bridge deck acting on the abutment cap, which sits on top of the backwall. At the bottom, lateral restraint is also present due to the soil surrounding the wall. For the laboratory testing, the backwall was modeled as simply supported at the top and bottom of the wall, with the long edges free. For the loading, it was assumed that the front of the wall was not supporting any soil, as would happen due to extreme scouring, and that the back of the wall was supporting a granular soil. Simulation of the field support conditions in the laboratory set-up are presented in Figure 2.34.

**Figure 2.34. Correlation of field conditions to the laboratory set-up**

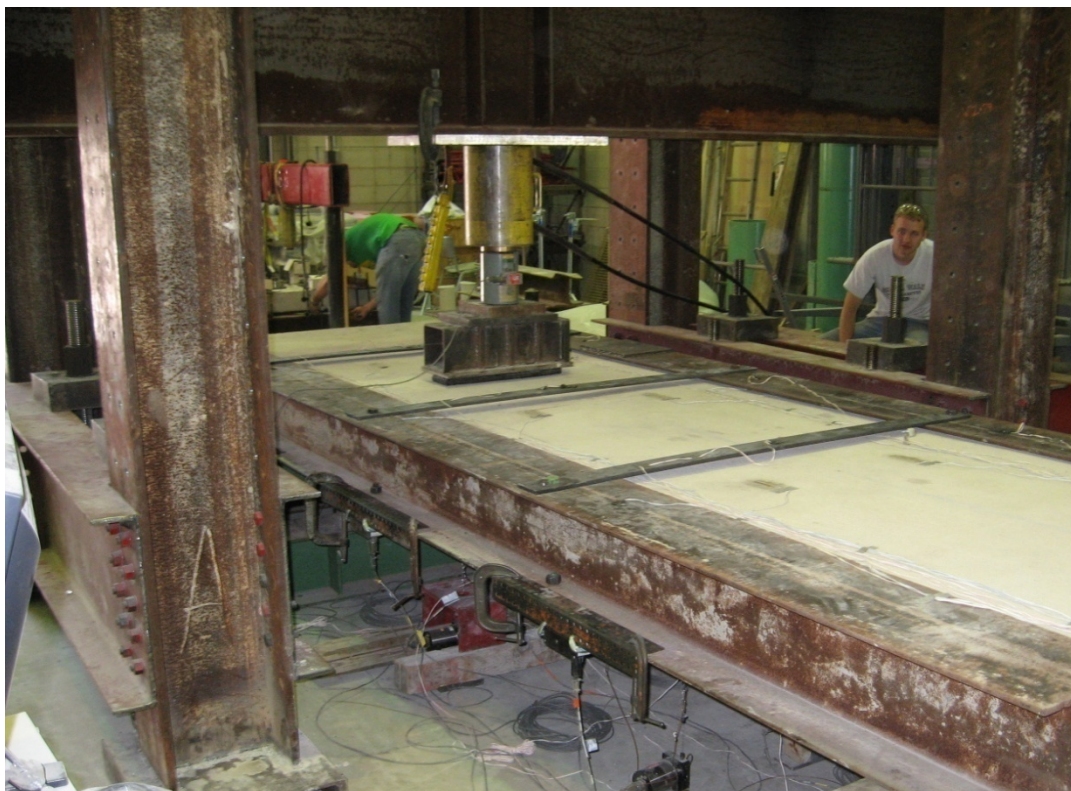
The position of the load in the ultimate strength test is 61.4 in. from the bottom of the wall, as shown in Figure 2.40. This location corresponds to the location of the resultant force due to worst case soil loading and five 5-ton axles spaced at 4.25' on the abutment. Load was applied at this location until the wall was unable to support the load.

a) Location of load for strength test

b) Photograph of test in progress

An ultimate load test was performed by loading the slab at a single point 61.4 in. from the bottom of the wall. The slab was damaged during the first attempt when the spliced H-pile failed; the quality of the weld was poor, and the tension flange ruptured. At the time of the failure, the system was carrying 80 kips. The H-pile was repaired by welding plates to the exterior of each flange, and using a full-penetration weld along the web; the splice repair is shown in Figure 3.20.

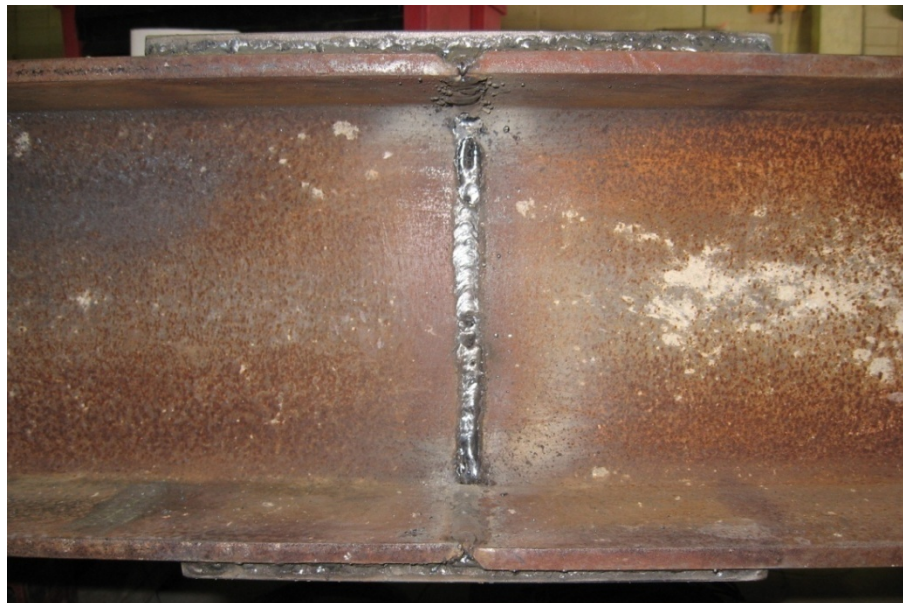
**Figure 3.20. Repaired H-pile splice**

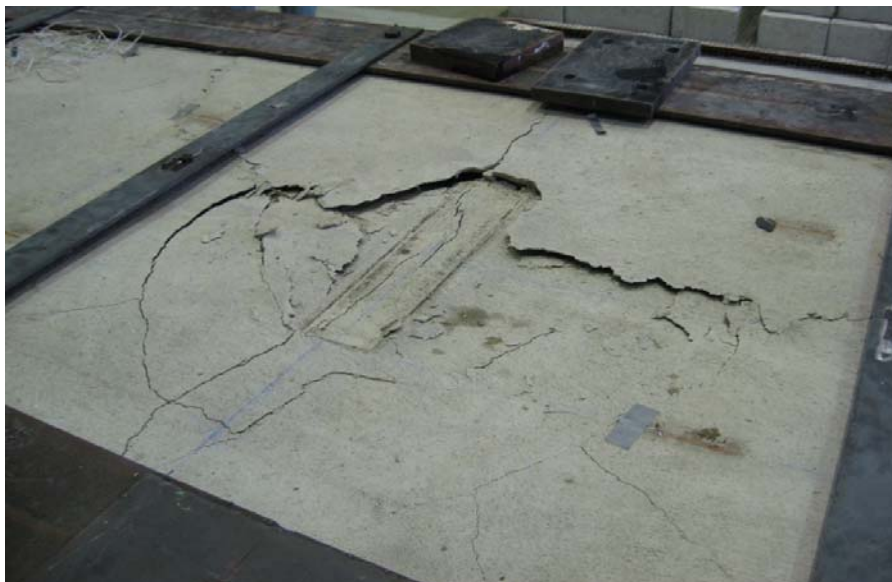
**Figure 3.22. Failed abutment backwall specimen**
