MIDWEST SMART WORK ZONE DEPLOYMENT INITIATIVE

Testing Temporary Work Zone Rumble Strips

Alan J. Horowitz and Thomas Notbohm

March 4, 2005

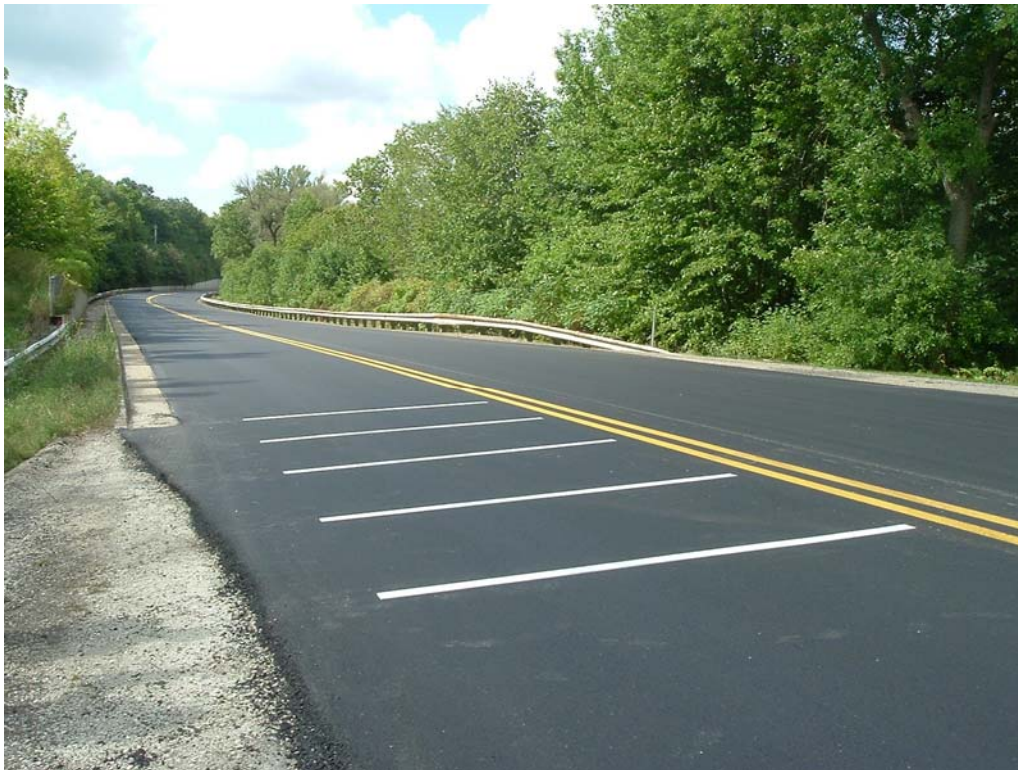
FIGURE 1 Eastbound Test Strip, Viewed Looking West (Upstream)

The ATM rumble strips were deployed within an actual work zone in Washington County, Wisconsin along STH 33. This essentially rural work zone was 3 miles long with its western end located east of West Bend, WI and its eastern end located within Newburg, WI. STH 33 is a two-lane highway. The rumble strips were first deployed to locations just ahead of flaggers on a Thursday, then left as they were for the subject evaluation by drivers on Friday and objective measurements on Sunday. Figure 1 shows the installation of the eastbound (EB) rumble strip on new pavement, and Figure 2 shows the installation of the westbound (WB) rumble strip on pre-existing pavement. Each rumble strip consisted of 5 bumps spaced 7 feet apart. The spacing was chosen by WisDOT such that a motorcycle would be unlikely to have both wheels over bumps at the same time.

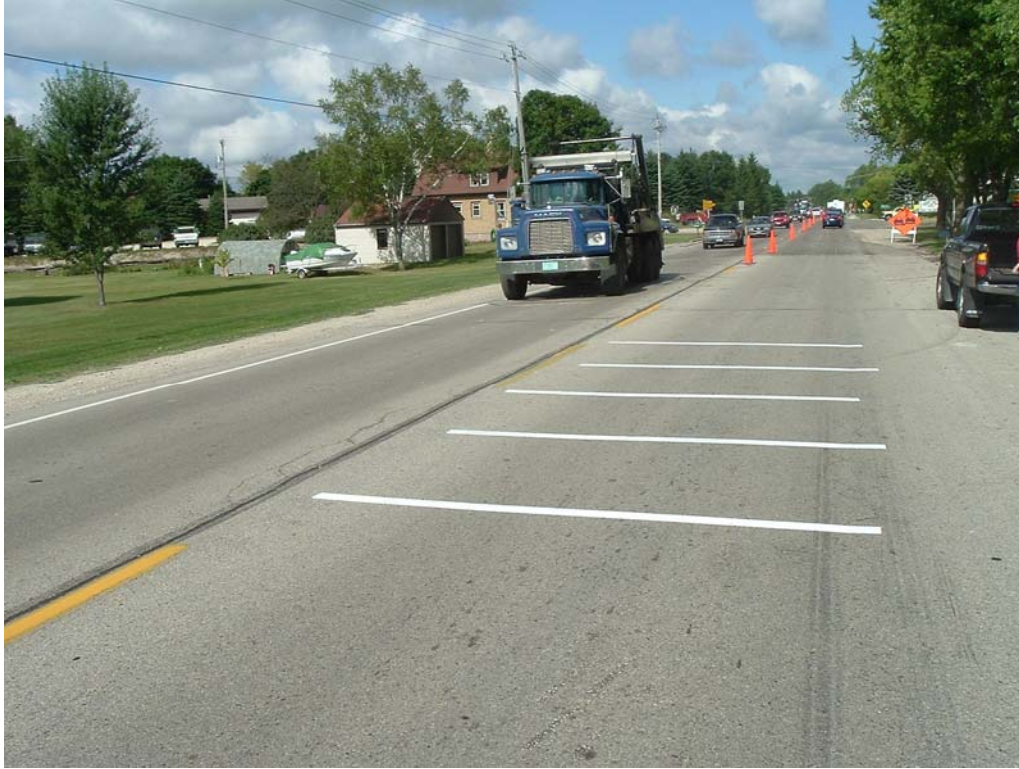
FIGURE 2 Westbound Rumble Strip, Viewed Looking West (Downstream)

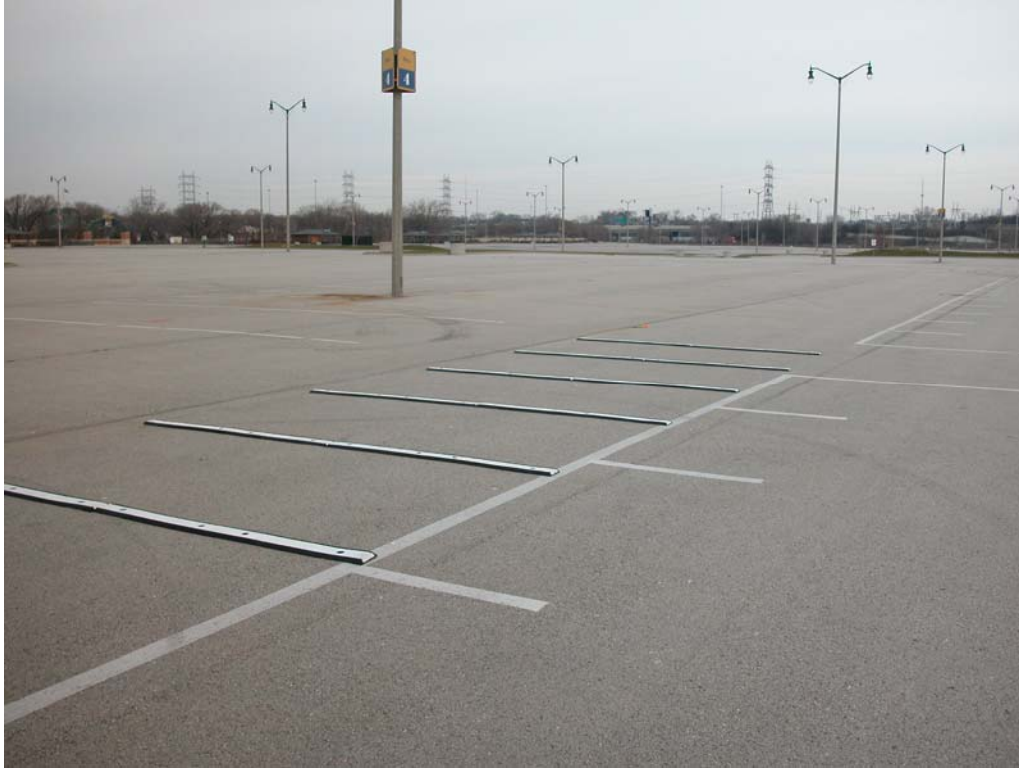
Figure 3 Deployment of RTI Bumps in Parking Lot at Seven Foot Spacing

The RTI bumps were installed in a very large parking lot so that sound levels could be measured at varying speeds from 10 to 40 miles per hour. The pavement within the parking lot was almost new condition. The RTI product was not affixed to the pavement with adhesive. Figure 3 shows the location of the strips within the parking lot.

Each RTI bump was 6 feet long, so they were aligned in pairs to create a bump that was 12 feet long. Six pairs were arrayed for each test. Thus, the amount of time a vehicle spent over each strip was affected by the spacing. The total longitudinal distance across all bumps ranged from 10.5 feet for the 2-foot spacing to 35.5 feet for the 7-foot spacing.

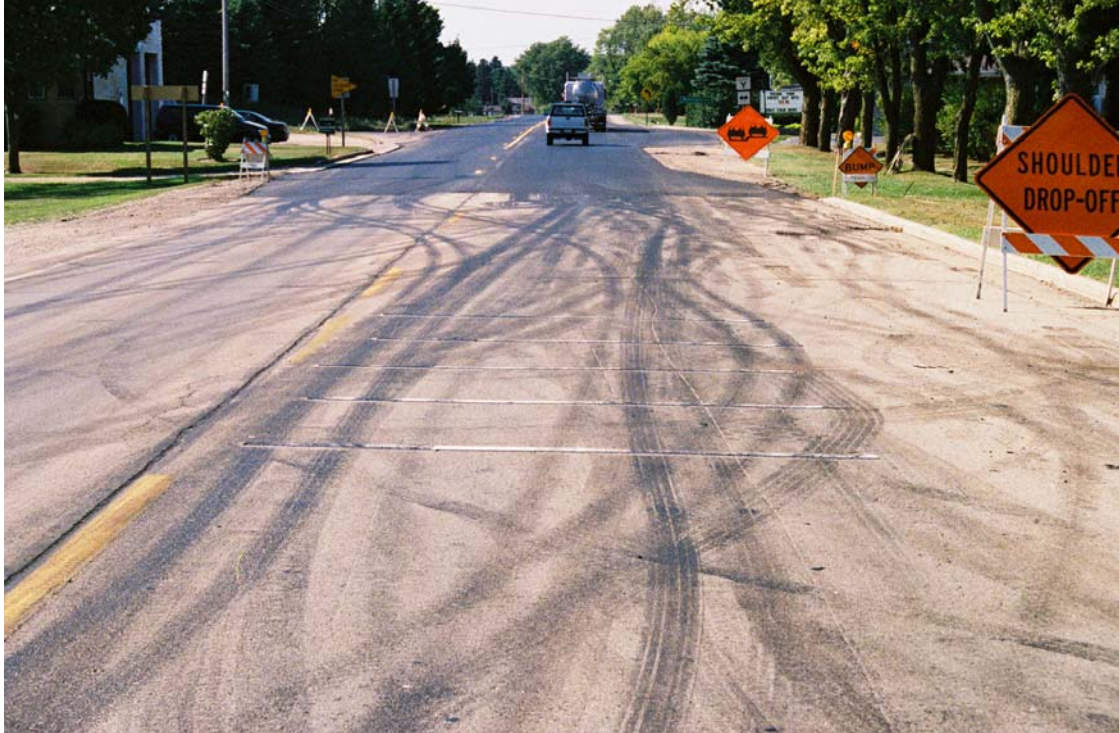
FIGURE 7 WB Test Strip at End of the Day of Psychological Scaling, Viewed Looking Downstream

The visibilities of the strips were expected to be influenced by the sun angle at different times of the day. A more important influence, it was found, was the soiling of the WB strip, which became worse as the day progressed. The soiling was caused by loose oil that had been spilled about 100 ft upstream of the strip. Figure 7 is a picture of the WB strip, taken about ½ hour after the last subject completed the course. The view is from the east. Late in the day the strip was barely visible to an approaching driver and would probably have been unseen by any driver not specifically looking for it.

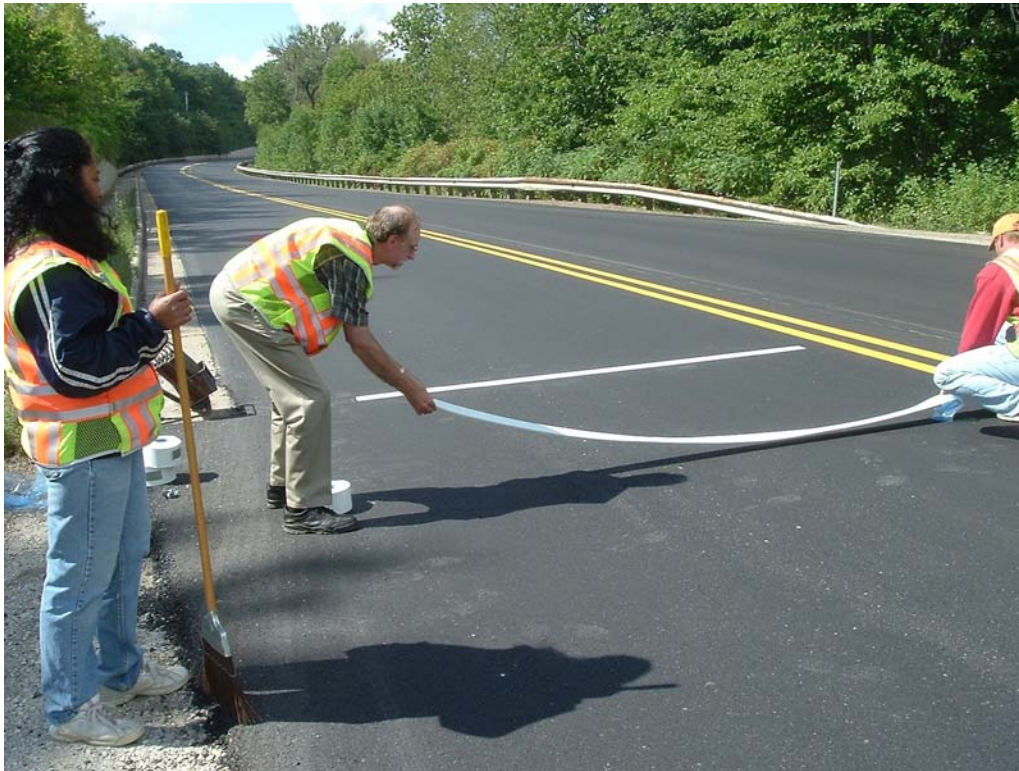
FIGURE 8 Installation of the Work Zone Test Rumble Strip

Figure 8 shows the installation process for the EB strip. Although this photograph shows two people applying a bump, it was later ascertained that one person could do the job in about the same amount of time. The tamping cart and extra bump material can be seen on the left hand side of the figure, just in front of the worker holding the broom handle. Washington County used a small asphalt roller that they owned for pothole repair to press the strips to the pavement.
