# Performance-Based Evaluation of Cost-Effective Aggregate Options for Granular Roadways

**Final Report**  
**October 2019**

**Sponsored by**  
Iowa Highway Research Board  
(IHRB Project TR-704)  
Iowa Department of Transportation  
(Intrans Project 16-570)

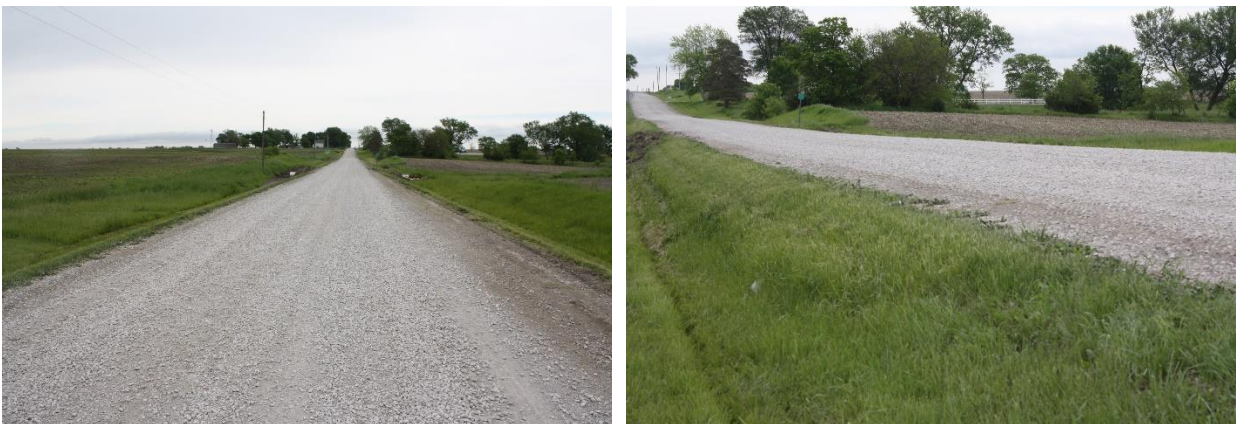
This site was selected for several reasons. Annual average daily traffic (AADT) for this location was 80. Daily traffic load and the percentage of trucks were slightly above average compared to other granular roads in Iowa (Iowa DOT 2012). The surface level of the road was reasonably higher than the ground surface around the road. This provides better conditions for drainage. In addition, the site was three miles away from an interstate, which provided reasonable accessibility. Furthermore, the subgrade was very strong (California bearing ratio [CBR] >5). Figure 2 shows the site prior to construction.

**Figure 2. CR J22 before construction**

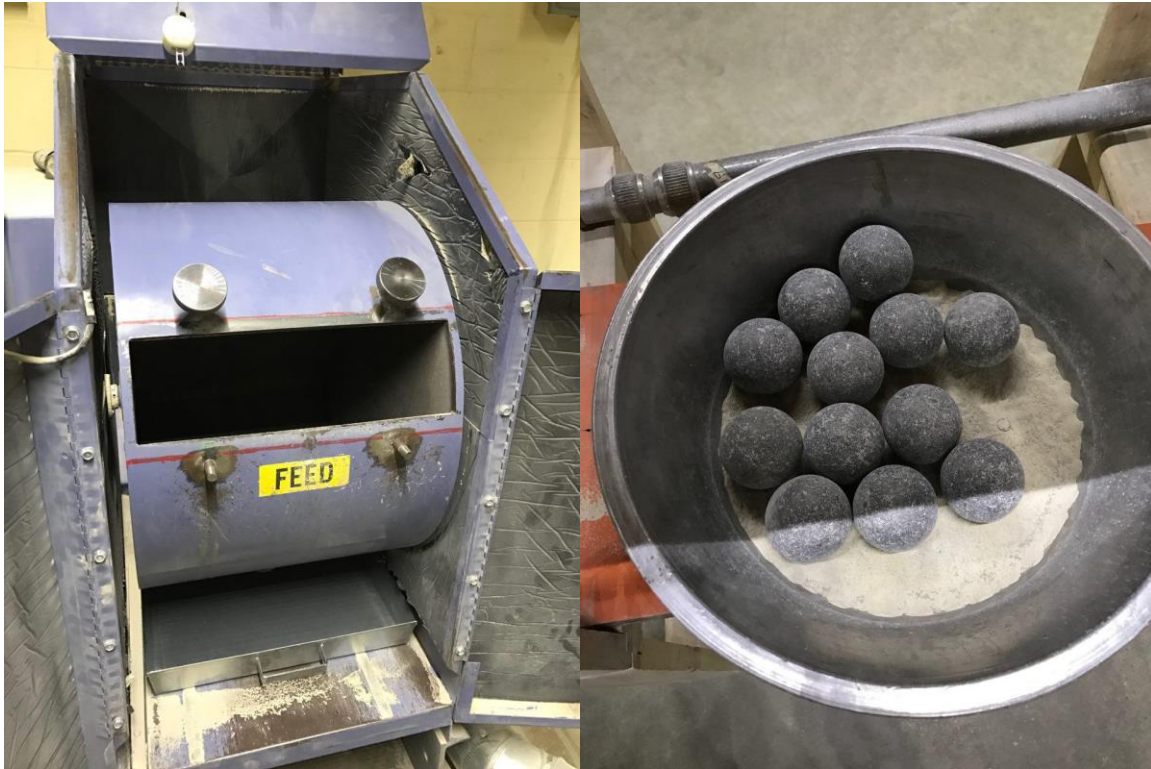
The LA abrasion test was performed on aggregate particles over  $\frac{3}{4}$  in. in size to evaluate their degradation. It was conducted in accordance with ASTM C535-12 Standard Test Method for Resistance to Degradation of Large-Size Coarse Aggregate by Abrasion and Impact in the Los Angeles Machine. Soil samples were placed into the LA abrasion machine's steel drum alongside 12 steel spheres, and the drum was rotated at 30–33 rpm for 500 revolutions. The change in the weight of the washed and dried aggregate materials above sieve #12 is reported as the percentage of loss (Iowa DOT 2018). This test was performed on granular road surface aggregate materials from all sections to determine the degradation resistance of each material. Figure 5 shows the LA abrasion equipment.

**Figure 5. LA abrasion test device**

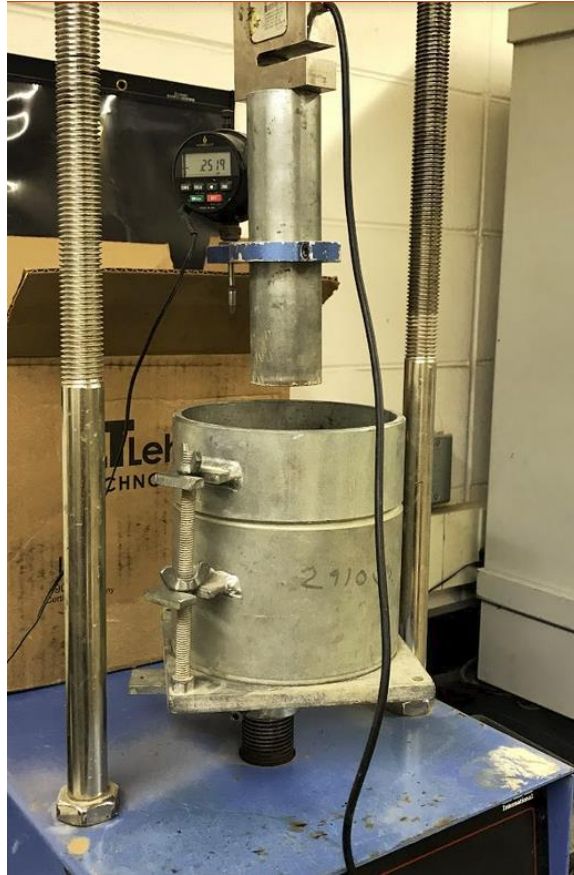
The CBR test was performed to evaluate the shear strength of the granular road surface aggregate and subgrade materials. It was conducted in accordance with ASTM D1883-16 Standard Test Method for California Bearing Ratio (CBR) of Laboratory-Compacted Soils. Each specimen was compacted at optimum moisture content with standard Proctor energy. CBR tests were performed on both unsoaked and soaked specimens to simulate the optimum and saturated conditions in the field, respectively. Figure 8 shows the CBR equipment.

**Figure 8. California bearing ratio device**

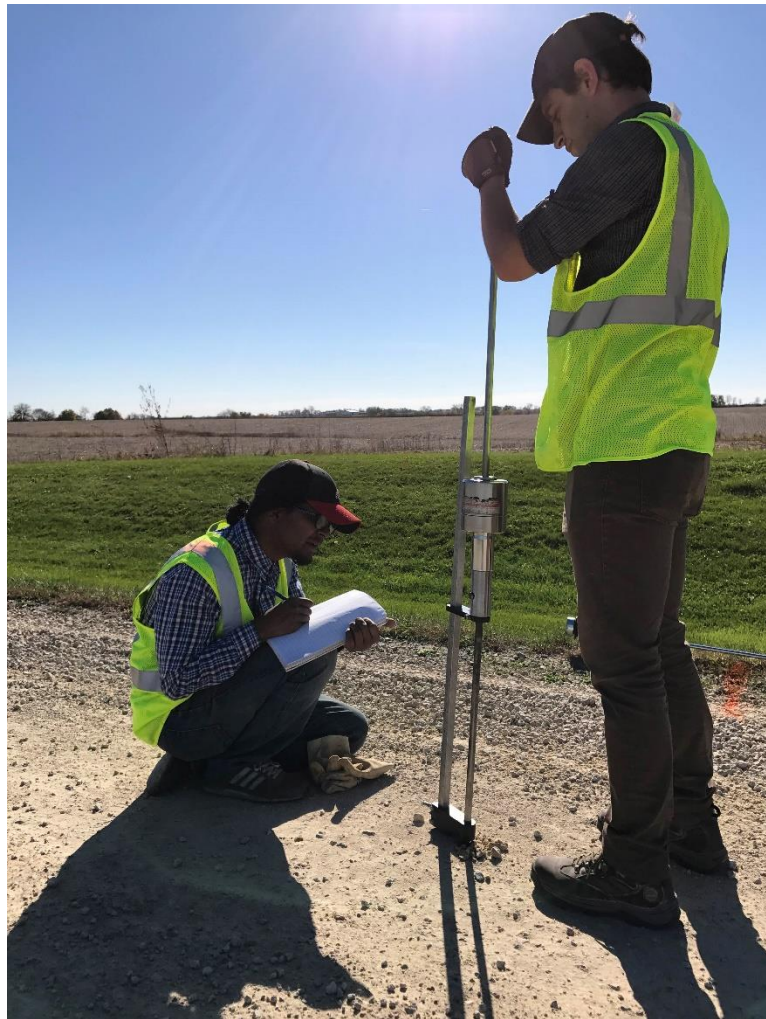
D6951 (D6951M-09 2015). A DCP cone with a 0.79 in. base diameter was used to penetrate to the soil up to 23 in. by using a 17.6 lb hammer. Figure 17 shows the DCP setup.

**Figure 17. Dynamic cone penetrometer device**

Using the DCP index (DCPI) (in./blow) as the rate of penetration and empirical correlations based on the ASTM standard, the CBR values for each layer were calculated, as noted in equations 17 and 18.

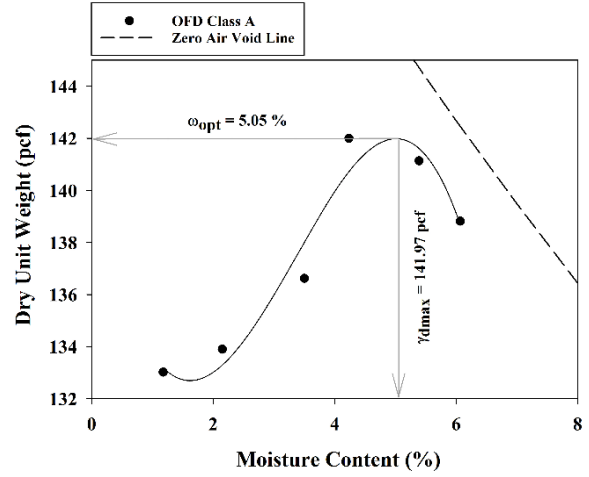
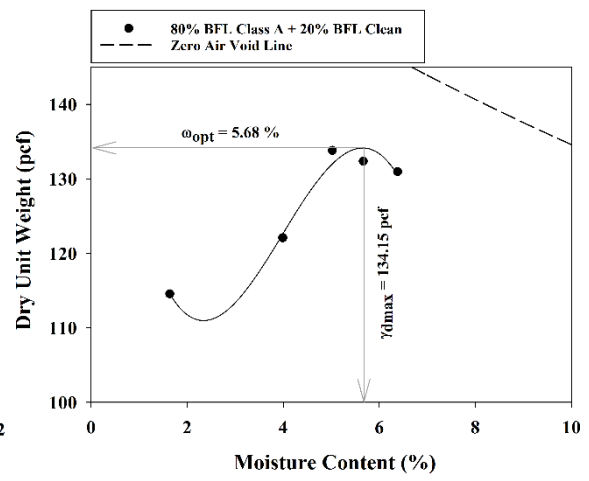
Moreover, the eight graphs in Figure 29 show the compaction curves obtained for all materials along with zero air void lines.

**Figure 29. Dry density vs. water content graphs from standard Proctor tests for all materials**

The standard Proctor test was performed on the surface aggregate materials and subgrade to determine the optimum moisture content ( $w_{opt}$ ) and the maximum dry density ( $\gamma_{dmax}$ ) of each material (ASTM D698-12e1). A summary of the results is shown in Table 5.

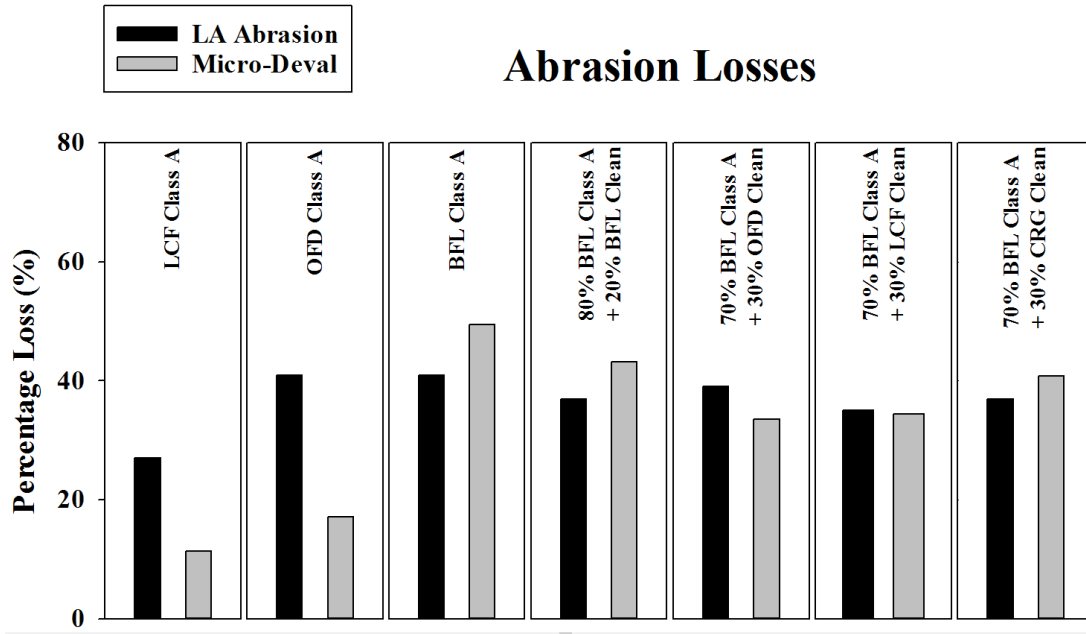
The results of the LA abrasion and Micro-Deval tests performed on all of the surface materials are presented in Figure 32.

**Figure 32. LA abrasion and Micro-Deval test results**

The Micro-Deval test results showed that the LCF Class A experienced the least material loss (11%) while local BFL Class A had the highest material loss (49%). This indicates that the BFL Class A does not have high durability under wet conditions. After LCF Class A, OFD Class A had the second lowest Micro-Deval material loss (17%). Material loss for the mixtures of BFL Class A with the four clean aggregates were between 33% and 43% according to the Micro-Deval tests. These results indicate that inclusion of BFL Class A in the surface mixtures will yield a significant decrease in the resistance to abrasion.

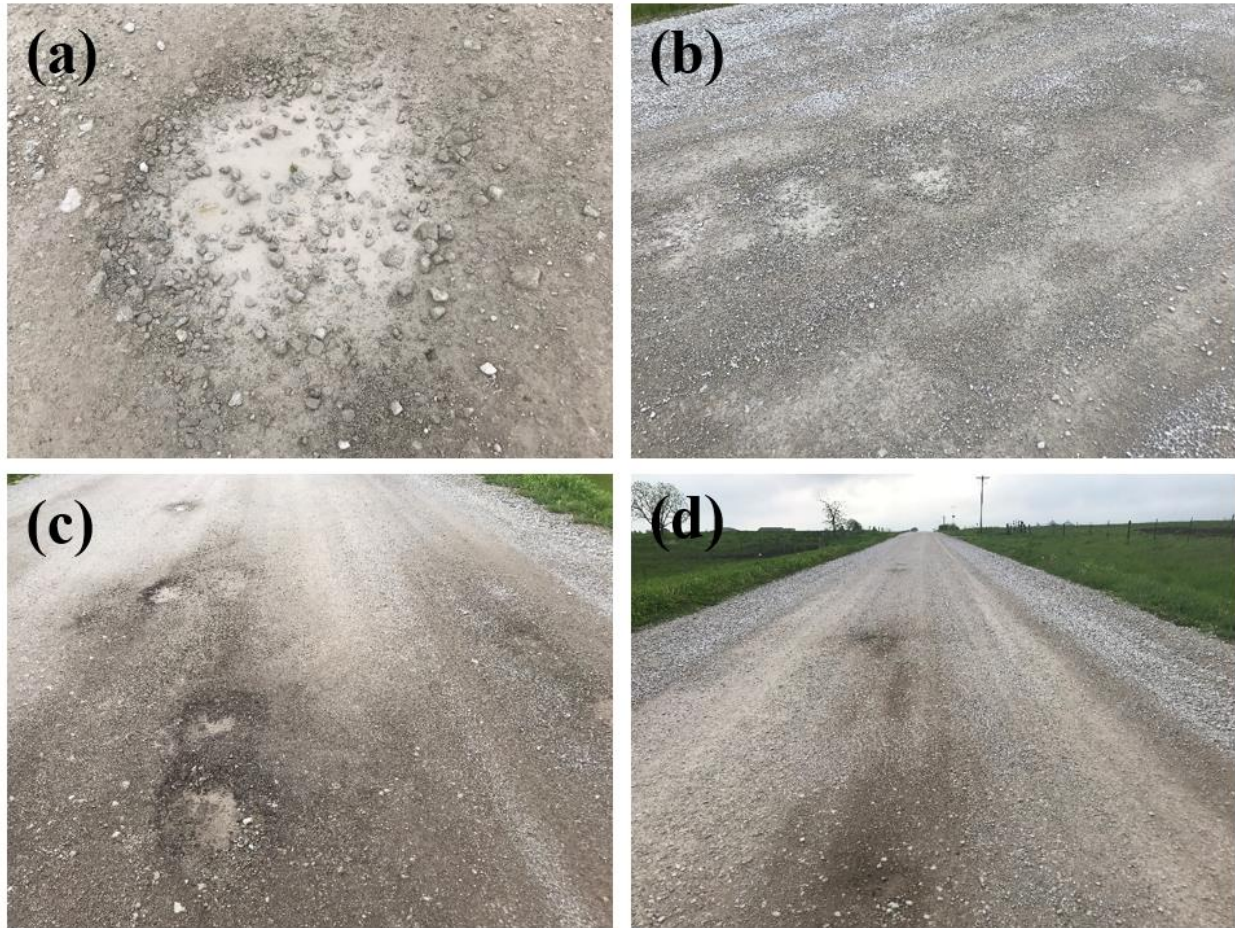
Granular roadways in cold regions, such as Iowa, are prone to harsh surface deteriorations and distresses due to freezing and thawing. Figure 49 shows a few examples of these distresses, including potholes, rutting, and wash boarding.

**Figure 49. Distress types on surface materials: (a) big pothole in middle of BFL Class A, (b) severe rutting in 80% BFL Class A + 20% BFL Clean, (c) scattered potholes in 70% BFL Class A + 30% LCF Clean, and (d) material movement 70% BFL Class A + 30% CRG**
