Field Demonstration of an Innovative Box Beam Connection

tech transfer summary

February 2023

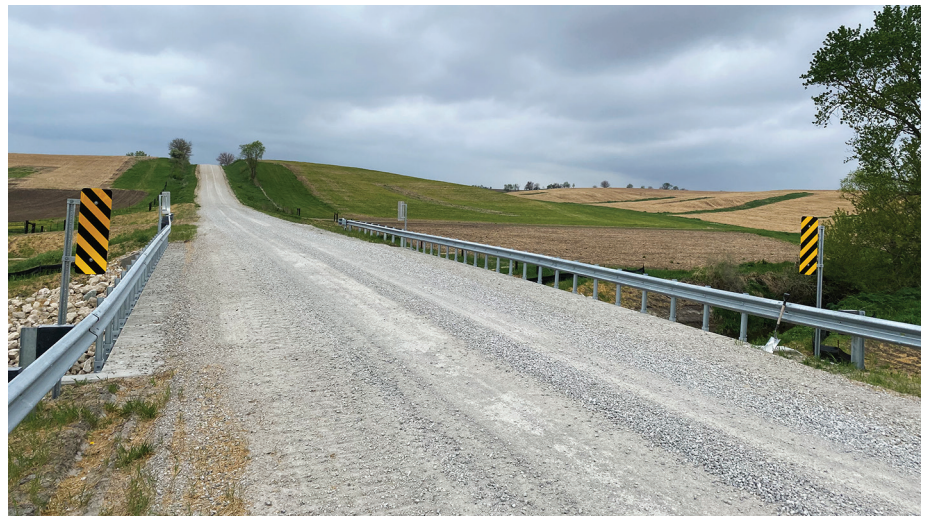
Completed box girder bridge in Washington County, Iowa

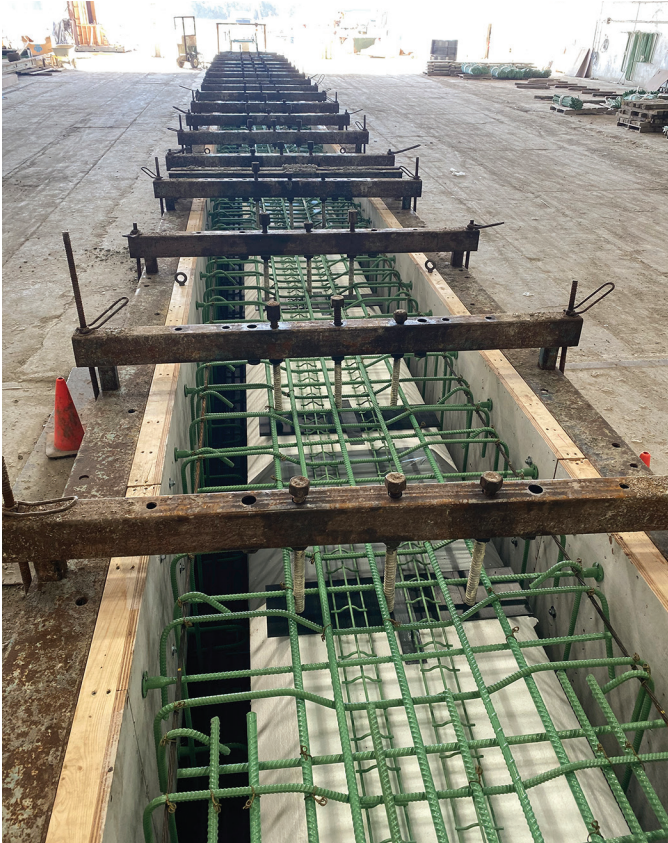
Box girder form with reinforcement in precast concrete plant

The research team observed and documented the fabrication of specially designed box girders in a precast concrete plant and the field construction of the bridge, including installation of the girders and placement of the joint concrete. The bridge was constructed in early October 2020 and opened to traffic in November.

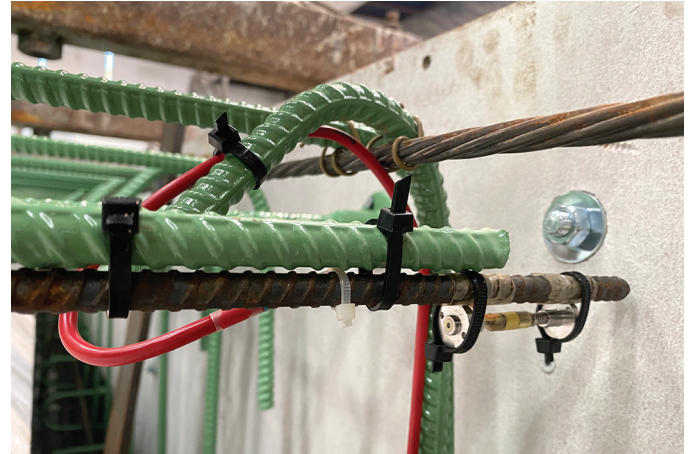
Embedded strain gauge at the top of a box girder before concrete pouring

During construction, two joints were selected for early-age monitoring, and 24 strain gauges with thermistors were embedded in the joints and adjacent girders. A seven-day

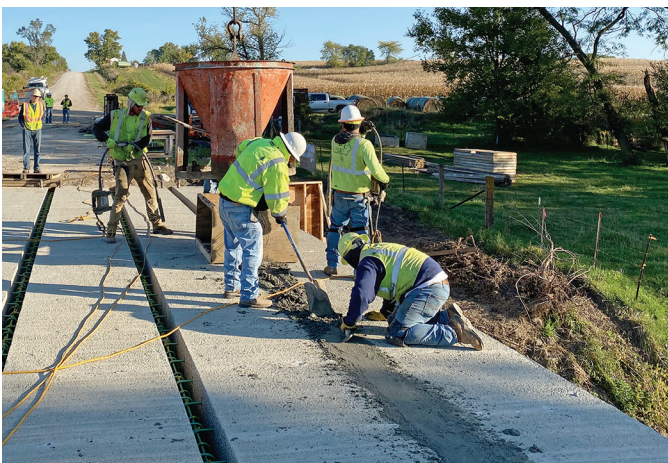
Placement of joint concrete in the field

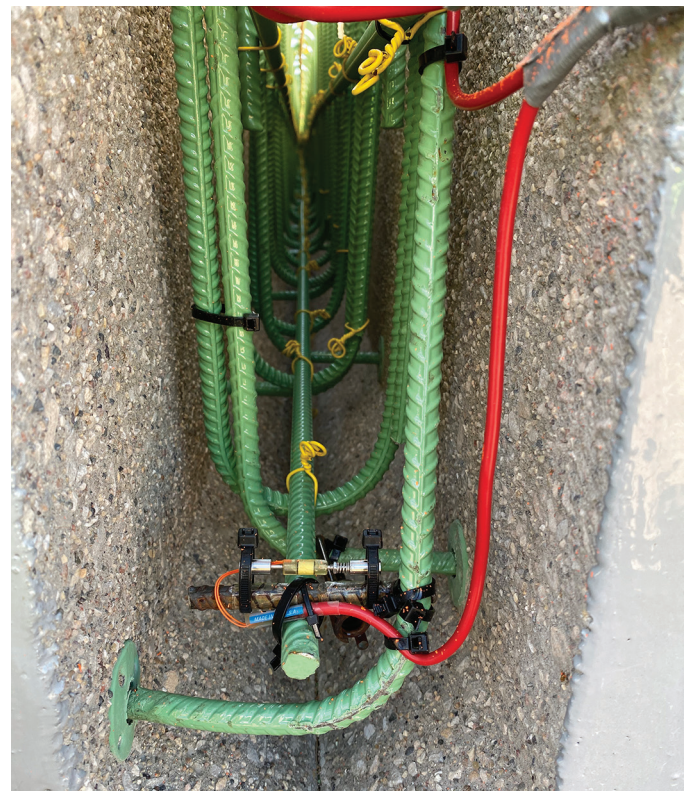
Embedded strain gauge at the bottom of a joint before concrete placement

field monitoring period focusing on those joints began immediately after construction, with temperature and strain data collected every 10 minutes.

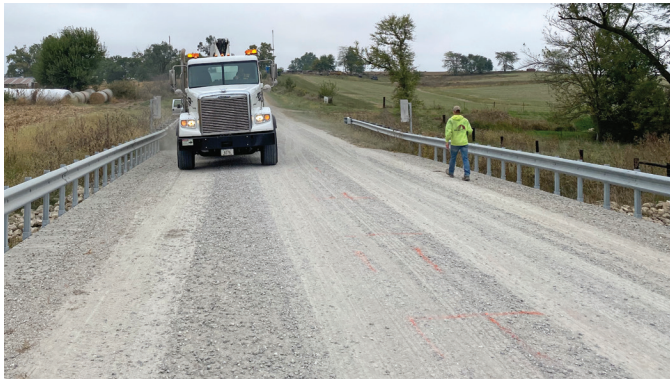
Live load testing

After the bridge was opened to traffic, long-term monitoring commenced. The bridge was instrumented with eight strain gauges and six displacement transducers, and three live load tests were conducted in November 2020, October 2021, and August 2022 to evaluate load distribution and performance changes over time. Additionally, the bridge deck was visually inspected in October 2020, May 2021, October 2021, and August 2022 to monitor cracking.
