Simple Design Alternatives to Improve Drainage and Reduce Erosion at Bridge Abutments

ABSTRACT

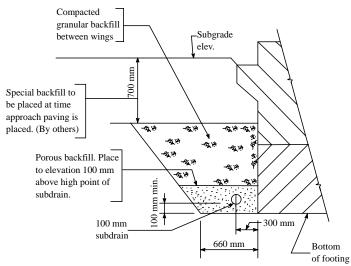
Figure 1. Typical Iowa DOT subdrain design (Iowa DOT Bridge Standards 2005)

Monitoring new bridges under construction also revealed that out of eight bridges, only two bridges had the proper porous backfill material around the perforated subdrain (see Figure 1). Other bridges used granular backfill directly around the subdrain, which is believed to contribute to plugging of the drain tile. Determining the grain-size distribution for six granular samples collected at six bridge sites and comparing them to the average opening sizes of the perforated subdrains revealed that, on average, about 70% of the granular backfill gradation is finer than the average openings of the perforated subdrain (about 2 mm). On the other hand, porous backfill with no particles smaller than the No. 8 sieve has virtually no material finer than the openings of the perforated subdrain.

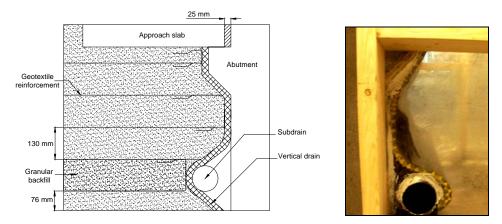
Figure 7. Using geosynthetic vertical drain at the face of the abutment with soil reinforcement

For the geocomposite drain with backfill reinforcement (No. 9 in Table 1), the drainage detail consisted of a vertical geocomposite drain which was 1.9 cm thick HDPE polymer (see Figure 7). The geocomposite drain was laminated with a non-woven, needle-punched geotextile. Granular backfill material was placed at a 12% moisture content and compacted every 5 cm lifts to an average relative density of about 65%. Geotextiles were used as backfill reinforcement. The first reinforcement layer was placed on top of 7.6 cm of granular backfill lift at the bottom of the model. Additional geotextile layers were placed every 13 cm. At the abutment face, the geotextiles were folded and embedded under the overlying reinforcement. The length of the embedded geotextile was approximately 13 cm. After four hours of running the test, no void or settlement developed, and the maximum steady state flow measured was 383 cm^3/sec, which is approximately 12 times higher than the value measured using the specified Iowa DOT drainage detail (Nos. 1-3 in Table 1).

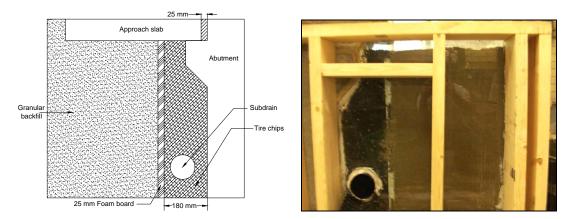
Figure 8. Using tire chips behind the bridge abutment

Similar to drainage detail No. 9, No. 12 (see Table 1), which uses tire chips behind the bridge abutment, showed good performance. The purpose of test No. 12 was to evaluate the use of tire chips as a drainage material, as well as its effectiveness in alleviating settlement and void development. Tire chips were placed behind the abutment without compaction over an 18 cm wide zone. For a separation barrier, a 2.5 cm thick foam board was placed between the tire chips and the granular backfill (see Figure 8). Granular backfill material was placed at a moisture content of 12%, and compacted in 5 cm lifts. An average relative density of about 70% was achieved. After four hours of running the test, the use of tire chips combined with saturated granular backfill eliminated settlement and void formation. The maximum steady state flow measured was 552 cm^3/sec, which is 43% higher than the drainage detail No. 9 and 17 times higher than drainage details Nos. 1 through 3. Although 30% of the tire chips were smaller than the drainage pipe openings, none of the tire chips were washed out. Even though this drainage detail No. 12 resulted in the highest flow capacity, this detail may require more complex construction.

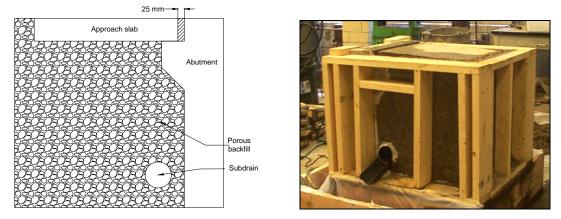
Figure 9. Using porous fill material behind the abutment

Another successful drainage detail was drainage model No. 13 (see Table 1), where porous backfill was used as a substitute for the granular material behind the abutment (see Figure 9). The drainage detail was evaluated based on the excellent performance of the porous material in the collapse test (no measurable collapse). The porous fill was placed at a moisture content of 4.6% and compacted every five cm to an average relative density of about 71%. The porous backfill prevented void formation and approach slab settlement. Furthermore, the maximum steady state flow measured was 92 cm^3/sec, which is approximately three times higher than the maximum steady state flow measured using the current Iowa DOT specification drainage detail (Nos. 1 through 3). However, the maximum steady state flow was lower than the measured using a geocomposite vertical drain and tire chips. Despite the relatively low flow, drainage detail No. 13 can be applied at bridge sites due to its good performance and simple construction sequence.
