Identification and Evaluation of Pavement-Bridge Interface Ride Quality Improvement and Corrective Strategies

Institute for Transportation

Report Number FHWA/OH-2011/1

January 2011

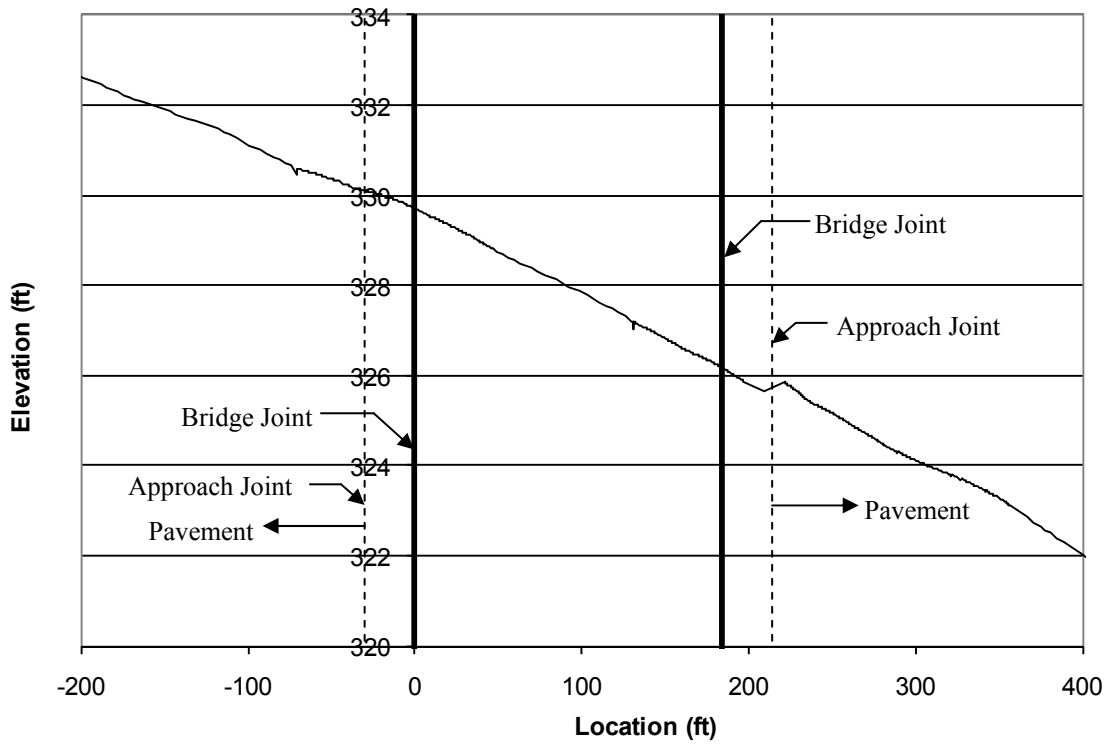
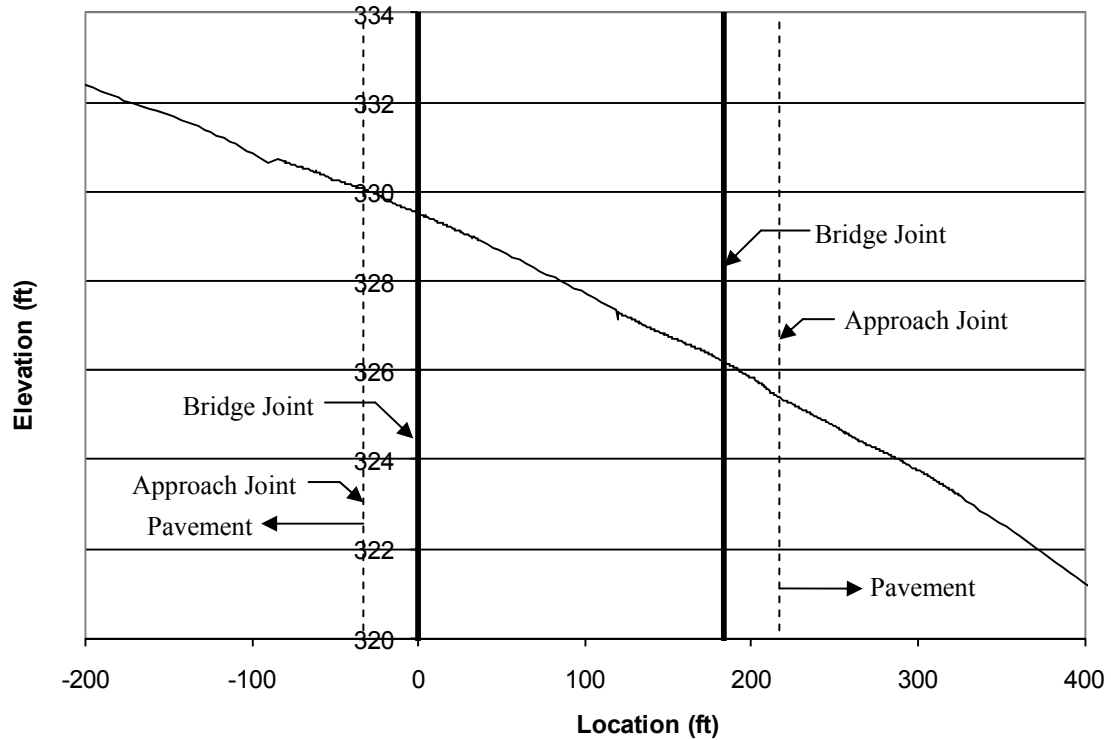
Figure 5.11. FAI 33-14.17 bridge geometric testing results

Figures 5.11a and 5.11b show the results of the laser-based survey. As can be seen, there is an overall slope of the bridge with three global geometric discontinuities observed. The first global discontinuity occurs at the entry end of the bridge and can be observed in both the right and left wheel lines. The location of the discontinuity relative to the bridge indicates that the discontinuity may be at the end of the approach slab system. The second discontinuity occurs on the bridge and can, again, be seen in both wheel lines. This discontinuity may be occurring at an on-bridge joint. The third and final discontinuity occurs only in the right wheel line after the exit end of the bridge. This discontinuity is a noticeable “ramp” occurring in the region of the approach slab.

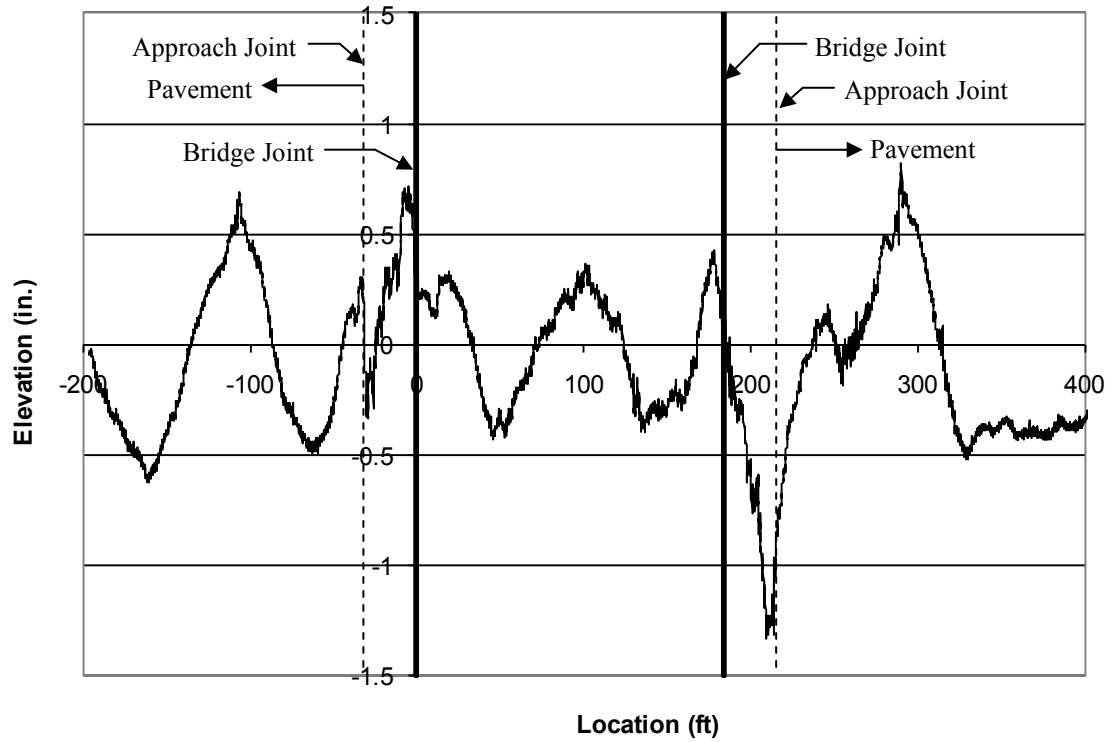
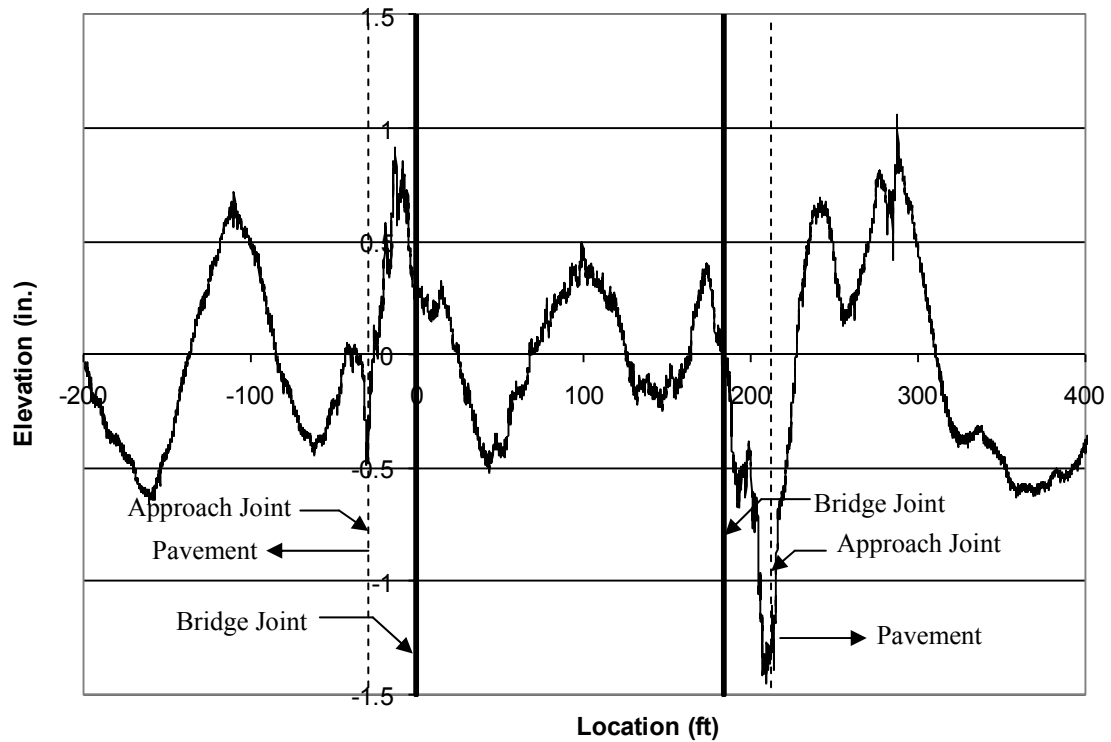
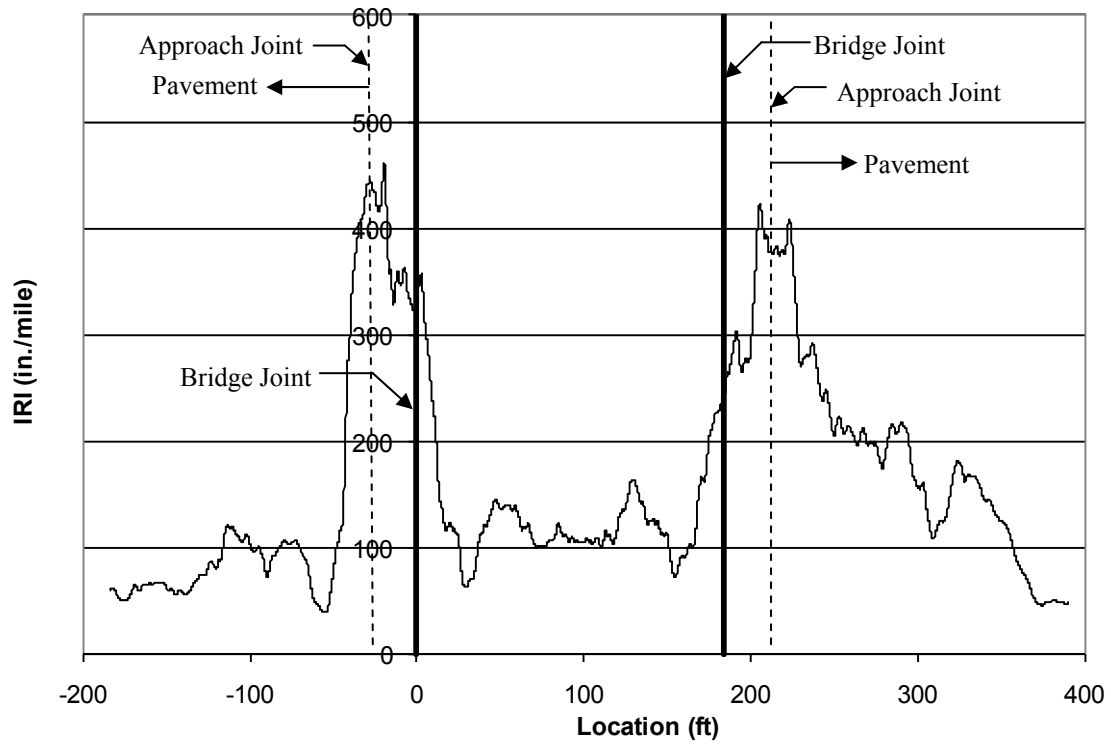
The raw profiler data are shown in Figures 5.11c and 5.11d. From these data it can be observed that both left and right wheel lines tend to track well together before/after the approach slabs. A general agreement in measurements can also be seen on the bridge itself. However, the approach slab regions show differing profiler data in the approach slab regions. The difference is most marked on the exit end of the bridge—possibly related to the right wheel line global geometric discontinuity noted above. The IRI results continue to corroborate the findings noted above. Further, the IRI results in the approach slab regions show IRI values approaching 600 in./mile. It should be noted that here, and in subsequent similar discussions, that maximum, instantaneous values will be cited. It is important to note that these represent the worst measurement for the site and not the site average. These instantaneous values speak to localized roughness, which usually occurs at the bridge-pavement interface.

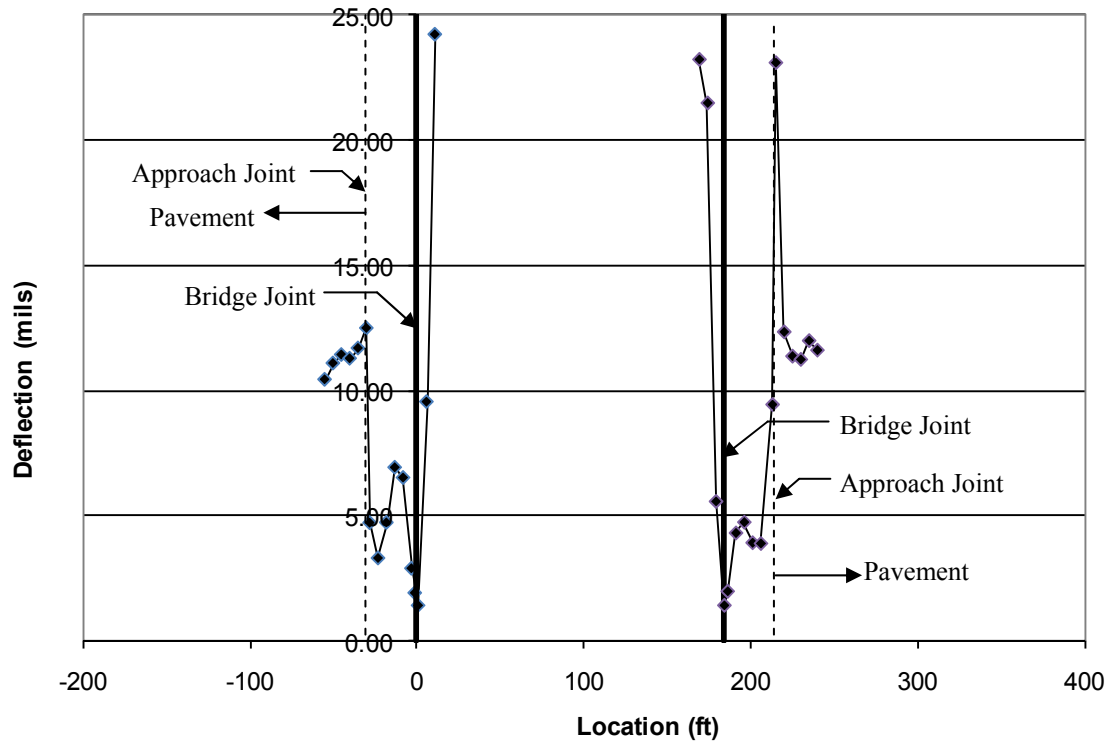
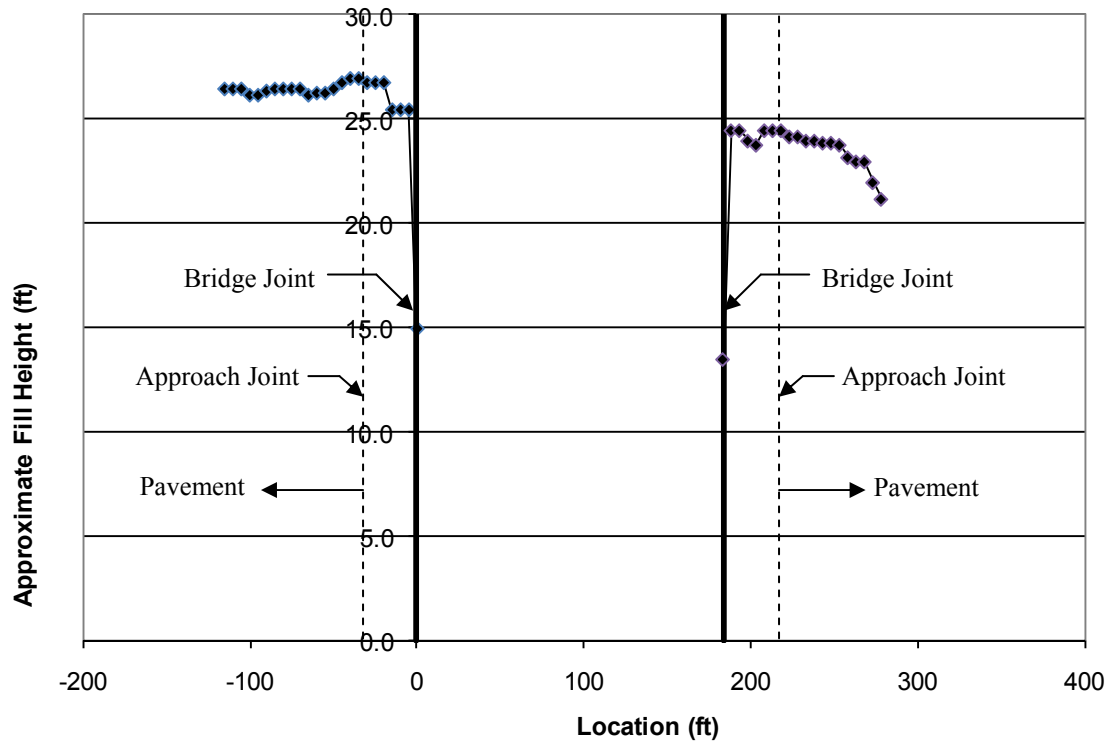
Observations from the FWD test results show a very stiff support system close to the bridge ends and that this support system seems to soften moving away from the bridge ends. The approximate fill heights, however, indicate only a minimal difference in the fill depths moving away from the bridge ends. Collectively, this would indicate that the stiffness differences are derived from differences in construction (e.g., soil compaction levels).

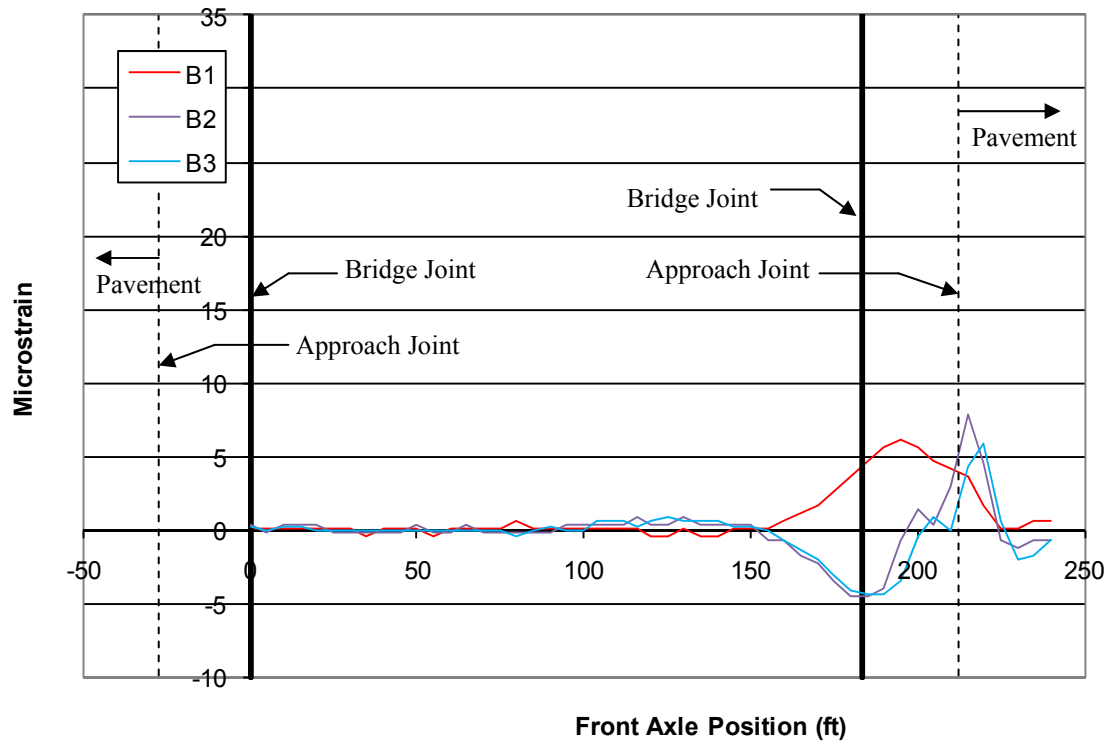
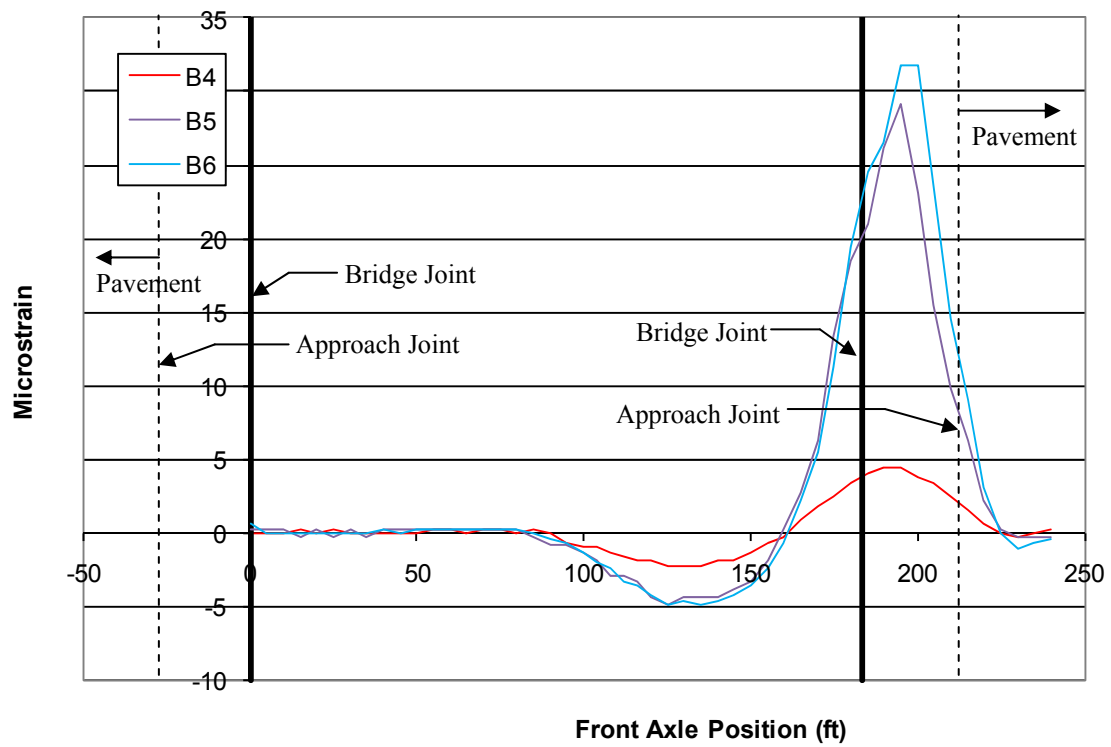
Figure 5.13. FAI 33-14.17 bridge live load testing results

From the end of the girder strain gages, relatively low strain levels were observed (See Figure 5.13a). However, the reversal of strain sign at this location indicates some unintended end restraint. It also appears that there may be some bending transferred from the approach slab to the bridge. The girder strain response near midspan further shows the unintended end restraint and load transfer from the approach slab to the bridge. Also evident from these data is the overall continuity within the entire bridge. From Figure 5.13d, the approach slab does not appear to be deflecting independently (e.g., it is well connected to the adjoining elements resulting in negligible differential displacement). Note that the “spikes” in the data are likely from outside electromagnetic (EM) interference.

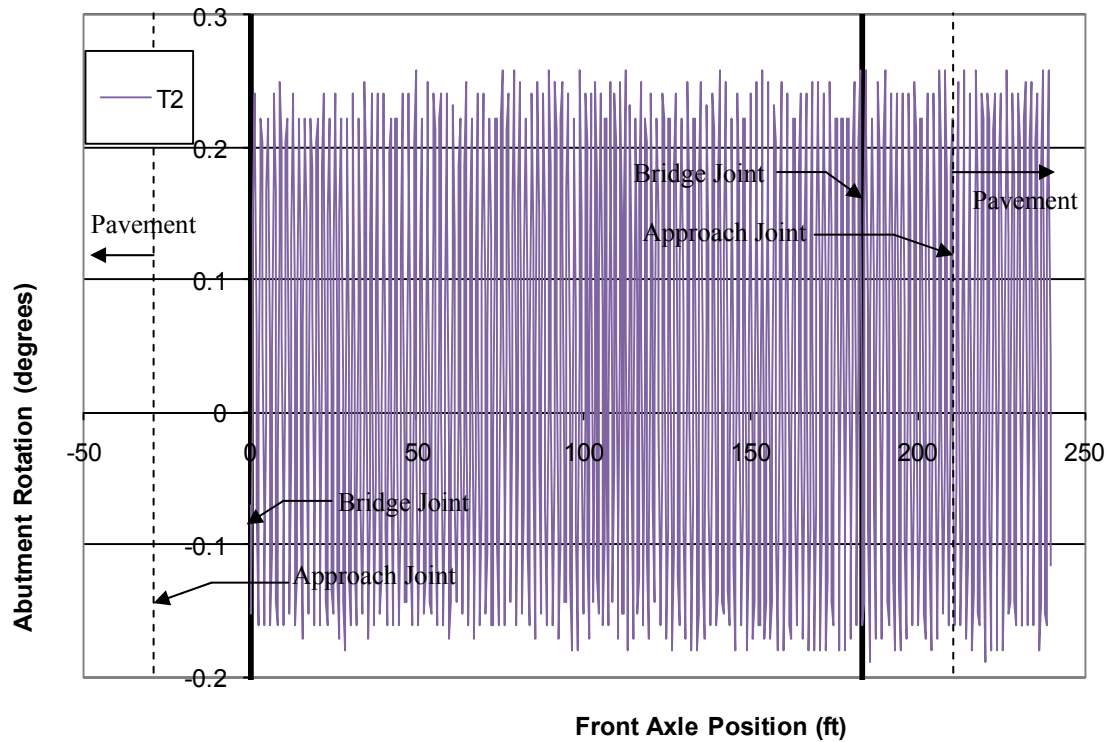
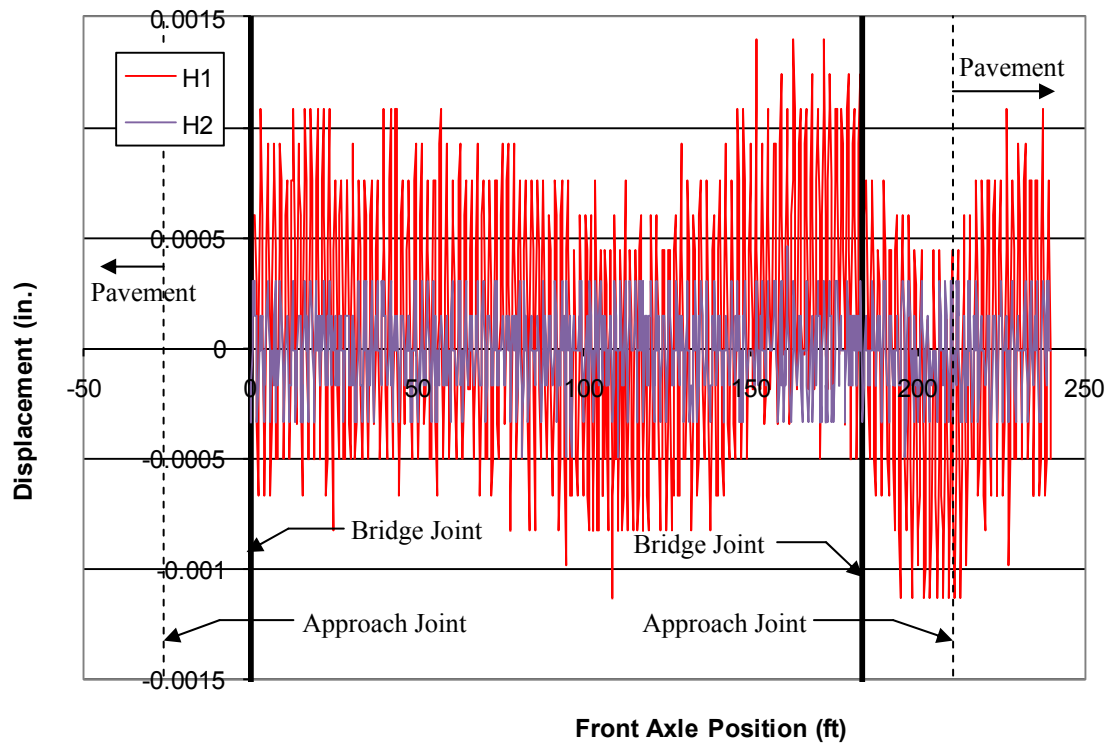
From Figure 5.13e, the abutment does not appear to be rotating under live load (and this is likely the intended behavior). However, Figure 5.13f shows that the abutment is translating. Furthermore, a reversal of movements is apparent—indicating that the abutment is moving both into and away from the supporting soil. This is likely an unintended behavior and potentially could cause for the formation of voids behind the abutment if the support material was not properly designed and installed.

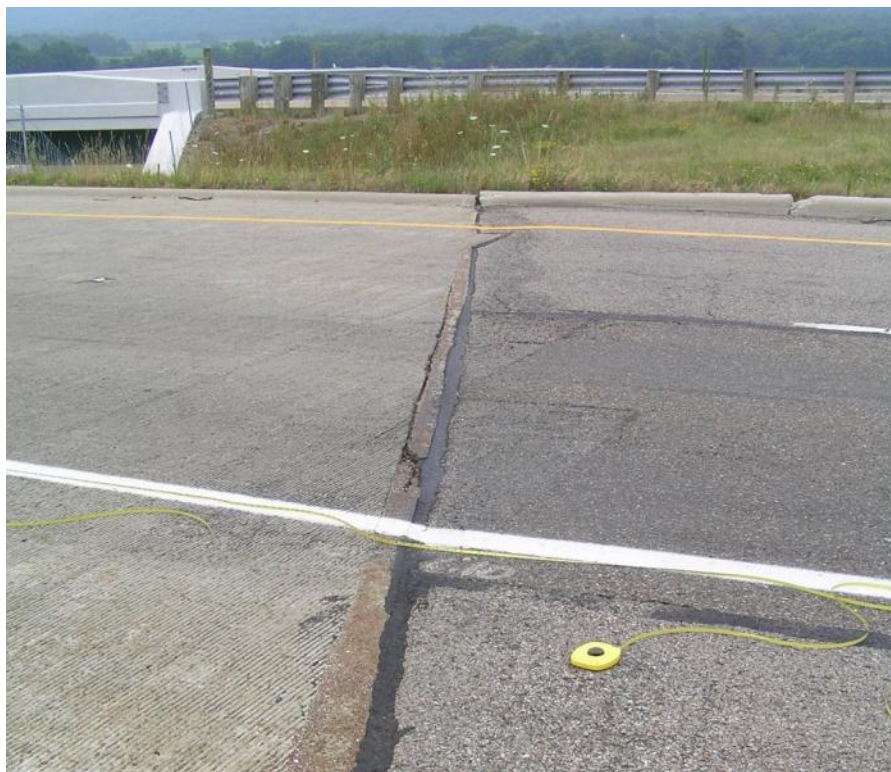
The MUS 16-7.69 bridge had multiple signs of distress causing ride quality issues. On the entrance side of the bridge, an 81 ft long asphalt wedge was located over both the mainline pavement and the approach slab. A small dip was located in the mainline pavement approximately 60 ft away from the bridge abutment. At some point, the joint had been filled with grout, which exacerbated the bump problem. The entrance edge of the bridge approach slab was also noted to have approximately 1.5 in. of differential settlement relative to the pavement, as shown in Figure 5.15. Similar issues were present on the exit end of the bridge. A 150 ft long asphalt wedge had been placed starting at the approach slab on the mainline pavement. The joint between the pavement and the approach slab did not allow for bridge or pavement expansion. The joint, at some point, was filled with grout causing a hump as seen in Figure 5.16. The approach joint, in combination with a large dip located just past the approach slab (seen in Figure 5.17), was causing oil staining and what appeared to be scrape marks from cars bottoming out.

Figure 5.16. Approach to pavement joint filled with grout causing a hump

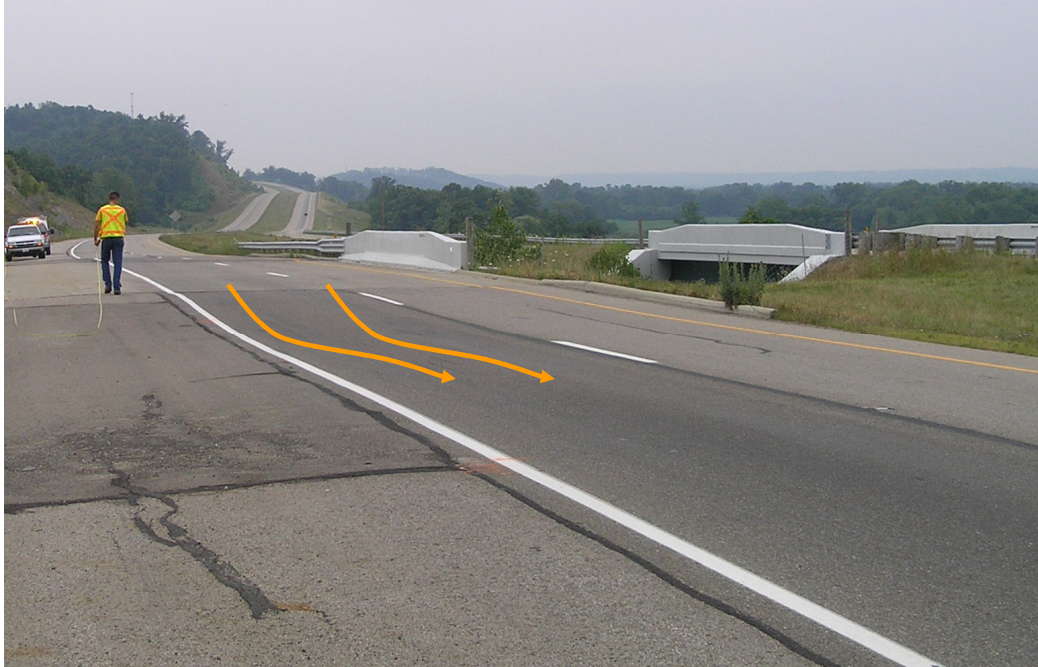
Figure 5.17 Dip in pavement when exiting the bridge

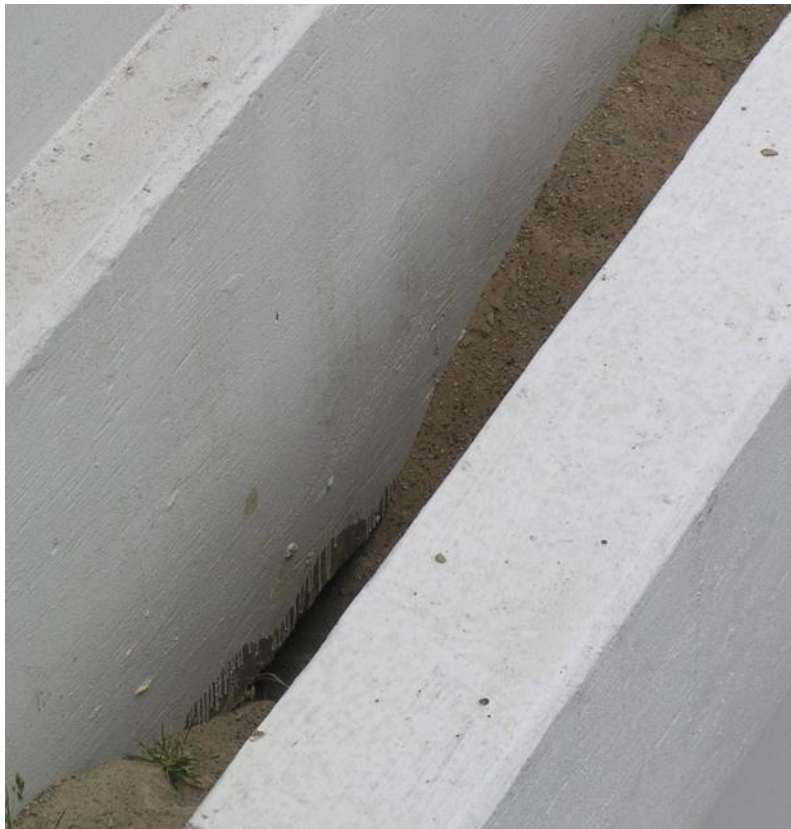
Some loss of fill was also evident at locations between the abutment and the MSE as shown in Figure 5.18.

Figure 5.18. Fill loss between the MSE wall and the bridge abutment

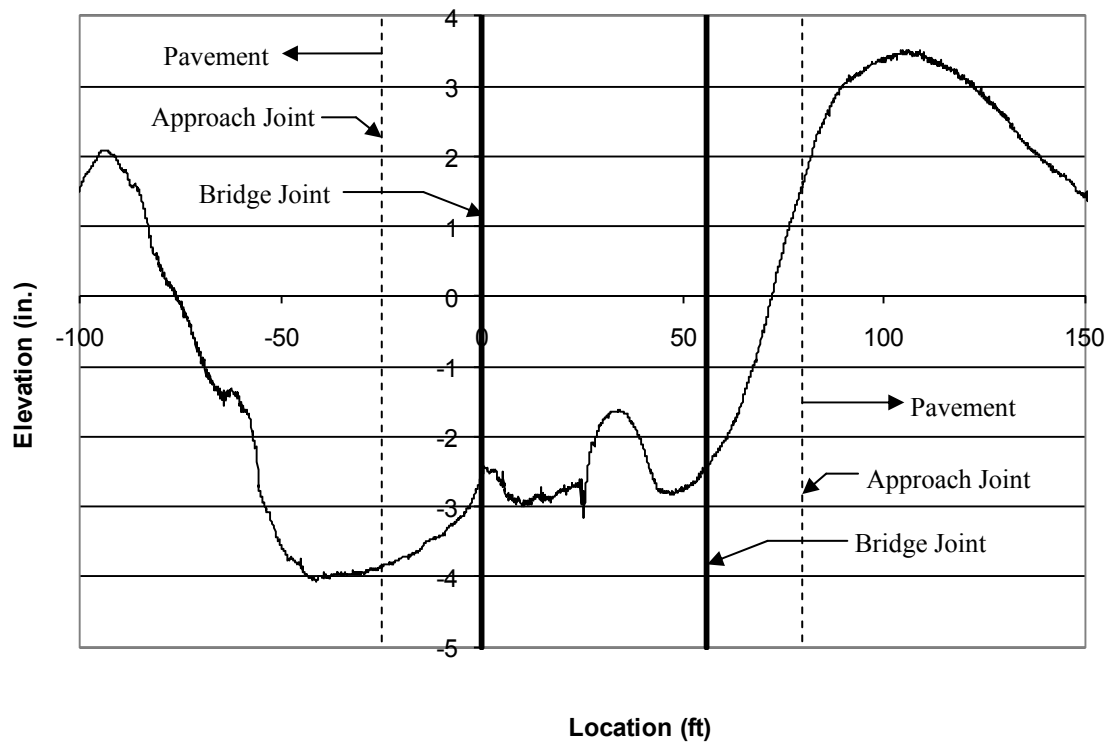
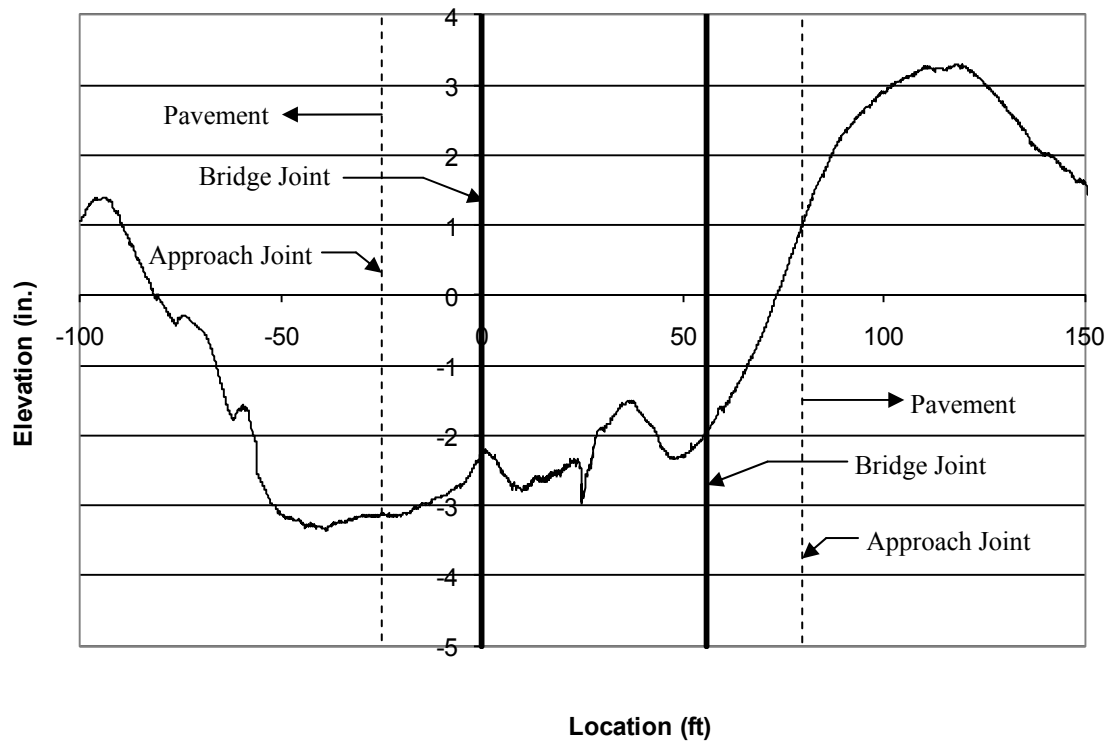
Figure 5.19. MUS 16-7.69 bridge geometric testing results

The profiler data (both in raw form and in computed IRI form) indicate that the bridge geometry at the local level is widely varying. Furthermore, the variances are consistent between the left and right wheel lines. The computed IRI data indicate that both wheel lines have IRI values approaching 800 in. per mile. Interestingly, the IRI data are not the “worst” in the area of the dip and hump mentioned previously (which might seem to be the worst from a driver perspective). Rather, the worst IRI values are on either the entrance end or on the bridge itself. These data indicate multiple factors may be impacting the ride quality.

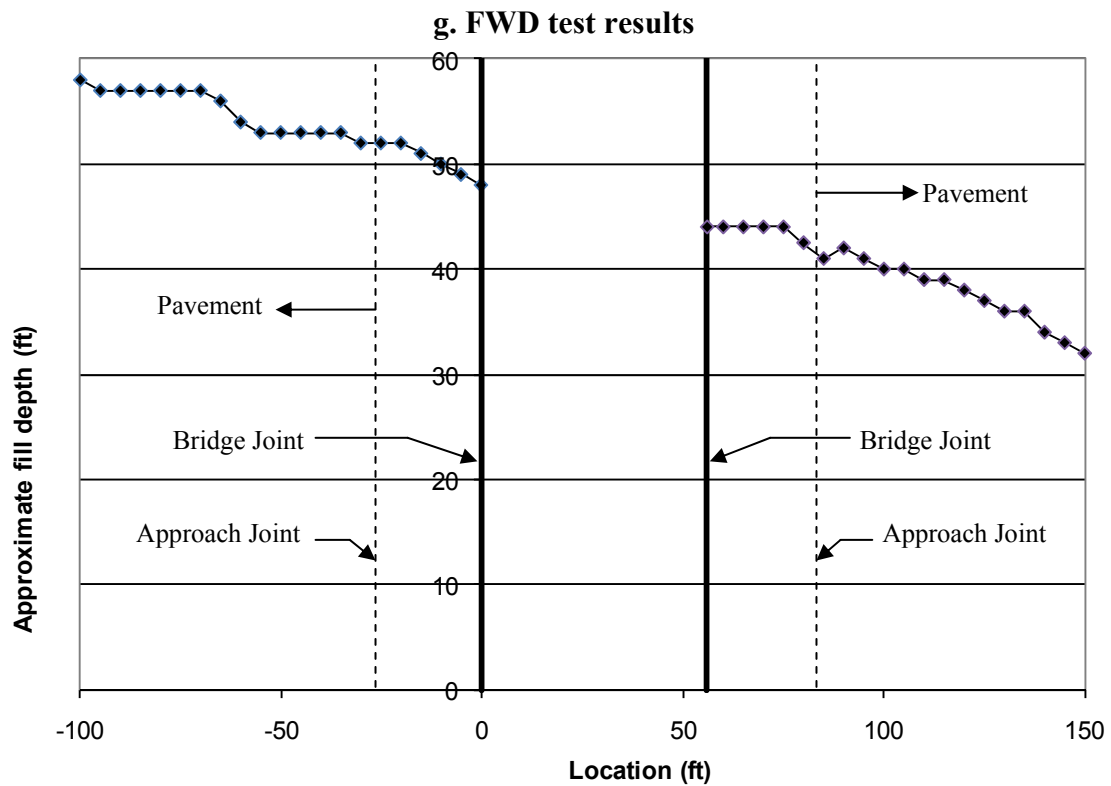
The FWD test results show that, again, the support system stiffness is widely variable. Immediately at the bridge abutment, the support system is very stiff (as expected). The support system consistently softens away from the bridge. At the exit end of the bridge is a gain in stiffness. The location of this stiffness again coincides with the dip and hump mentioned previously. The fill height is quite large with a consistent variation. Such large fill depths give greater opportunity for less than optimum post-construction soil compaction.

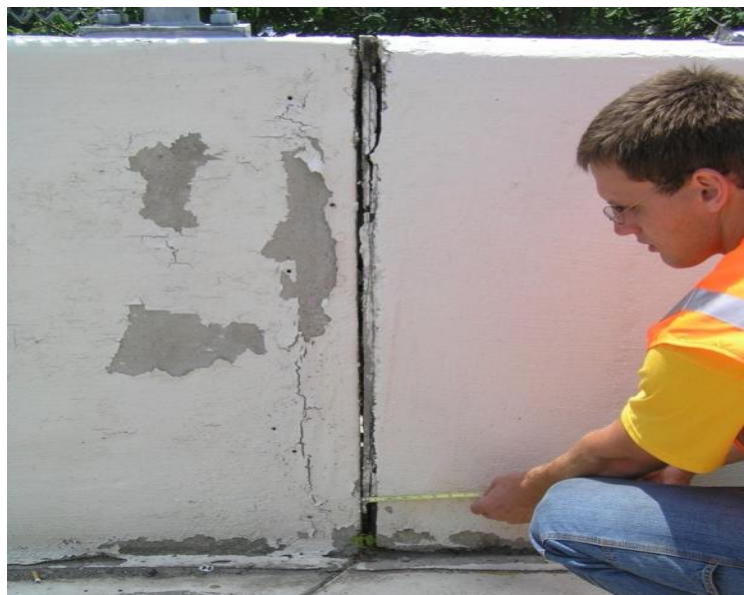
Upon investigation, the approach slab has settled causing the parapet's vertical joint at the bridge to be wider at the top than at the bottom, as shown in Figure 5.23. A 20 in. deep void was found between the wing wall and approach slab, as shown in Figure 5.24.

Figure 5.23. Tapered vertical gap at bridge to approach slab joint indicating settlement

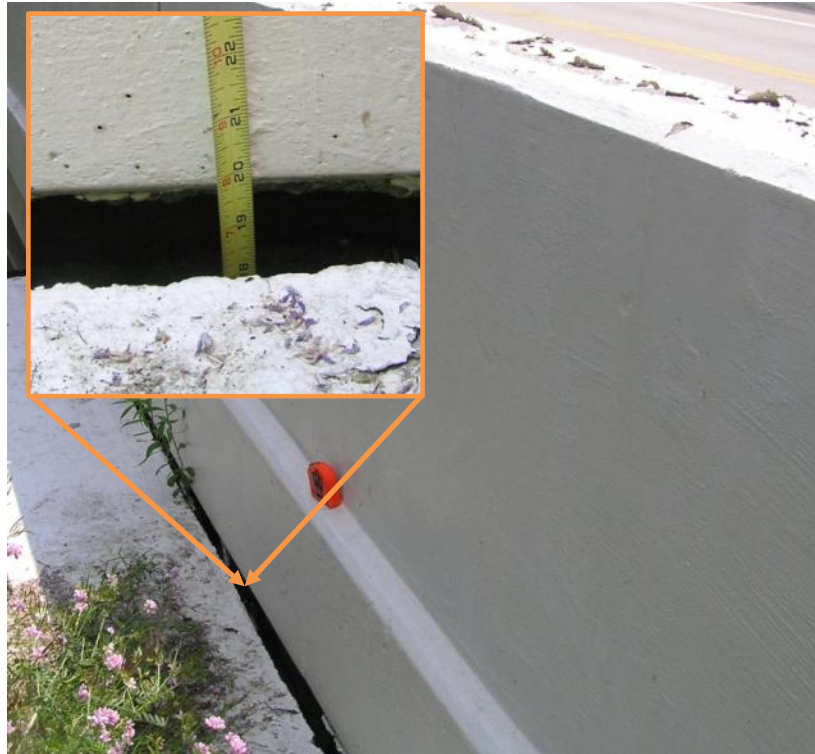
Figure 5.24. Void under approach

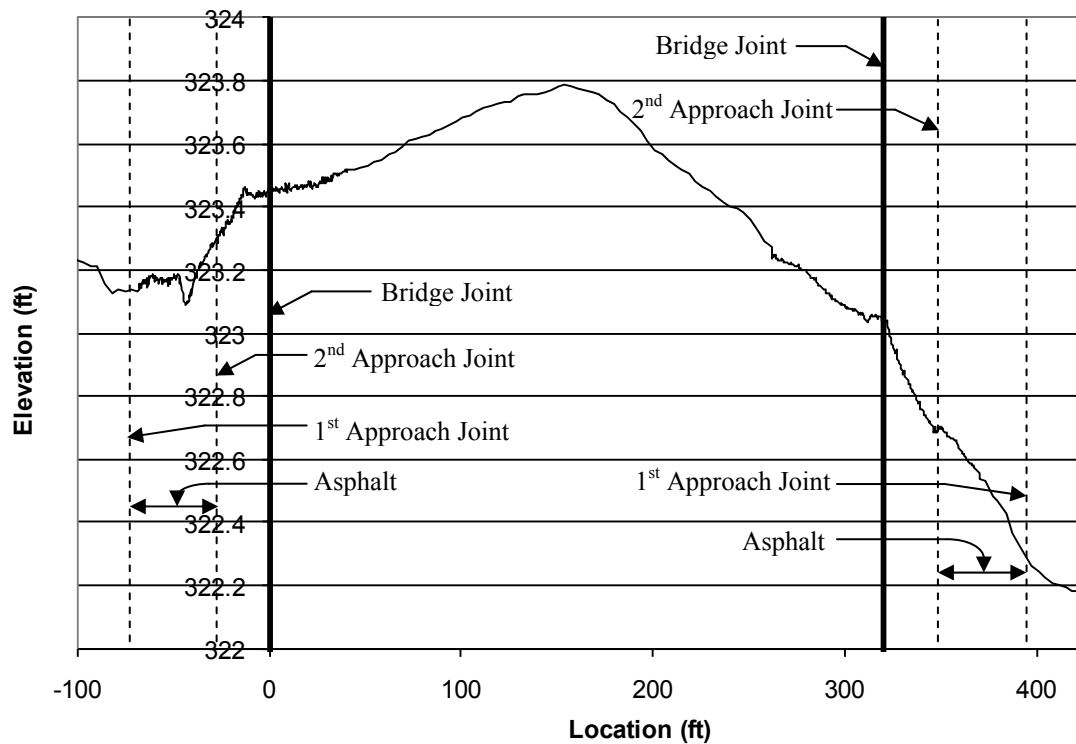
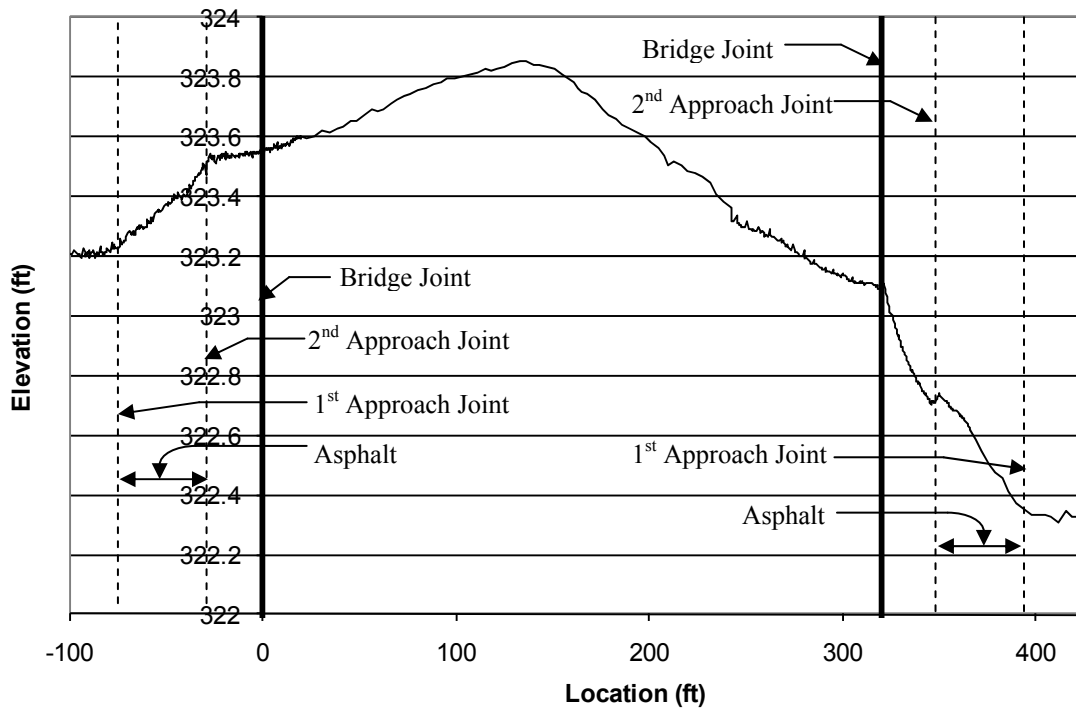
Figure 5.25. RIC 430-9.98 bridge geometric testing results

Figures 5.25a and 5.25b show the results of the laser-based survey. Generally, consistency is good between the survey data from the left and right wheel lines. The one exception is on the entrance end of the bridge, where the right wheel line has greater variability. This variability will also be evident in the calculated IRI data. Overall, the bridge has a sweeping vertical geometry that, in Figures 5.25a and 5.25b, appears relatively smooth—a fact that is again corroborated with the IRI measurements.

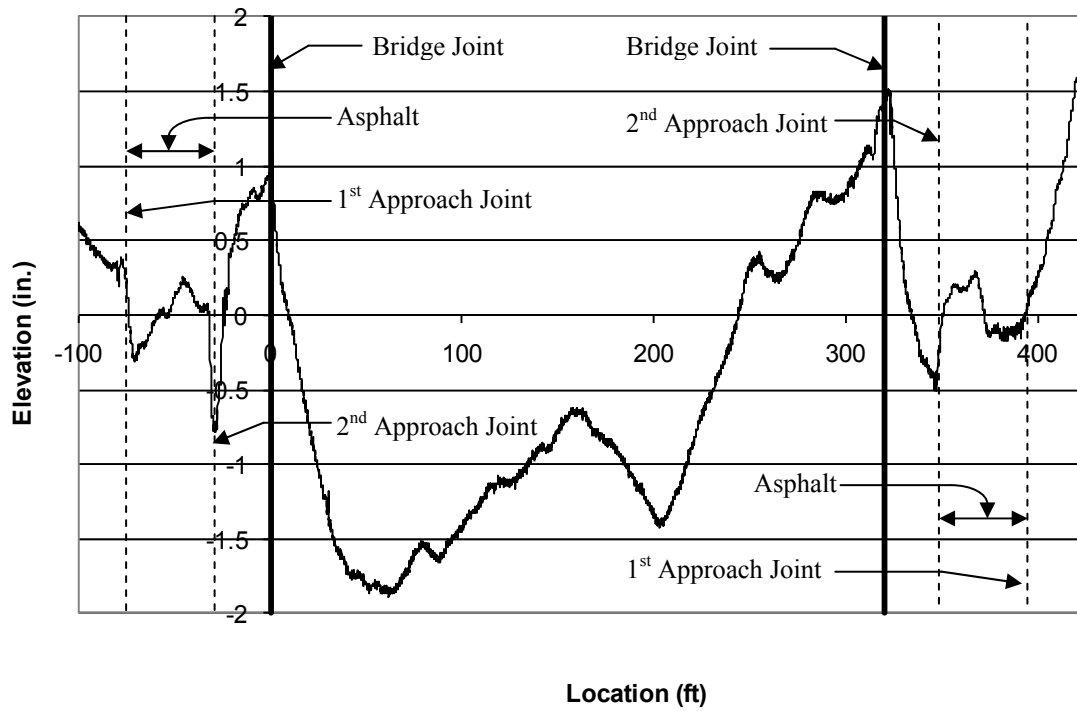
The raw profiler data indicates that, with the exception of the entrance end of the bridge, the two wheel lines show similar characteristics. The difference is even more obvious upon seeing the calculated IRI data, where the right wheel line has IRI values of more than 600 at the entrance. Consistent with the global measurements, the calculated IRI values on the bridge indicate a generally smooth and consistent surface. The problem areas seem to be concentrated at the approach pavement and the bridge joint. The FWD test results indicate a rapid degradation in the support system stiffness on the entrance end. The speculation is that this rapid change in support stiffness may be a source of the entrance conditions mentioned previously.
