Identification and Evaluation of Pavement-Bridge Interface Ride Quality Improvement and Corrective Strategies

Institute for Transportation

Report Number FHWA/OH-2011/1

January 2011

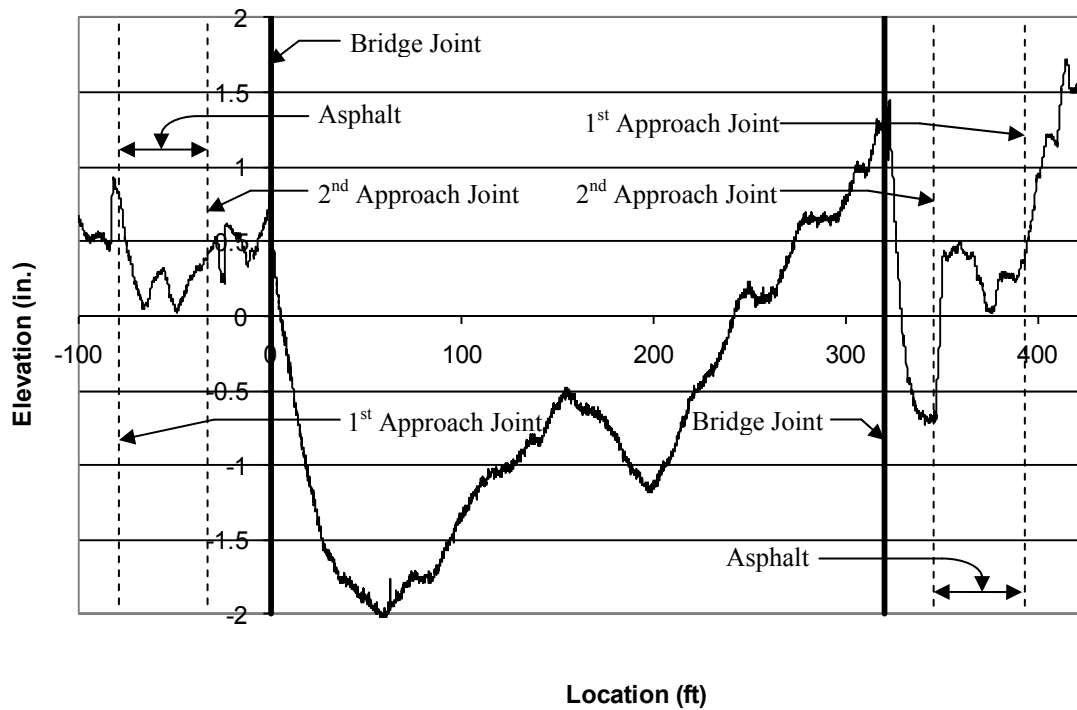
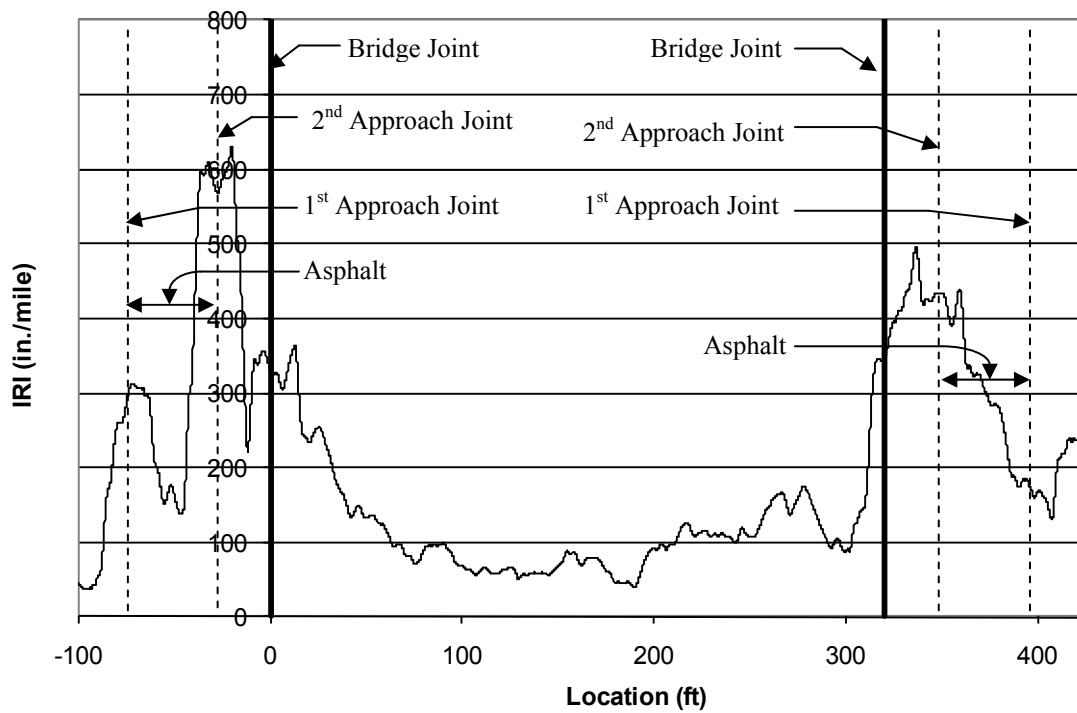
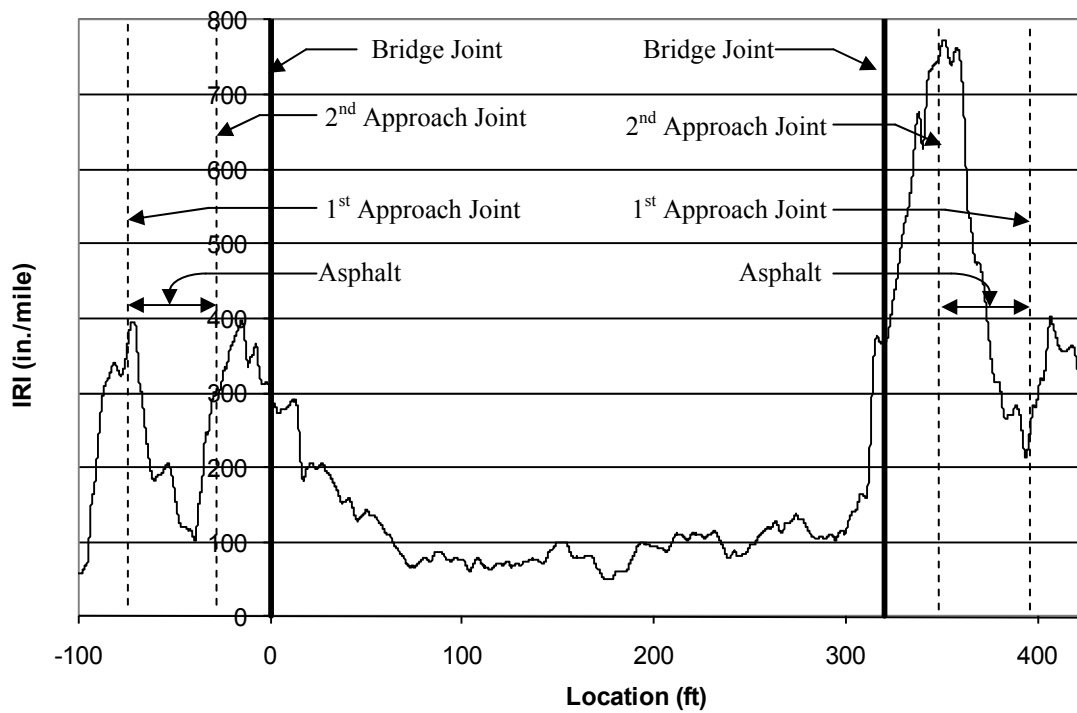
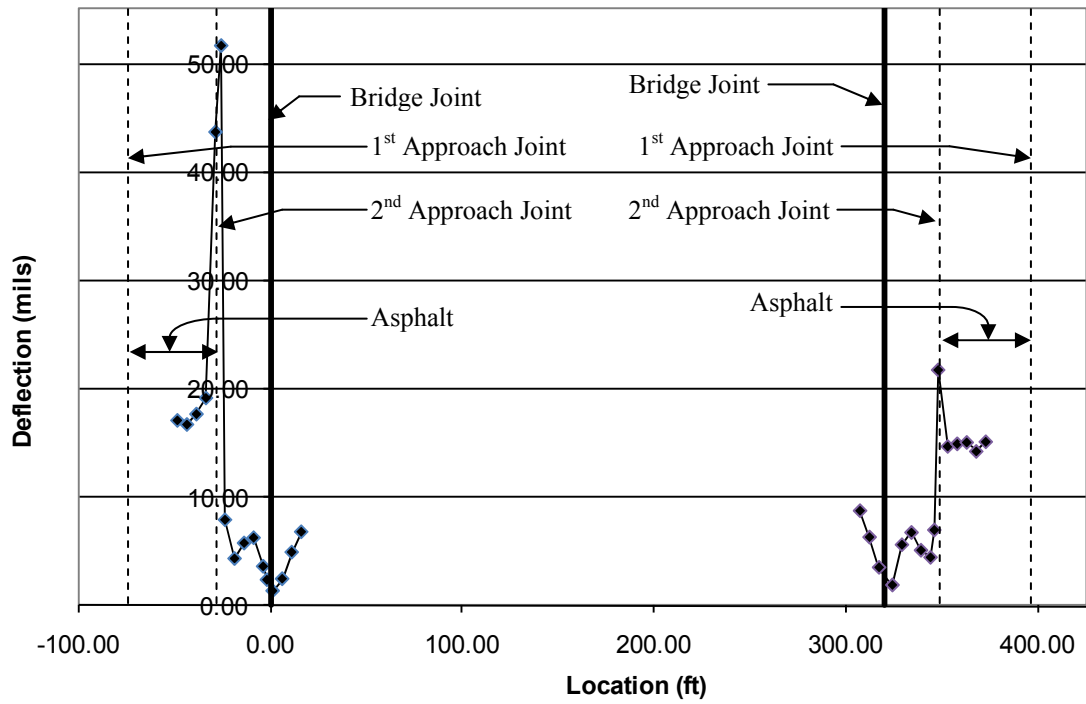
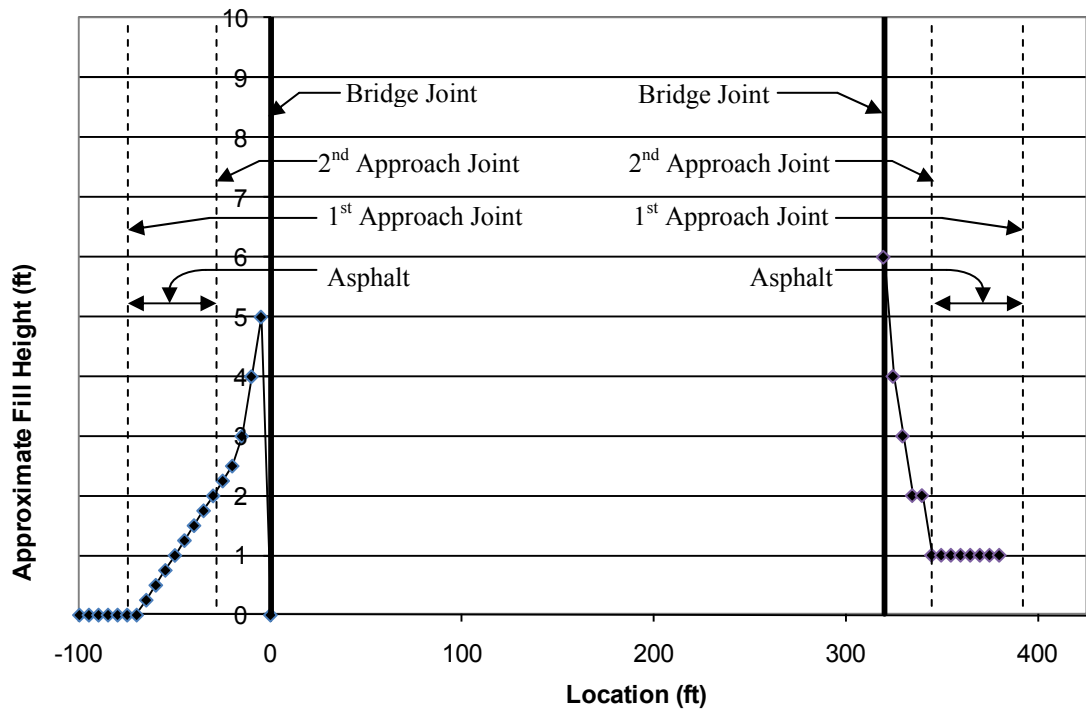
Figure 5.25. RIC 430-9.98 bridge geometric testing results

Figures 5.25a and 5.25b show the results of the laser-based survey. Generally, consistency is good between the survey data from the left and right wheel lines. The one exception is on the entrance end of the bridge, where the right wheel line has greater variability. This variability will also be evident in the calculated IRI data. Overall, the bridge has a sweeping vertical geometry that, in Figures 5.25a and 5.25b, appears relatively smooth—a fact that is again corroborated with the IRI measurements.

The raw profiler data indicates that, with the exception of the entrance end of the bridge, the two wheel lines show similar characteristics. The difference is even more obvious upon seeing the calculated IRI data, where the right wheel line has IRI values of more than 600 at the entrance. Consistent with the global measurements, the calculated IRI values on the bridge indicate a generally smooth and consistent surface. The problem areas seem to be concentrated at the approach pavement and the bridge joint. The FWD test results indicate a rapid degradation in the support system stiffness on the entrance end. The speculation is that this rapid change in support stiffness may be a source of the entrance conditions mentioned previously.

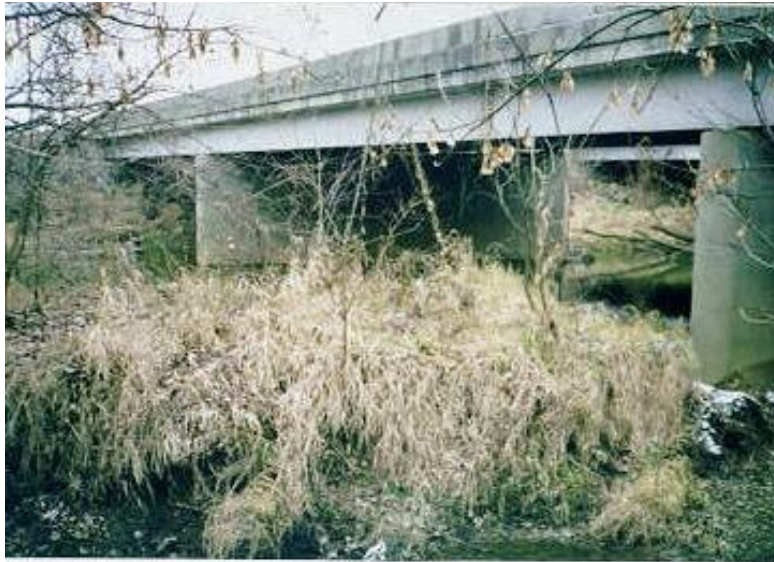
Figure 5.26. Profile view of FRA 317-8.09

FRA 317-8.09 is a 170 ft three-span bridge built circa 1970 at an existing bridge location. The bridge investigated is a two-lane bridge carrying northbound traffic over Blacklick Creek. The bridge is constructed of six rolled W36x135 steel beams with a non-composite reinforced concrete deck. The abutments consist of piles with concrete caps. The girders are attached to the pile cap as an ODOT typical integral abutment. The bridge plans show a 25 ft approach slab unattached on a 6 in. paving notch; however, during the site investigation, no approach slab was evident. Figure 5.26 shows a profile of the bridge.

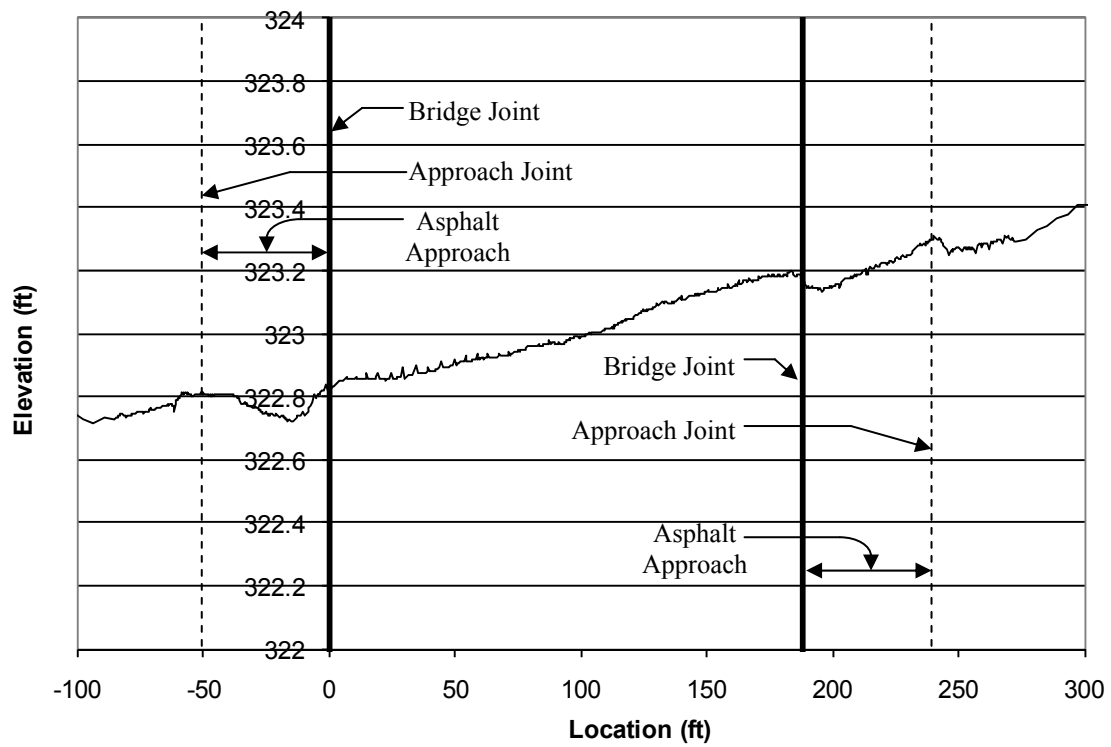
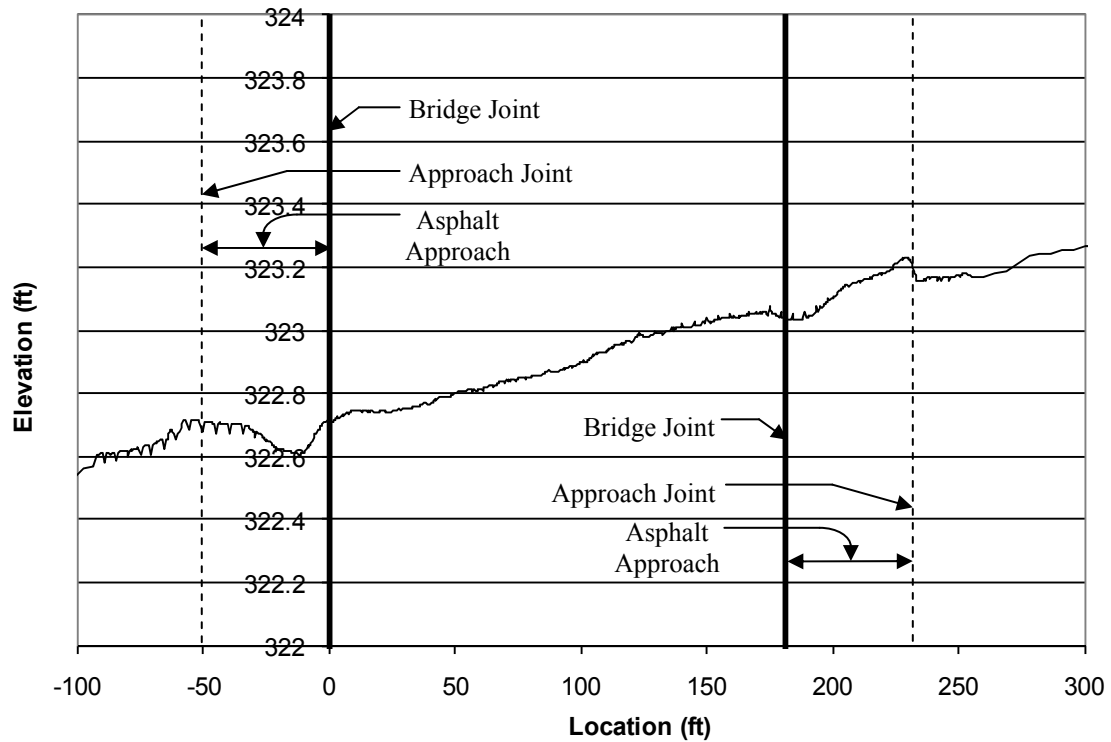
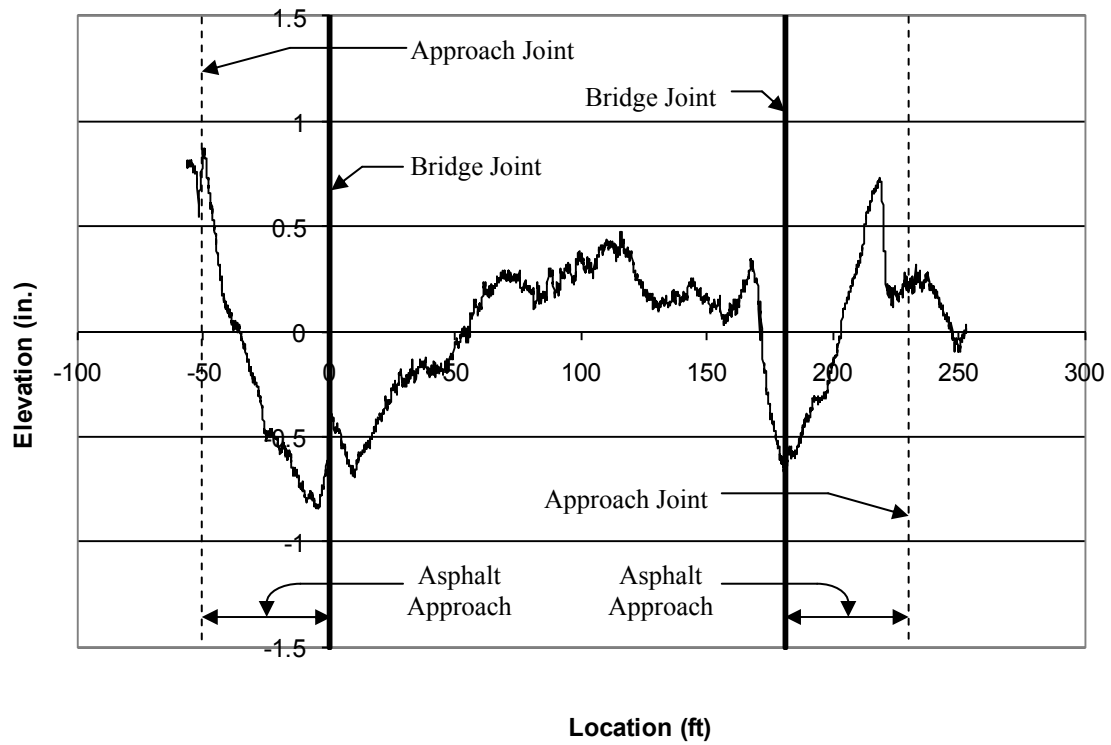
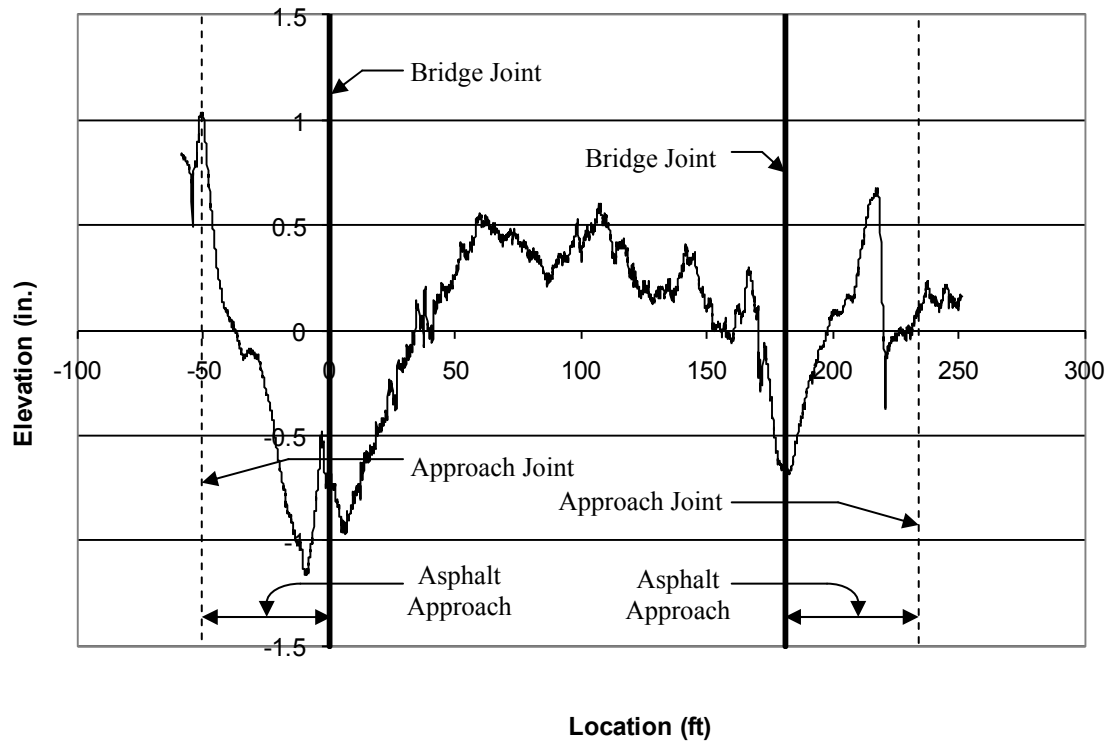
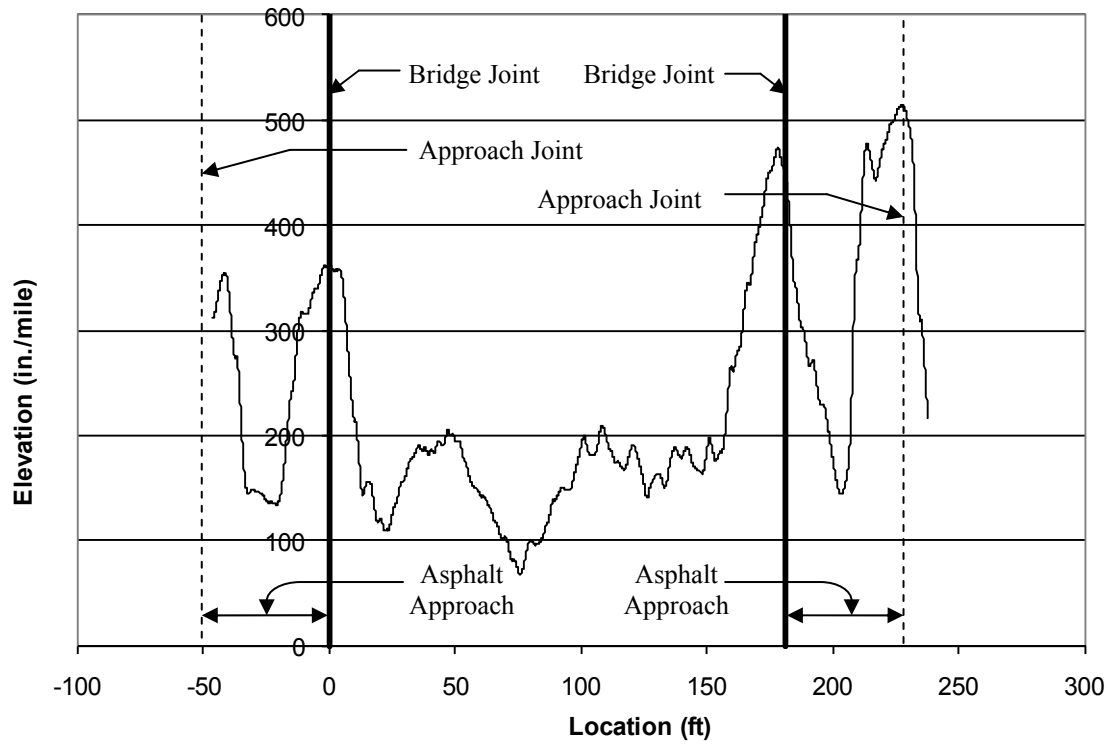
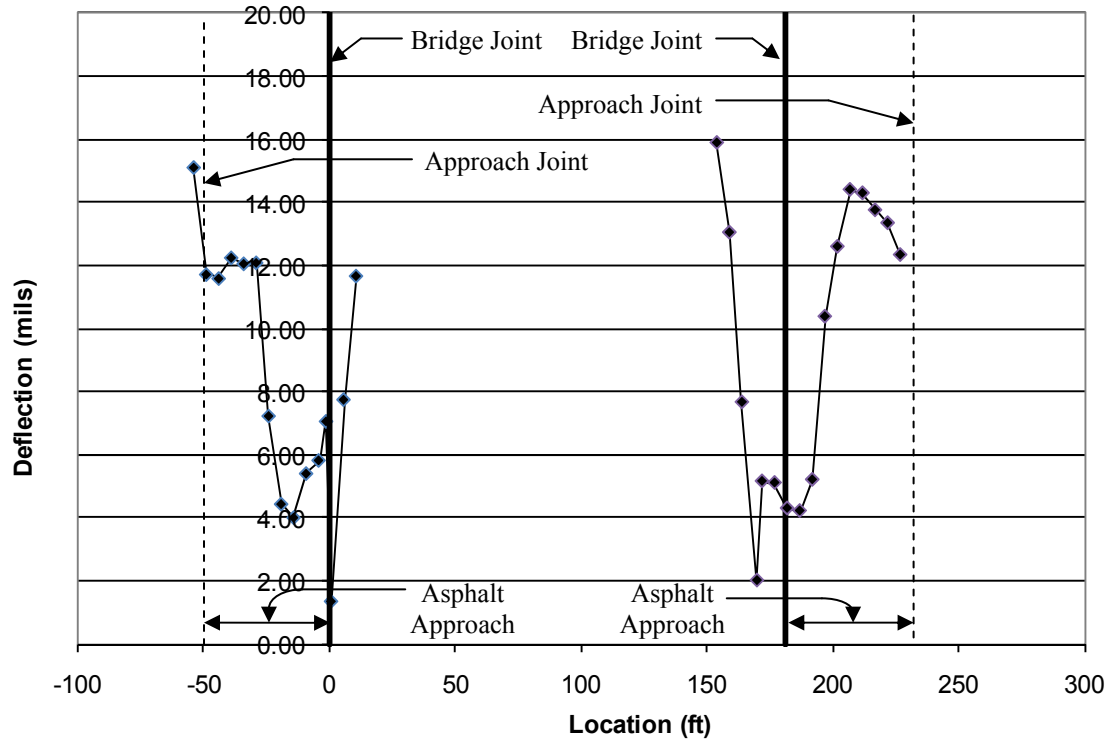
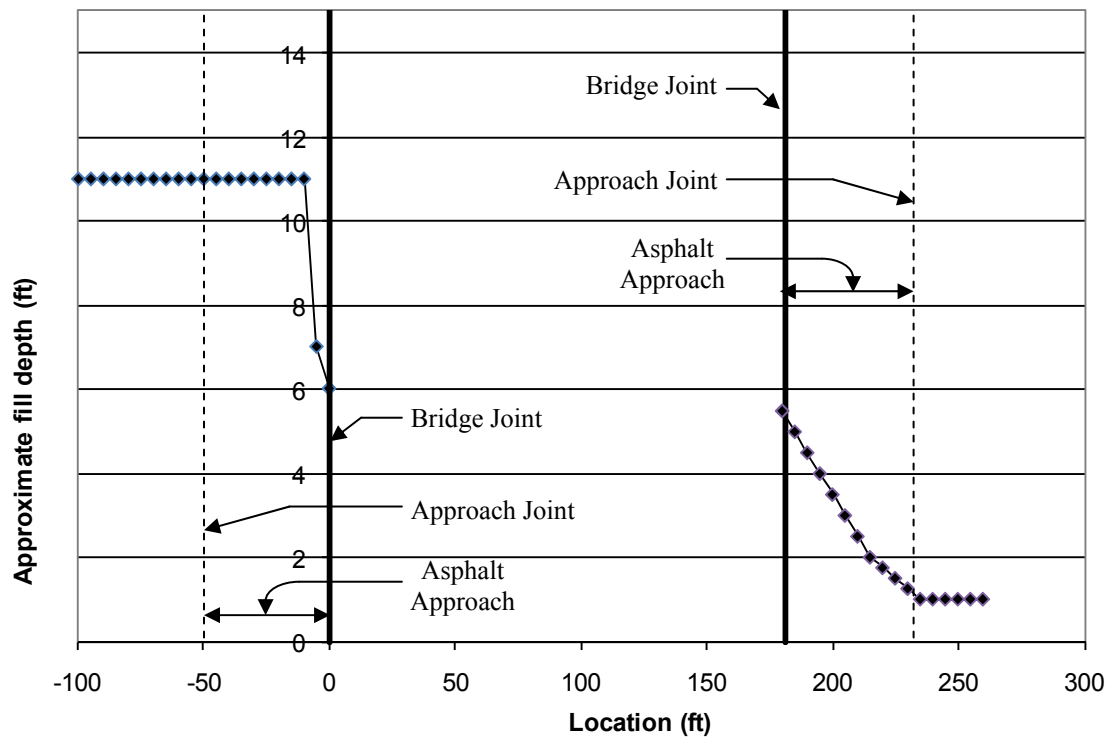
Figure 5.29. FRA 317-8.09 bridge geometric testing results

Figures 5.29a and 5.29b show the results of the laser-based survey. The data from the two wheel paths indicate that, generally, the two wheel paths are geometrically similar. Further observation of the data does not show a smoothly flowing geometry. In both wheel lines, prominent dips can be observed at both the entrance and exit ends and also a large hump on the exit. Note that the “fuzzy” appearance of the data is not believed to be real; rather, it is believed to be a remnant of errors propagating through the process of stitching together multiple data sets.

The profiler and IRI data shown in Figures 5.29c through 5.29f show that the local geometry of the bridge is comparable in each wheel path and that there is significant local variation. The calculated IRI data indicate that the worst ride characteristics are on the exit end of the bridge. This fact compares well with the findings from the global geometric measurements.

The FWD test results indicate that there is general similarity in the stiffness on and off the bridge. However, it can clearly be seen that the support system stiffness is extremely high in the immediate vicinity of the bridge abutment. The approximate fill heights vary significantly from the entrance to the exit bridge ends. These differences may contribute to the difference in observed roadway geometry (both local and global).

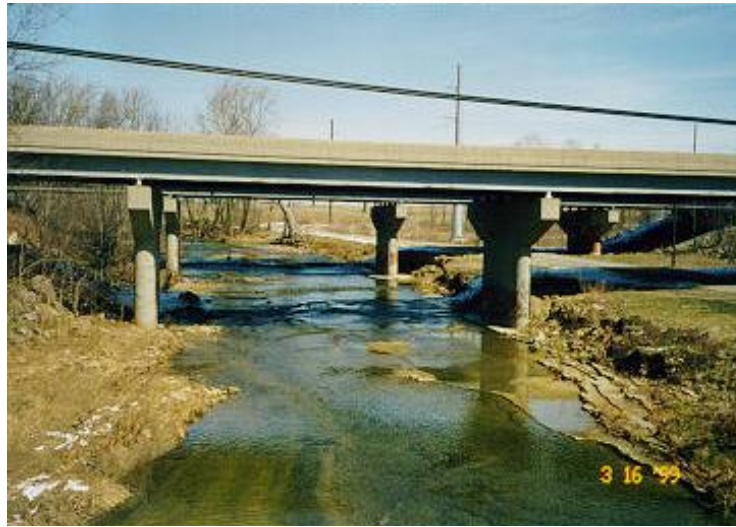
The original PRE 70-12.49 bridge was built in about 1962 at a new bridge site. The bridge crosses over Price Creek and Price Creek Road as shown in Figure 5.30. The eastbound bridge was investigated and consists of four spans with a total length of 220 ft and the longest span being 63 ft. In the past decade, the bridge was widened, adding three more steel beams and changing the abutments to an integral or semi-integral type abutment. Figure 5.31 shows the bridge beams and abutments. The abutments consist of vertical and battered steel piles with concrete caps. The bridge has no skew. The approach slabs are 25 ft long concrete and are supported on a 6 in. paving notch. No reinforcing attachment of the approach to the abutment is noted on the plans. The approach slabs appear to be relatively new.

Figure 5.30. Profile of PRE 70-12.49 prior to widening

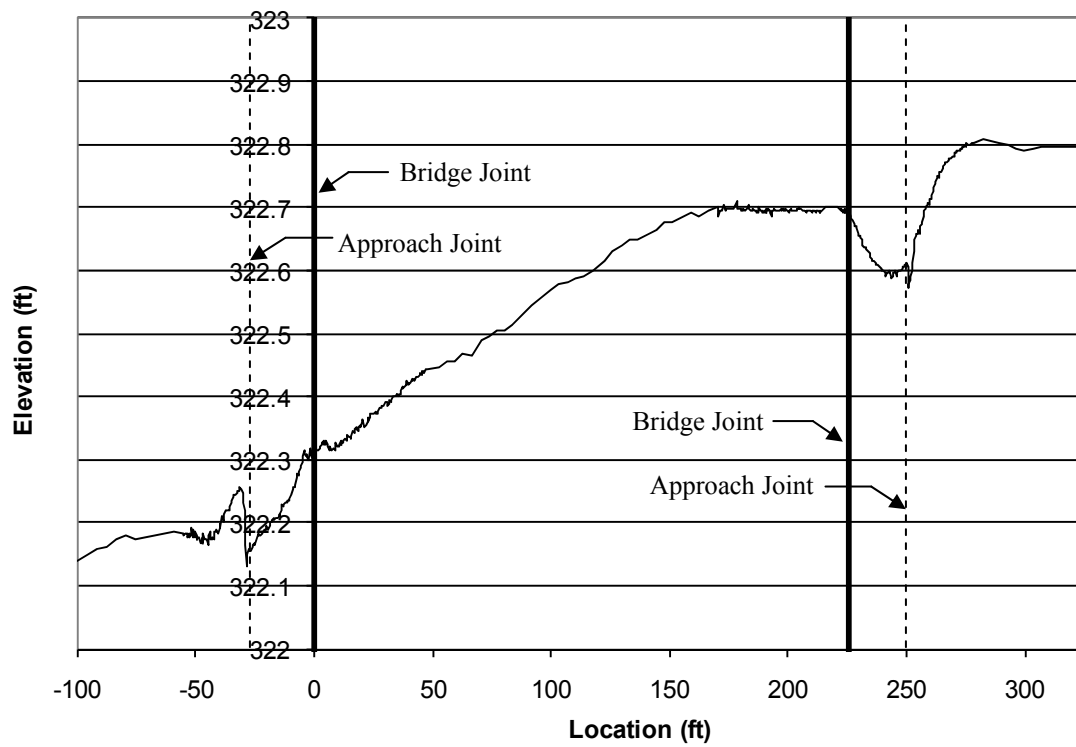
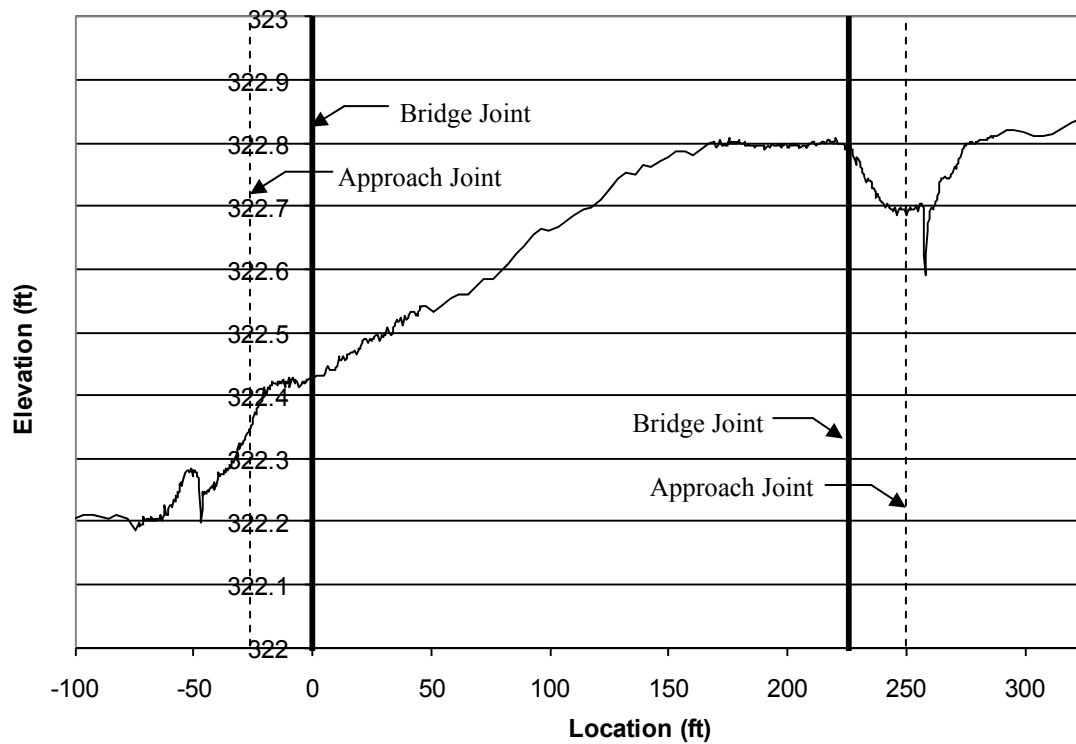
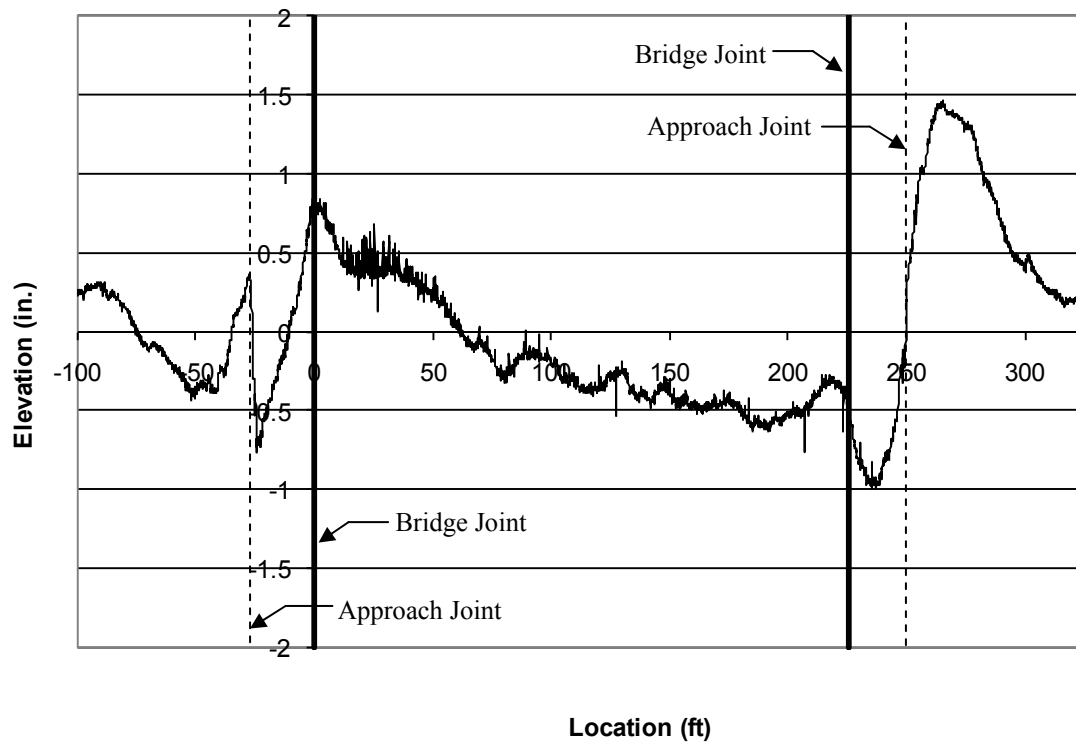
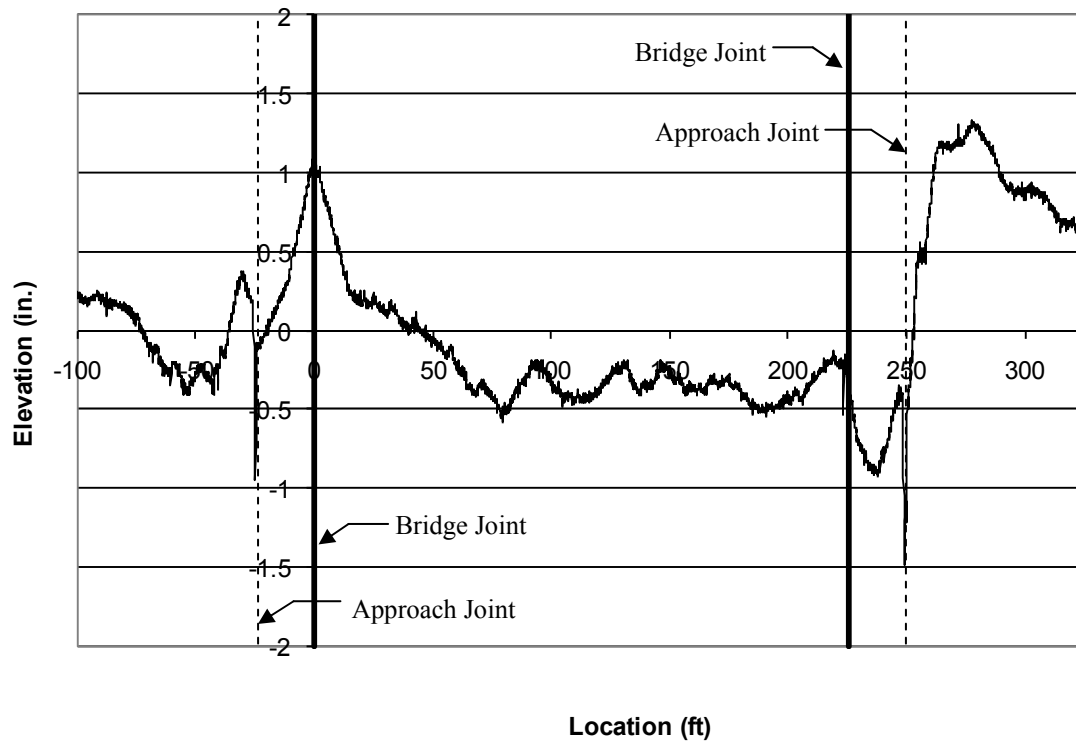
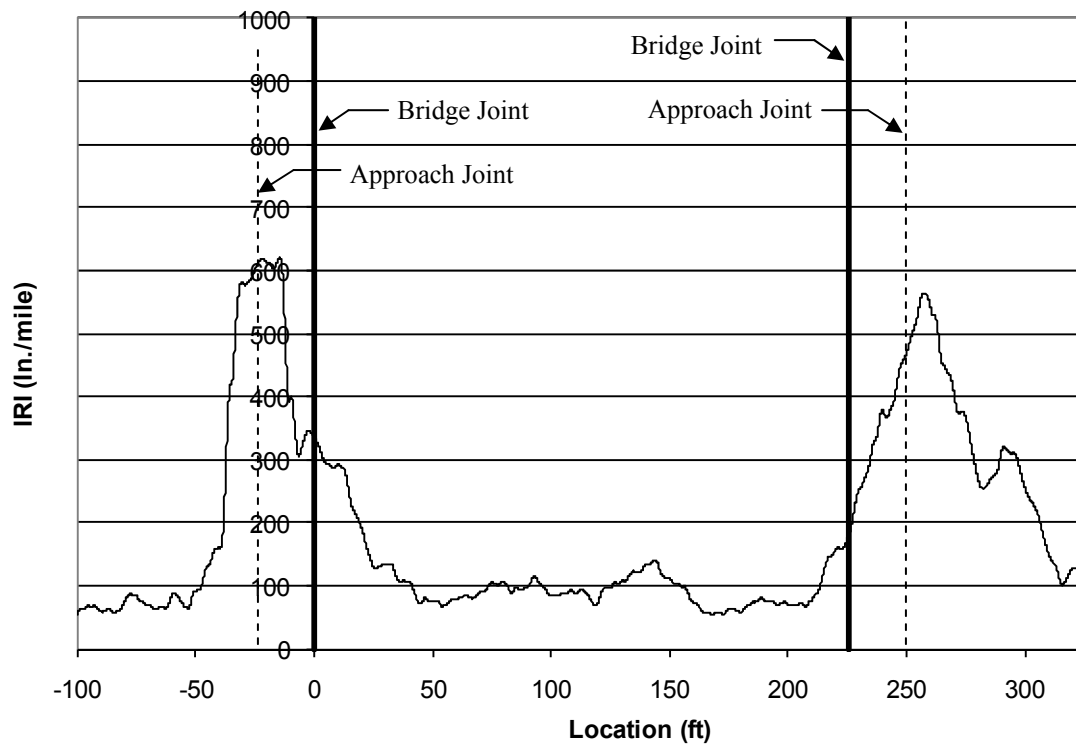
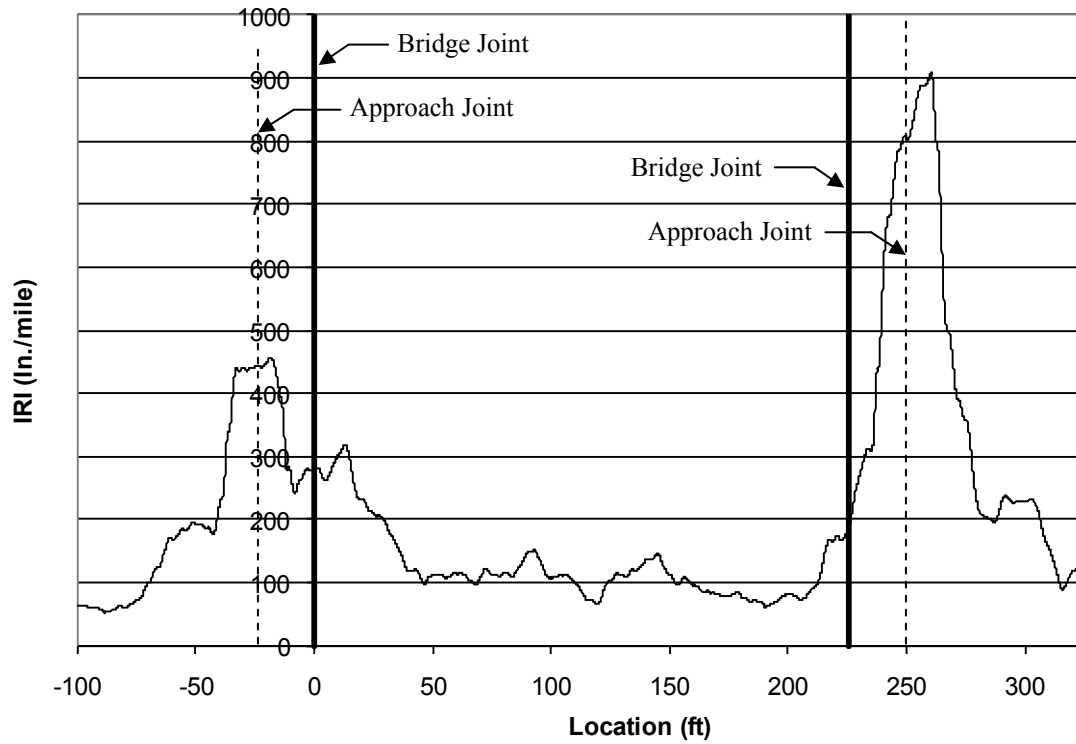
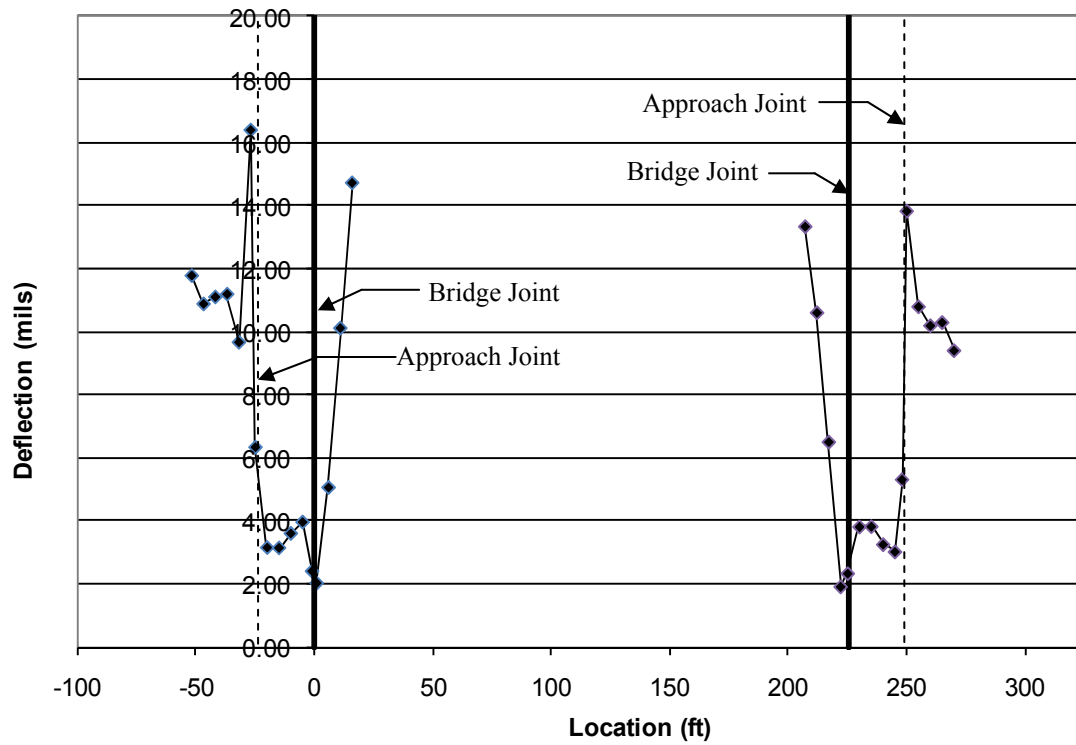
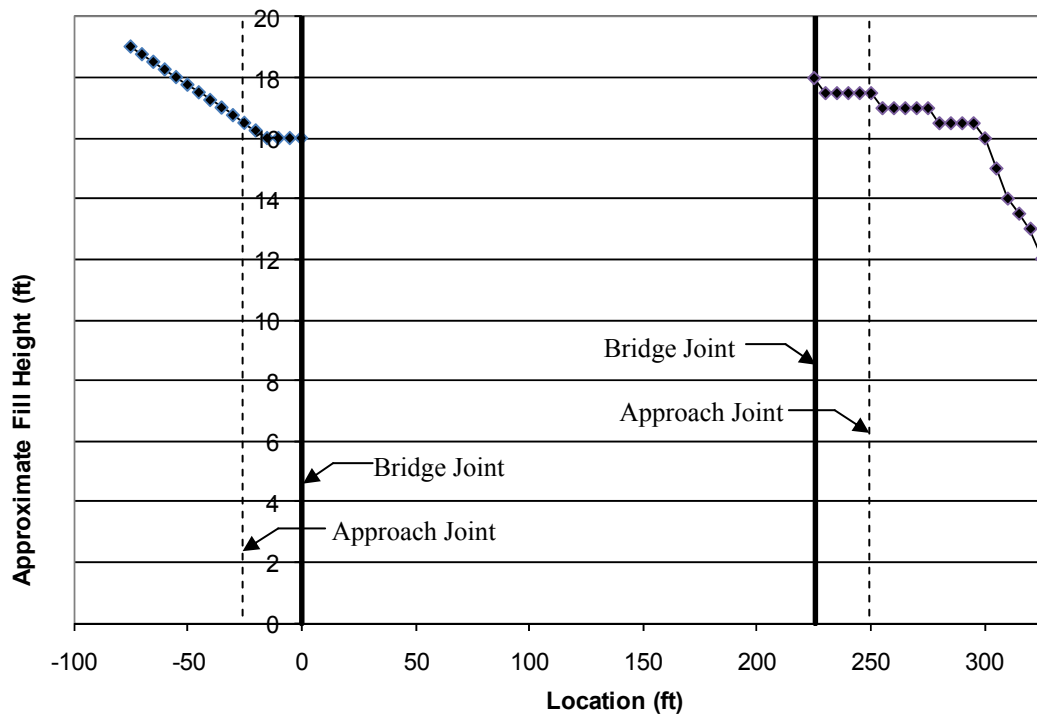
Figure 5.35. PRE 70-12.49 bridge geometric testing results

Figures 5.35a and 5.35b show the results of the laser-based survey. These data show that the surface of the bridge itself is relatively consistent (a fact also shown in the IRI data). However, the regions around the approach slabs show global geometries that change rapidly with numerous dips and humps evident. Note the consistency in the measurements from the left and right wheel lines is relatively good.

The profiler data (and the IRI data) show, as does the survey data, consistency in the profile of the bridge itself, with reduced consistency off the bridge. In fact, the IRI is more than 900in. per mile in one of these areas. When considering both the survey data and the profiler data, it seems as though some type of degradation in behavior/performance of the approach slab-to-bridge and/or approach slab-to-pavement connection may be contributing to the poor ride quality.
