Identification and Evaluation of Pavement-Bridge Interface Ride Quality Improvement and Corrective Strategies

Institute for Transportation

Report Number FHWA/OH-2011/1

January 2011

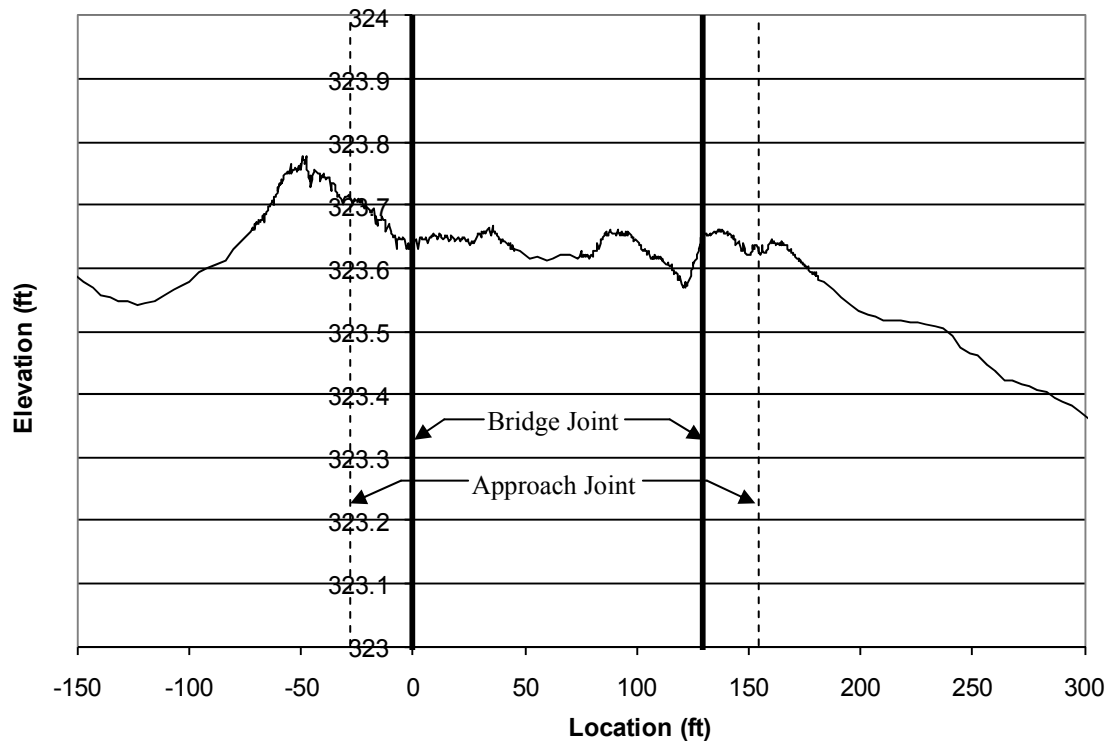
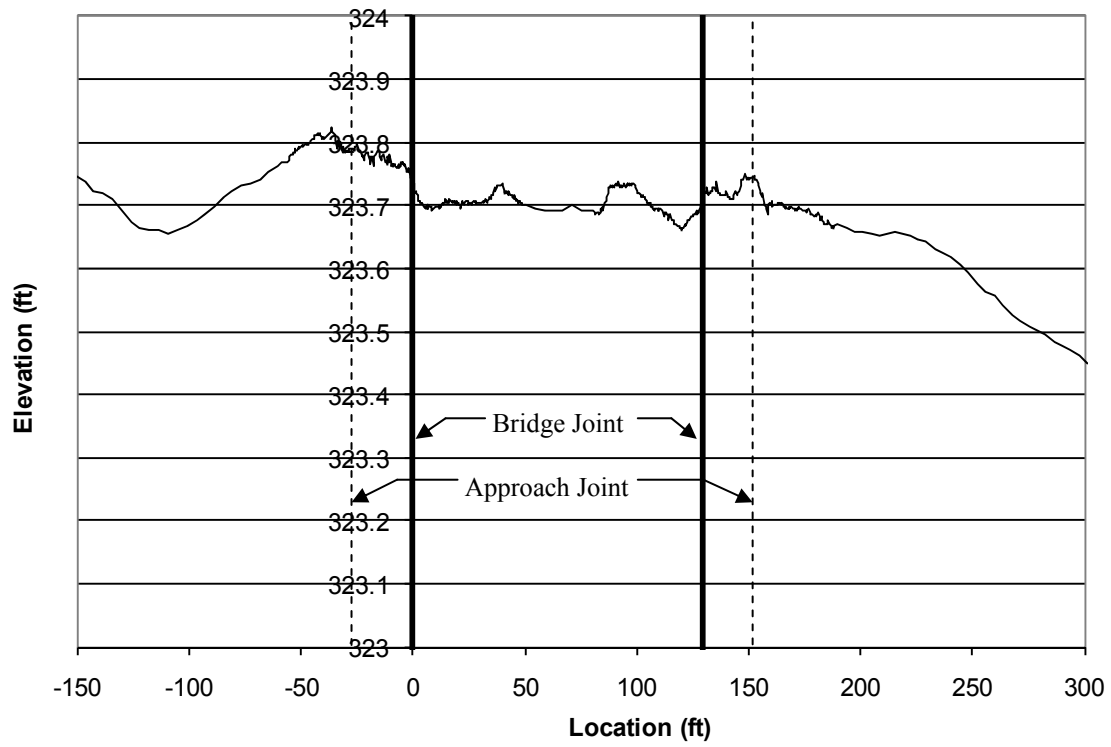
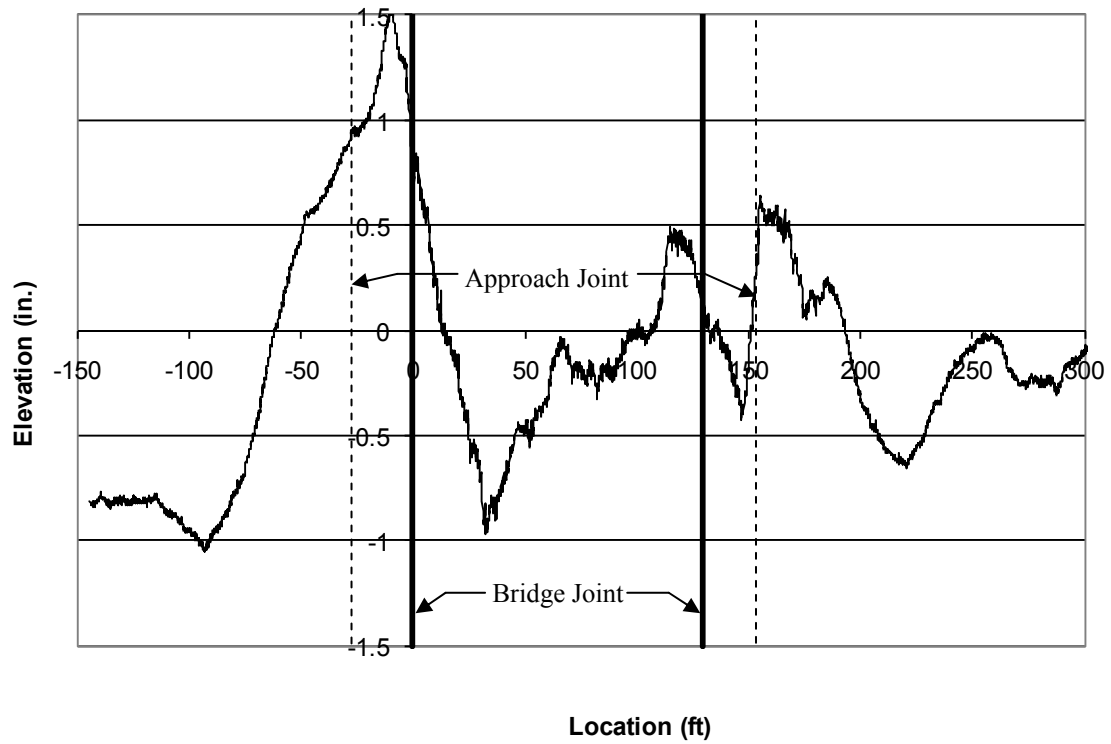
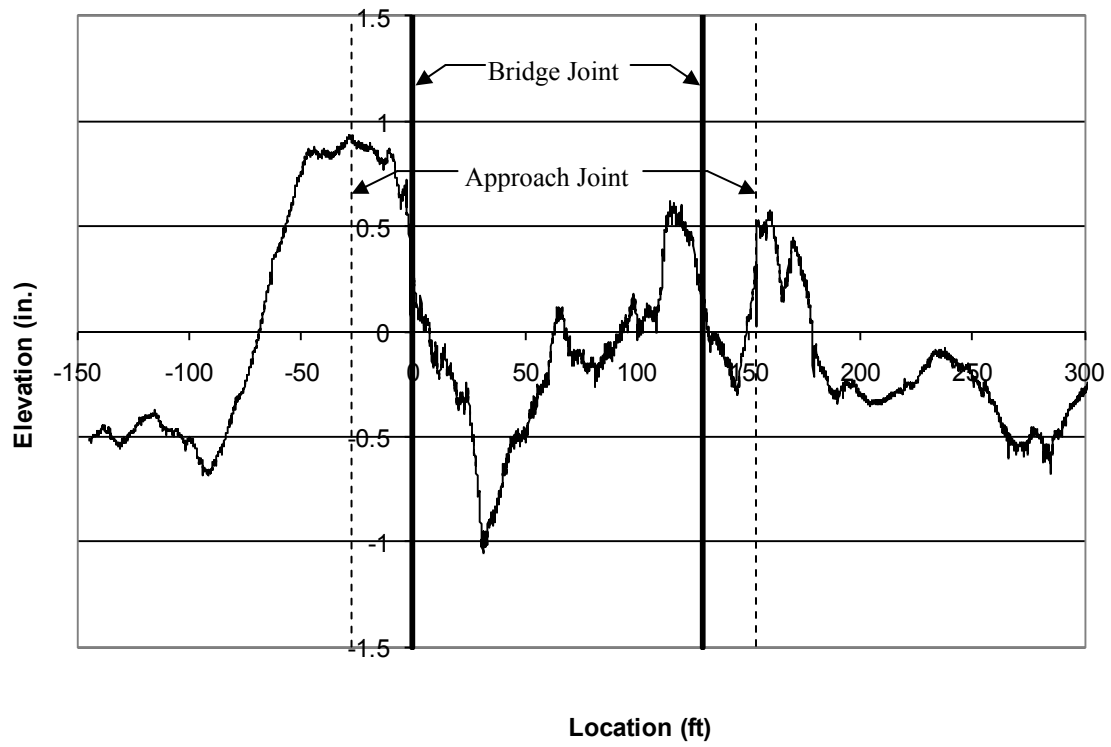
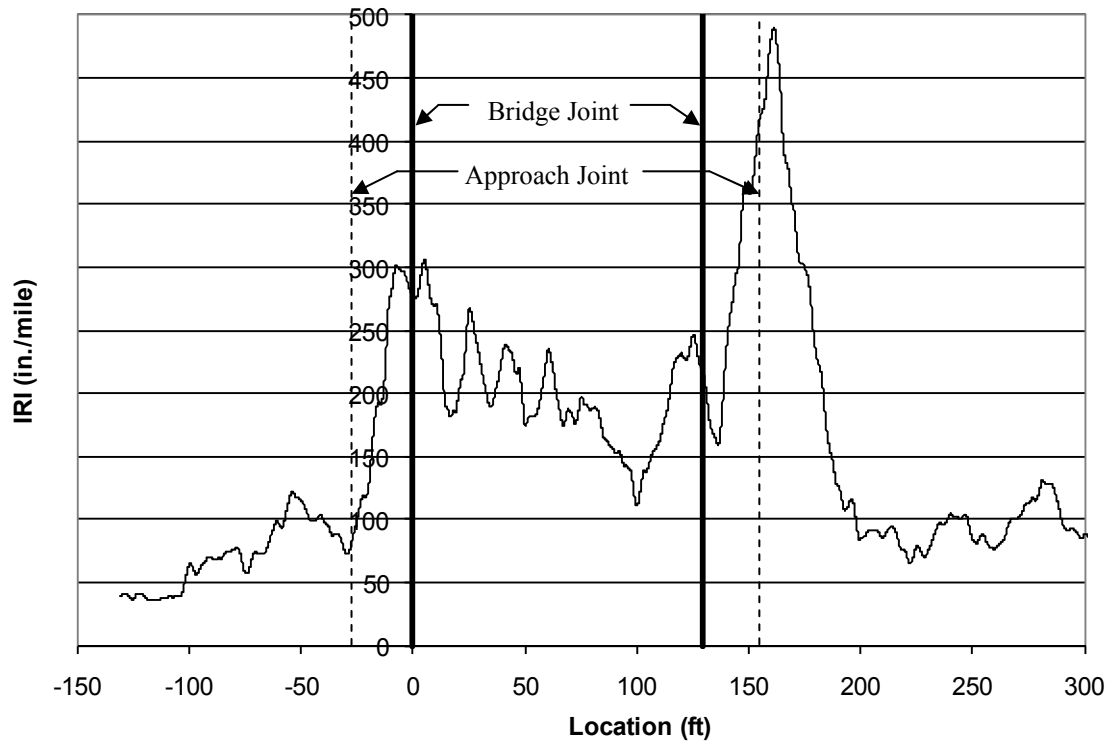
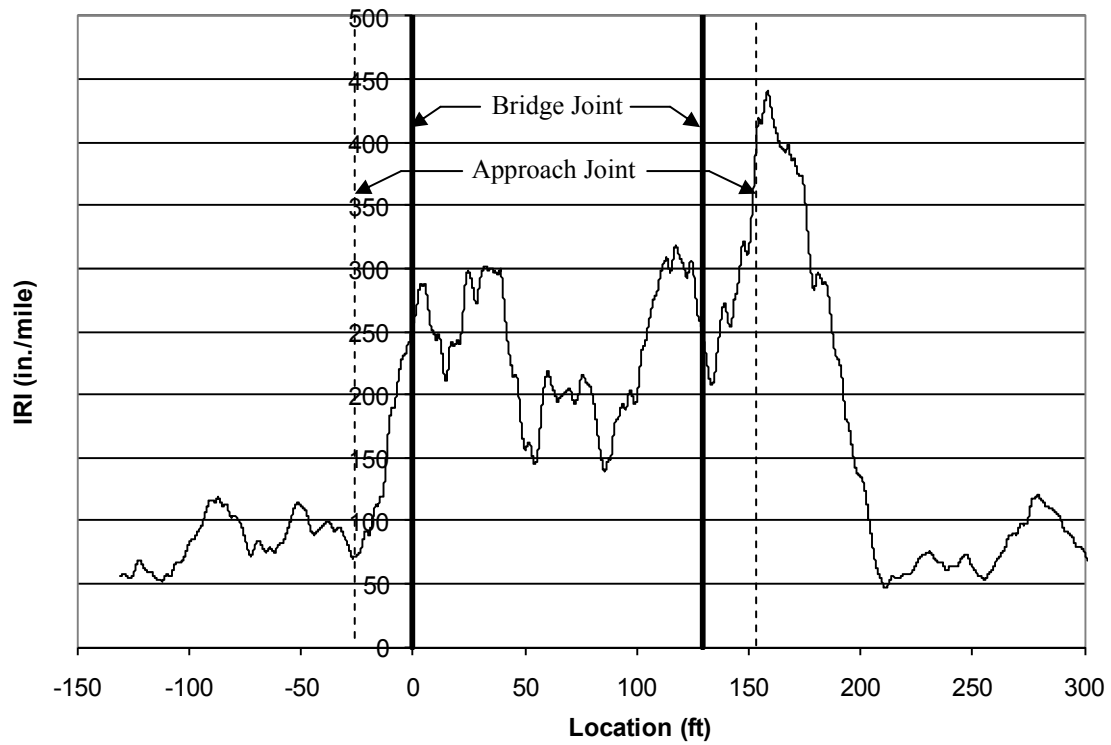
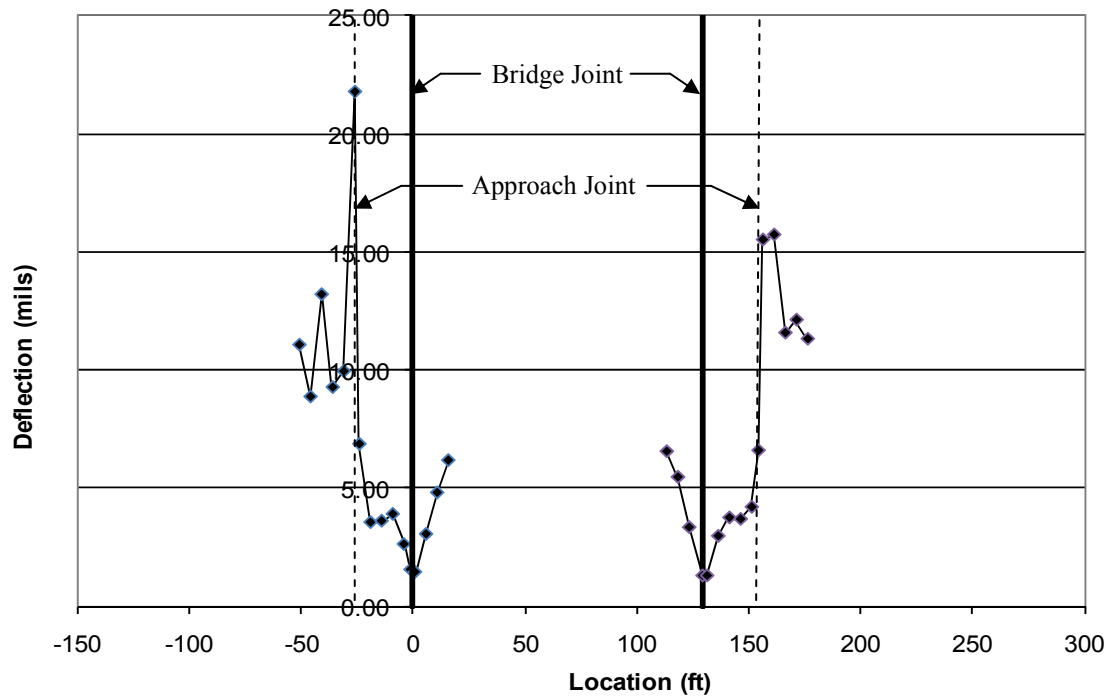
Figure 5.39. LIC 40-12.53 bridge geometric testing results

Figures 5.39a and 5.39b show the results of the laser-based survey. This bridge shows a consistent geometry from left to right. It further appears that the bridge consists of three distinct “regions,” both physically and in terms of data consistency. The entrance end of the bridge shows some variability that changes gradually. The bridge itself shows less overall variability in magnitude but that the variability changes quickly. The exit end of the bridge shows some instances of rapid, marked changes, indicating the potential for ride quality degradation.

In general, the above-mentioned observations are reified in the raw profiler and IRI data. Of greatest concern is the high spike in IRI data at the exit end on an otherwise acceptable bridge.

The FWD test results do not offer an explanation to the above-mentioned features. Specifically, the lowest stiffness is at the end of the bridge with the best ride quality. This may indicate approach slab connection problems.

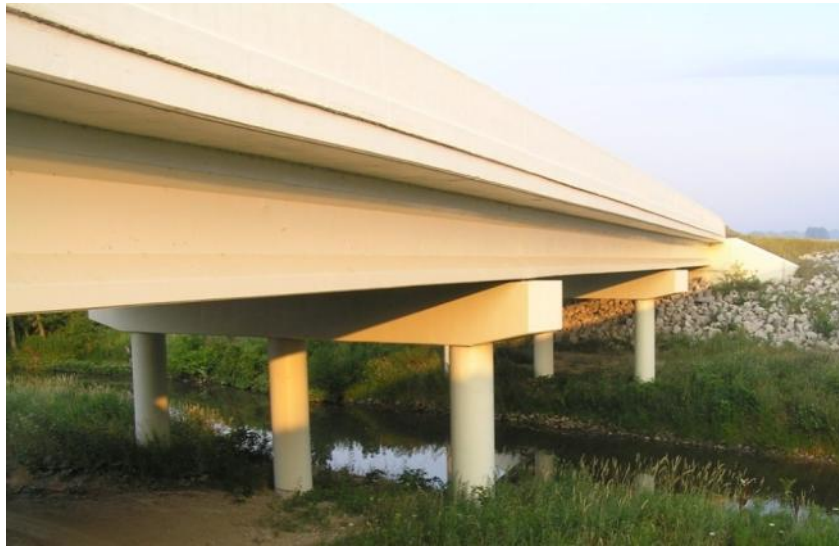
Figure 5.40. WYA 30-22.40 profile view

The WYA 30-22.40 bridge, shown in Figure 5.40, was built circa 2000 over Broken Sword Creek. The bridge has a 20 degree skew and is two lanes wide carrying eastbound traffic. The bridge is three spans with a total length of 233 ft. Six 54 in. deep pre-stressed concrete I-beams, with a composite concrete deck, make up the three spans. The abutments consist of one row of H-piles oriented with their strong axis parallel to the direction of travel. The piles have a concrete cap that connects to the girders to create an ODOT integral abutment. The approach slabs are 30 ft long and rest on a 6 in. paving notch. The approach slab is connected to the abutment with diagonal # 8 bars. The joint between the concrete pavement and approach slab has a 50 in. asphalt pressure relief joint.

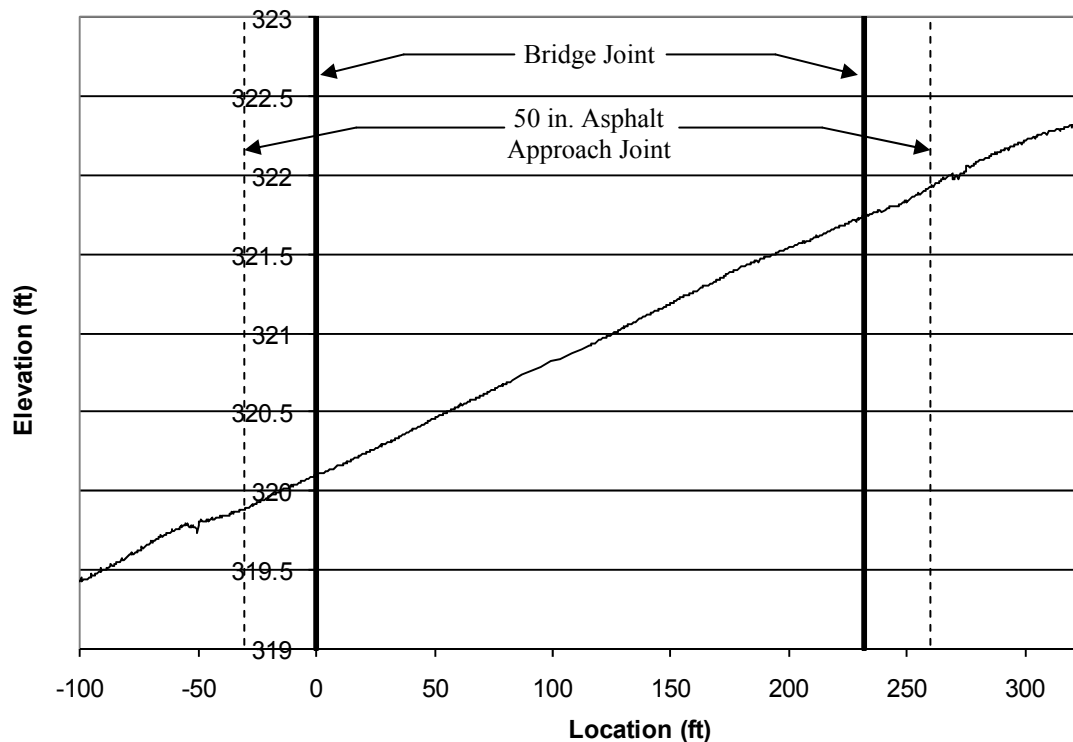
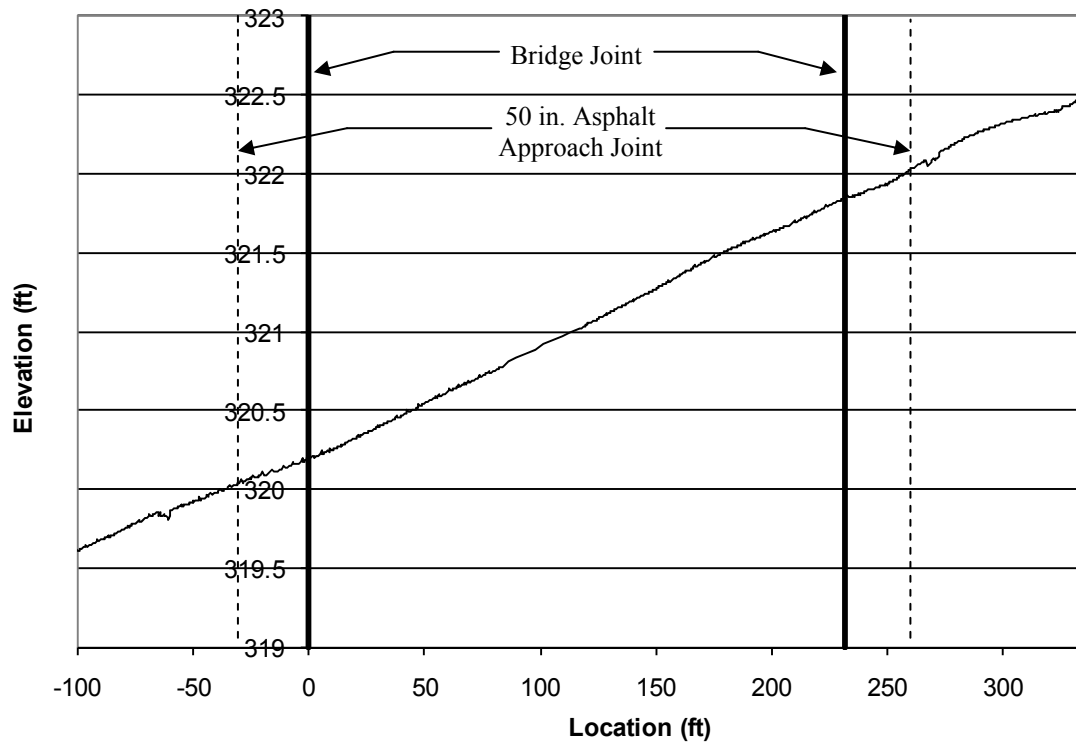
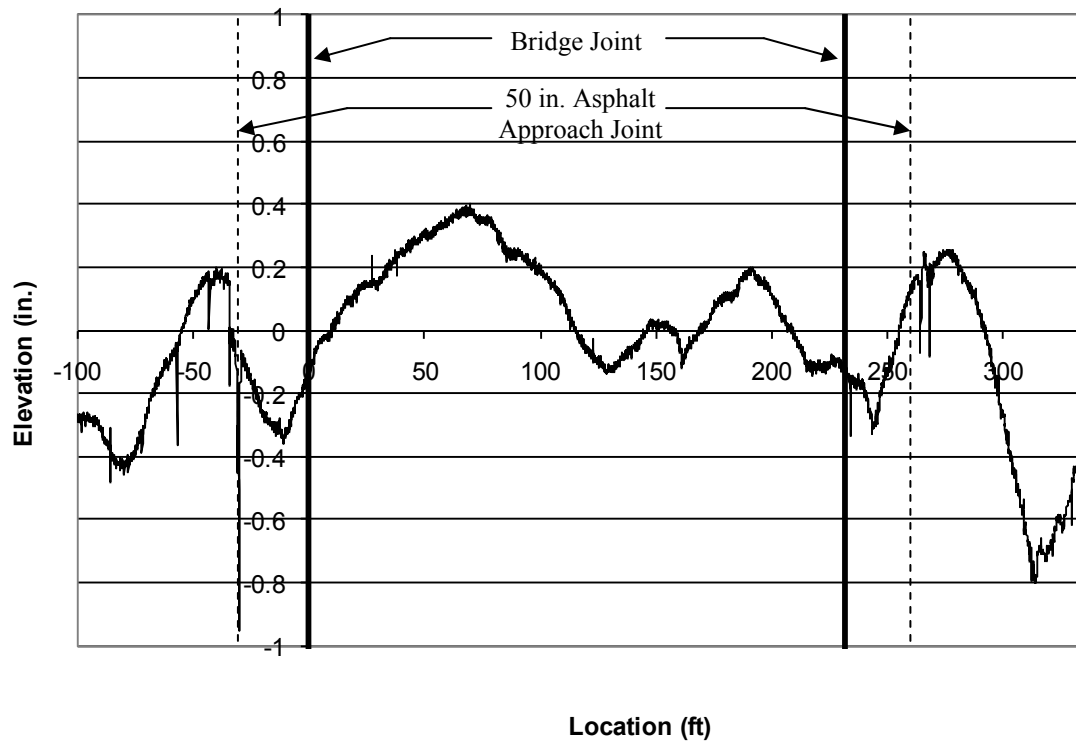
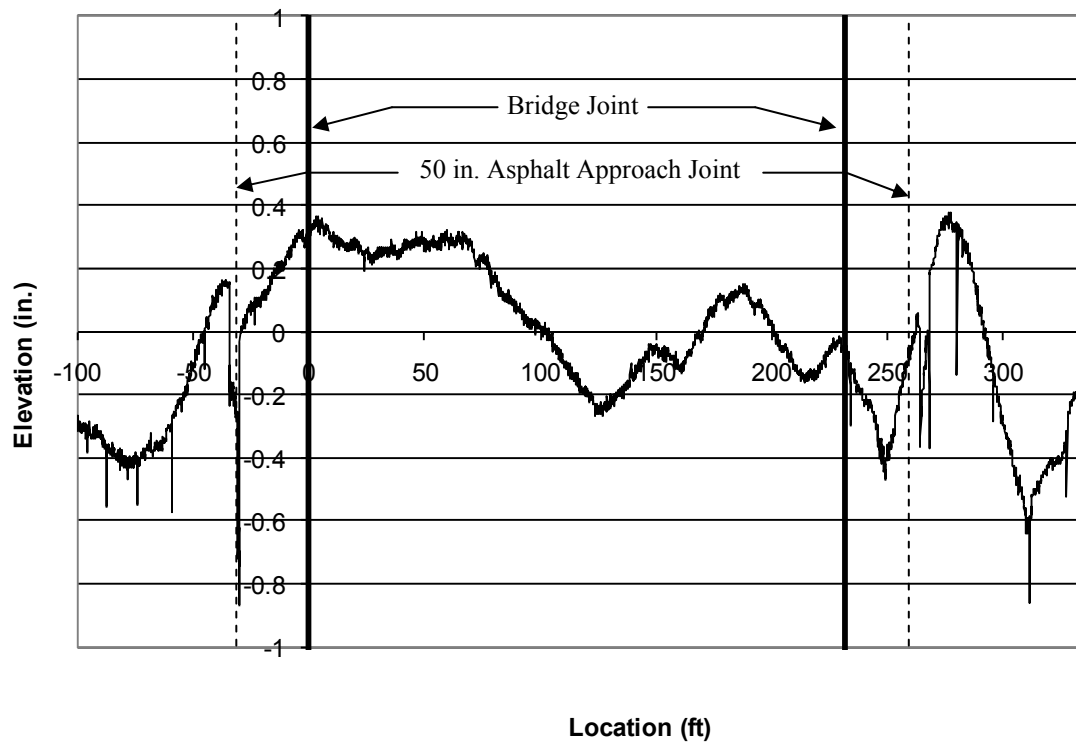
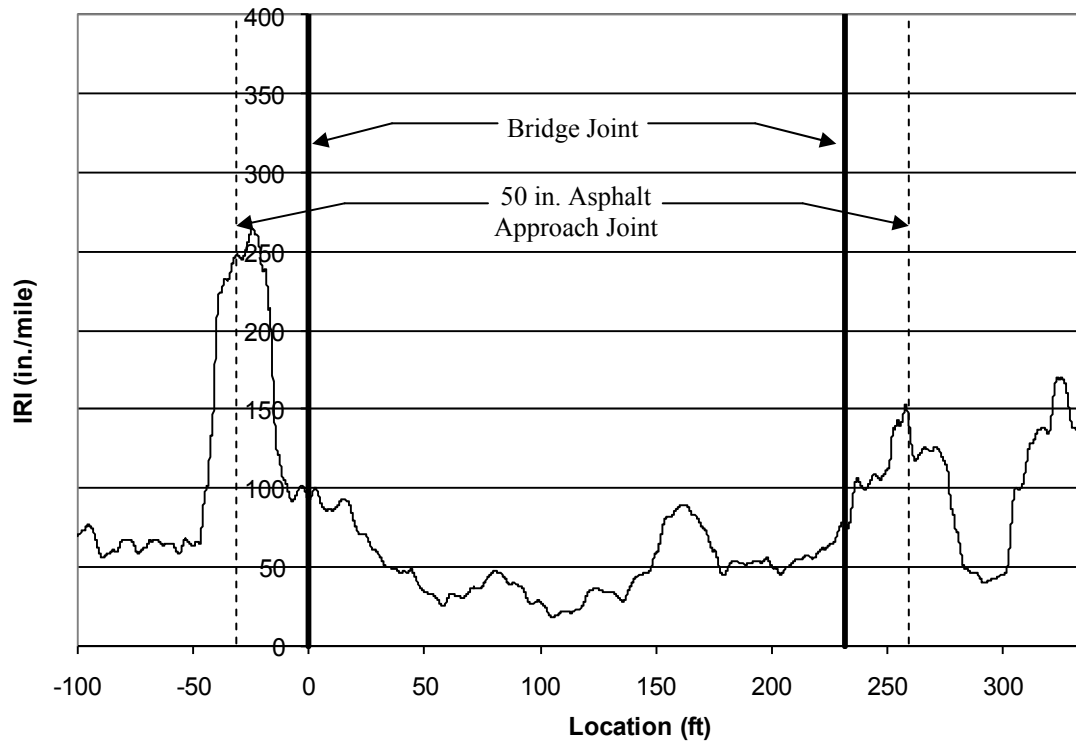
The profiler data (both raw and IRI) further confirm the observations made with respect to the survey data. With the exceptions of the area in the vicinity of the approach slab-to-pavement connection, this appears to be a bridge with very good rideability characteristics.

Unlike some of the previously-discussed FWD results, the WYA 30-22.40 bridge shows greater consistency in support system stiffness. Like the previously-discussed bridges, the greatest stiffness is at the abutment (as expected). However, the change in system stiffness with this bridge was less than that observed for other bridges.

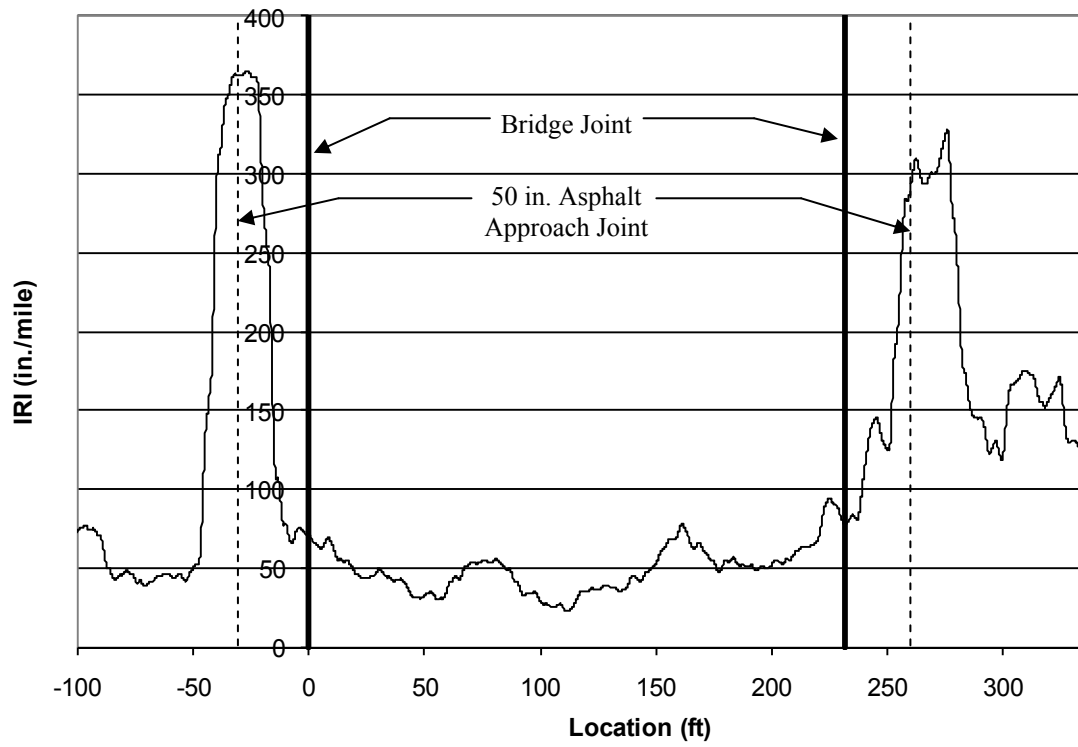
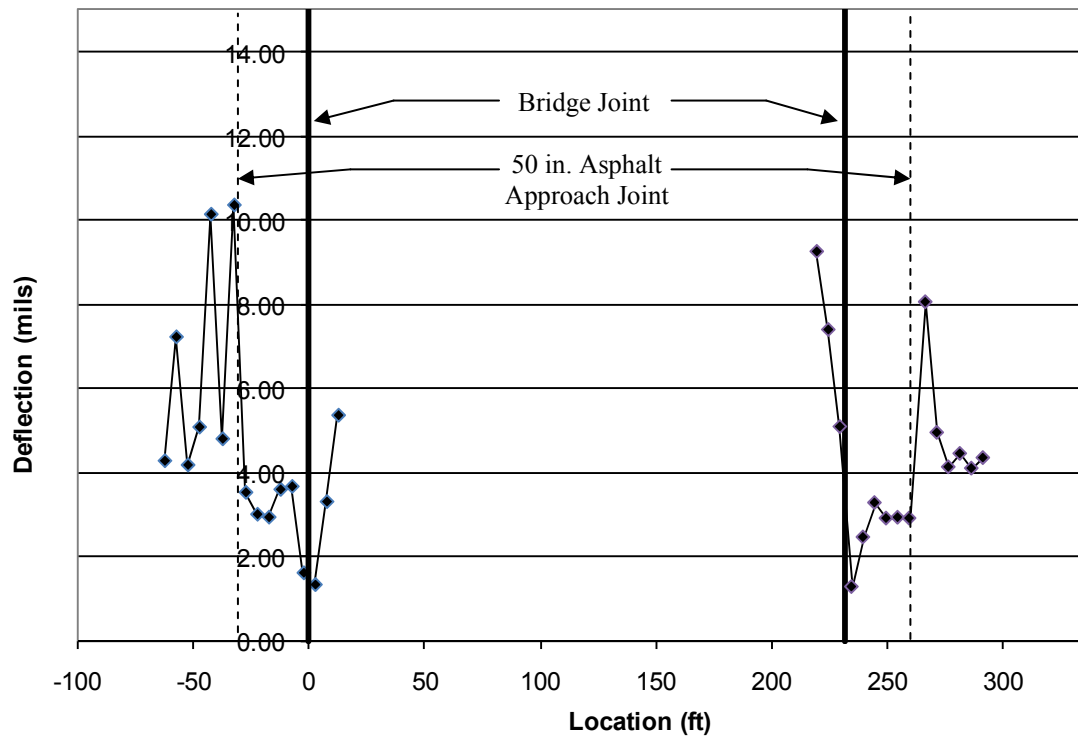
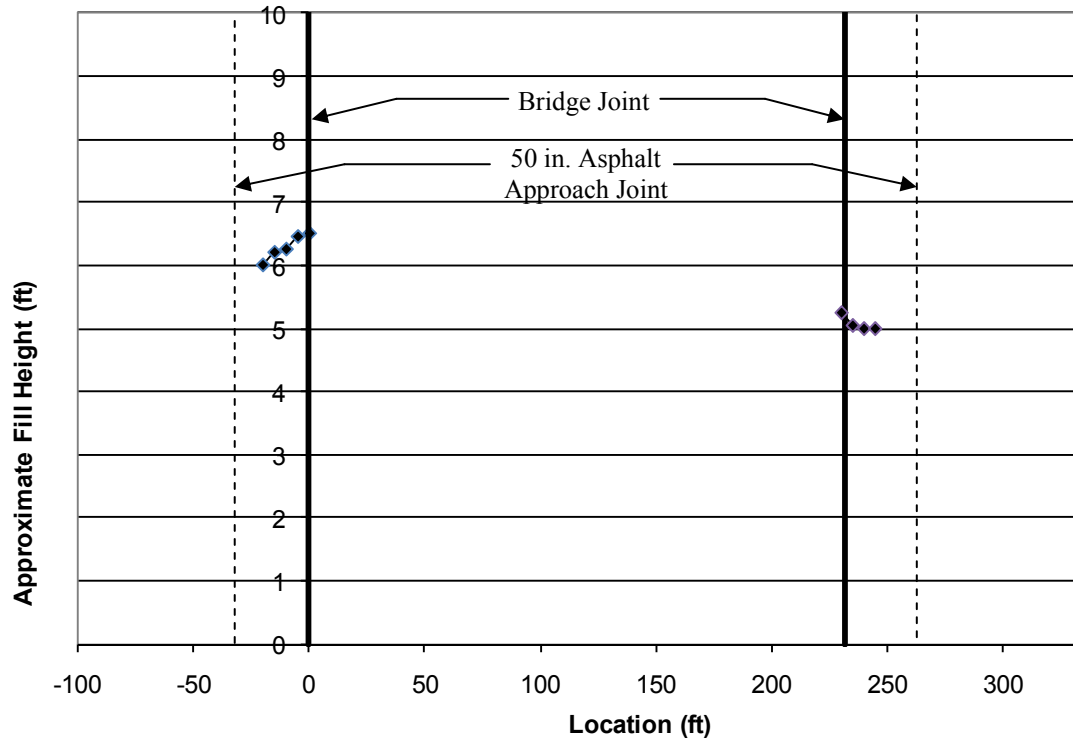
Figure 5.43. WYA 30-22.40 bridge geometric testing results

Figures 5.43a and 5.43b show the results of the laser-based survey. With only minor exceptions at both the entrance and exits of the bridge the global survey results indicate a bridge with few discontinuities. The discontinuities at both ends and in both wheel lines likely coincide with the approach slab-to-pavement joint. It would appear, then, that these areas would be the only locations where rideability may be less than desired.

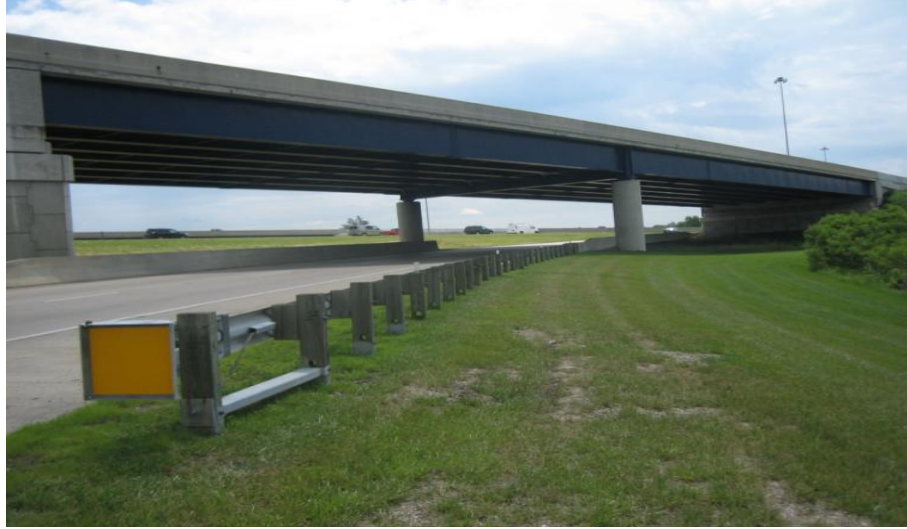
Figure 5.44. FRA 270-32.36 profile view

The FRA 270-32.36 bridge was built circa 1995 and carries three southbound lanes of traffic over an on ramp to Interstate 270. The bridge is a 304 ft long two-span bridge with the longest span being 173 ft, as shown in Figure 5.44. The bridge has seven 84 in. deep continuous steel plate girders with composite concrete decking. The abutments are semi-integral, which bear pile caps of two rows of vertical steel H-piles with their weak axis oriented parallel to the travel direction. Each abutment has 20 ft of MSE wall retaining the bridge embankments. The bridge, during the time of testing, had 30 ft concrete approach slabs. The highway pavement is concrete; therefore, a 12 in. pressure relief joint was placed at the end of each approach slab. In the past this bridge had experienced a severe erosion problem at the entrance abutment. Specifically, water began infiltrating the MSE wall, creating a large void under the approach slab. Subsequently, the void was filled with grout.

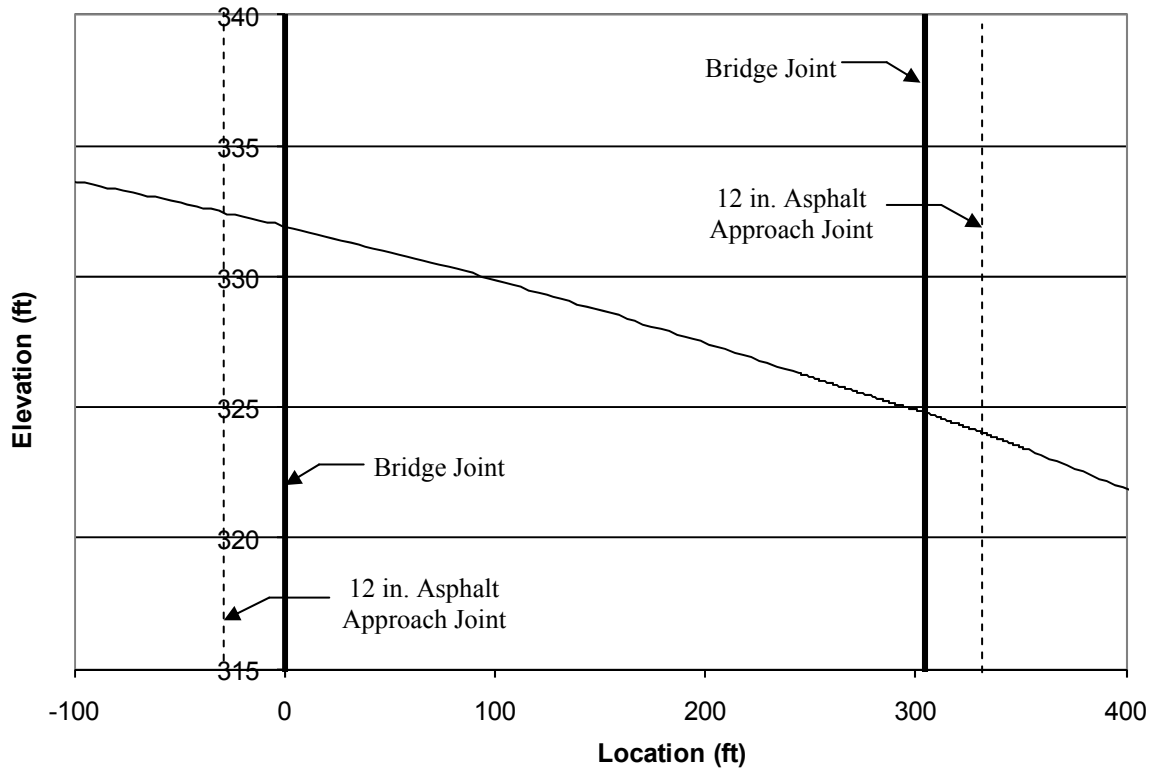
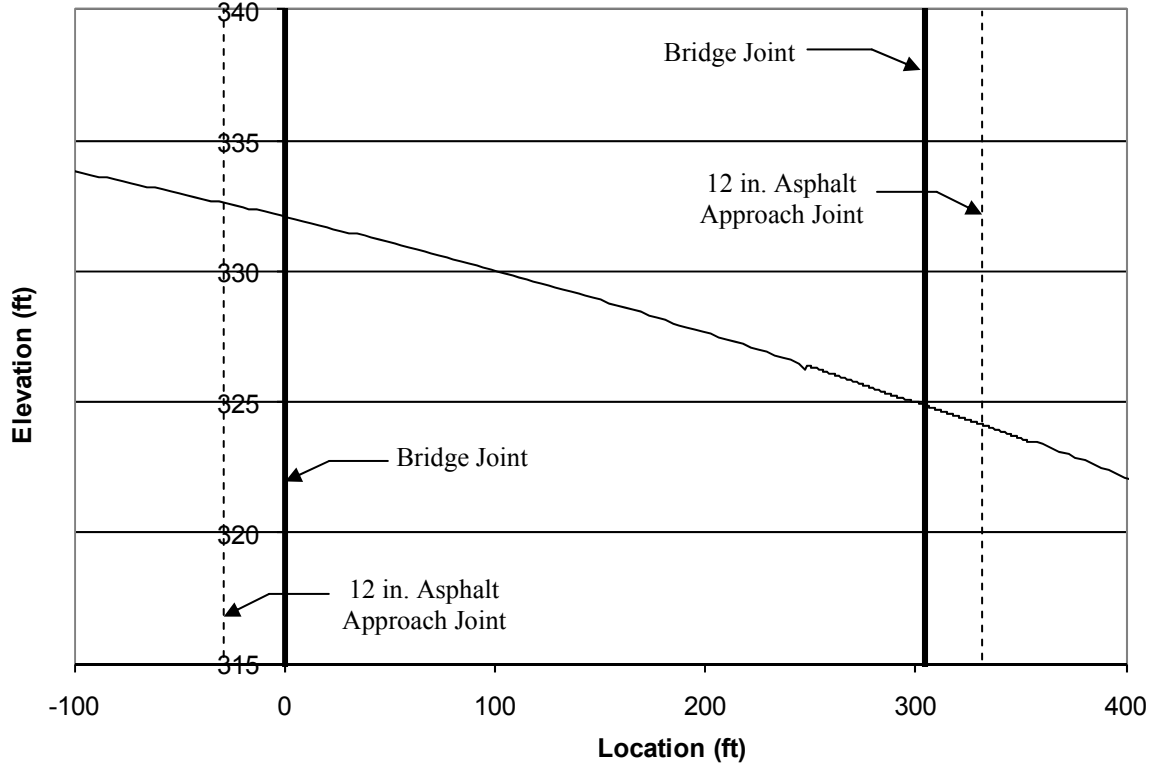
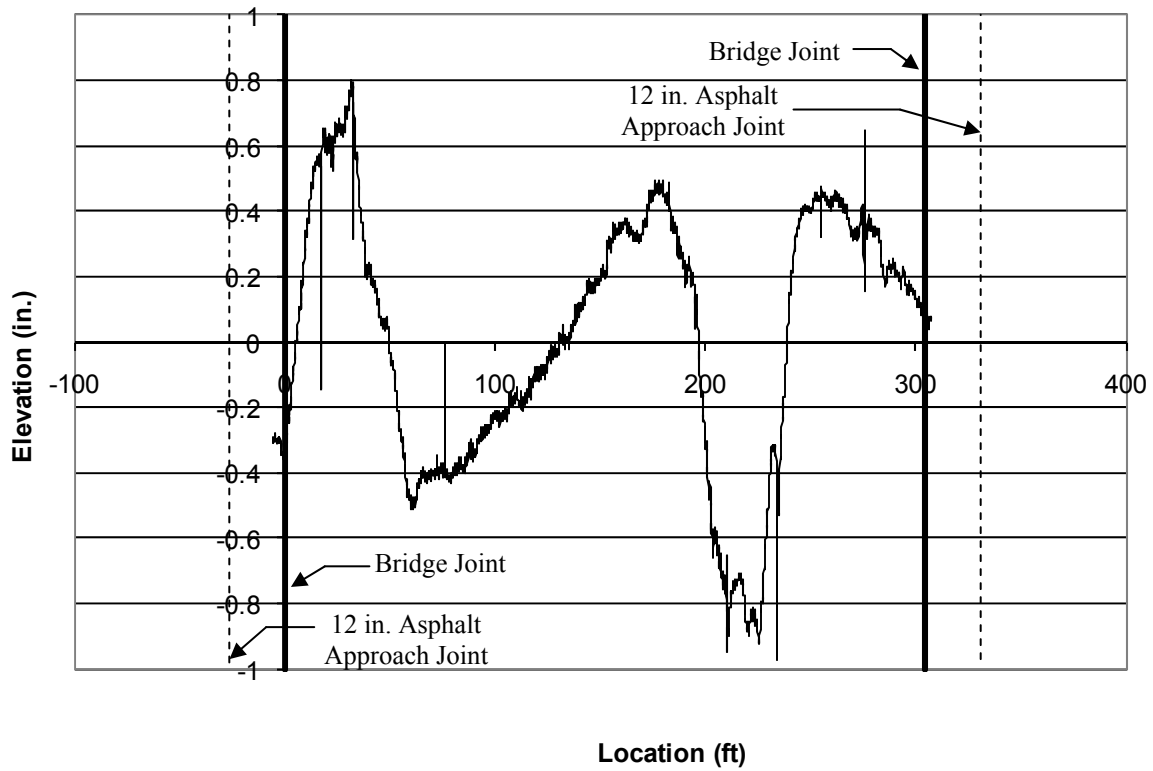
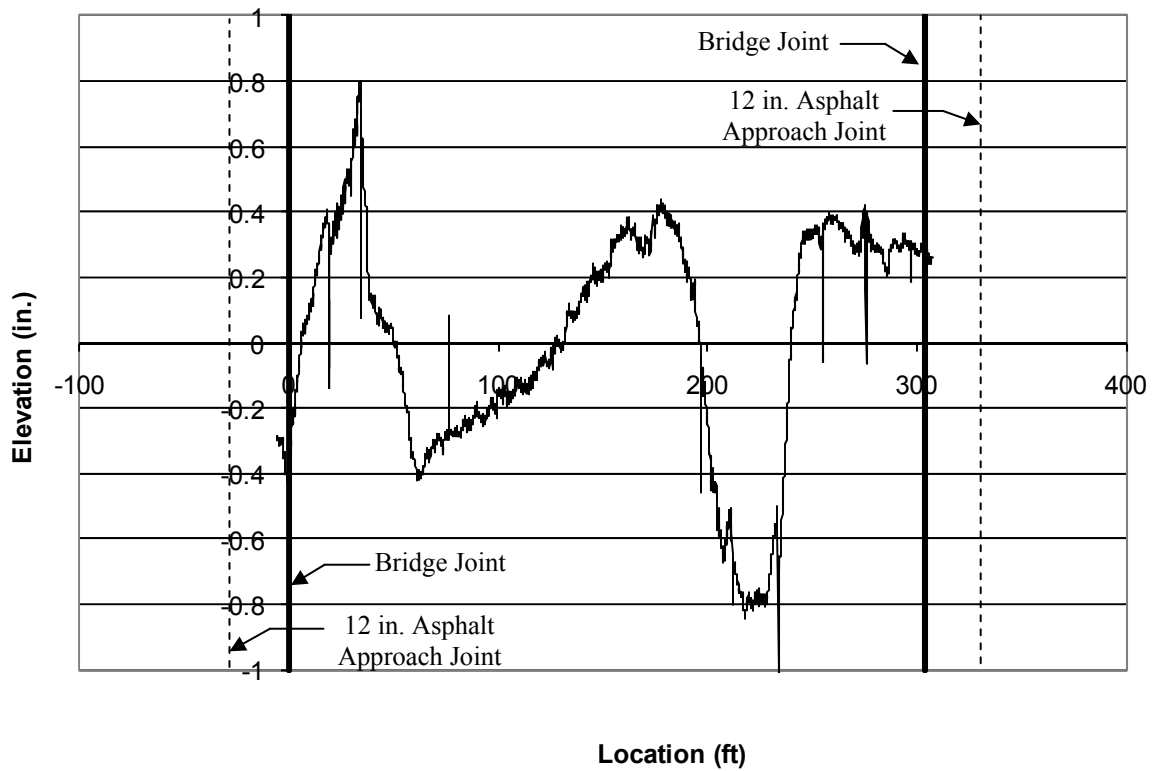
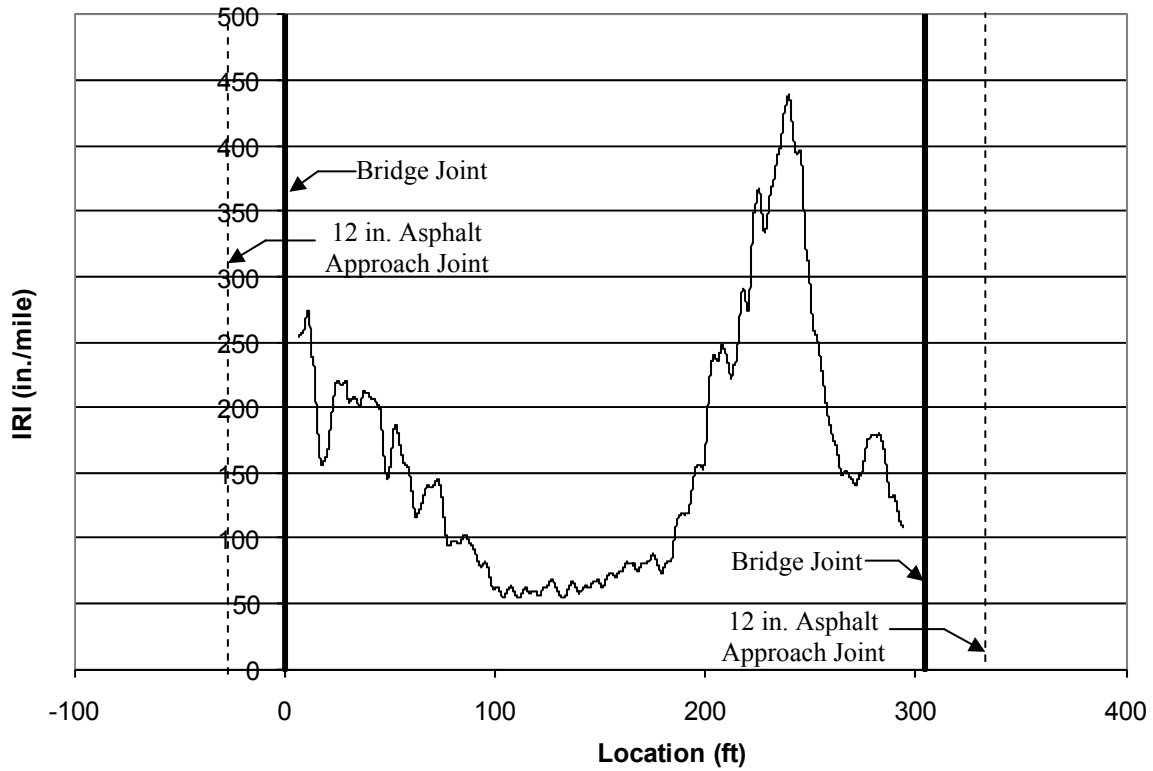
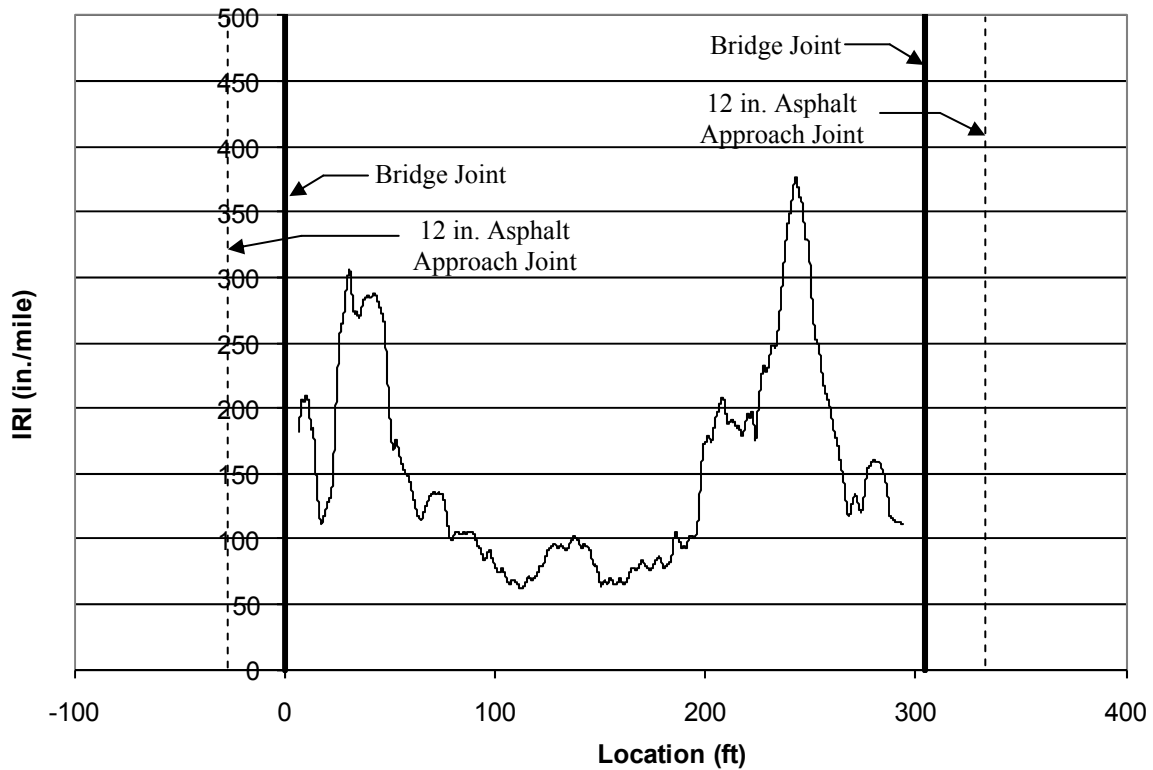
Figure 5.47. FRA 270-32.36 bridge geometric testing results

Figures 5.47a and 5.47b show the results of the laser-based survey. Generally, only one area showed a slight discontinuity in the survey results—approximately 75 ft from the bridge exit. The profiler data seems to substantiate the survey results, indicating this area has high IRI values (approaching 450). However, overall, the survey, raw profiler, and IRI data indicate a bridge with generally good rideability characteristics.

With only one exception, the FWD results indicate a support system that has very consistent stiffness characteristics. It is possible that this stiffness consistency contributed to the smoothness characteristics.
