Identification and Evaluation of Pavement-Bridge Interface Ride Quality Improvement and Corrective Strategies

Institute for Transportation

Report Number FHWA/OH-2011/1

January 2011

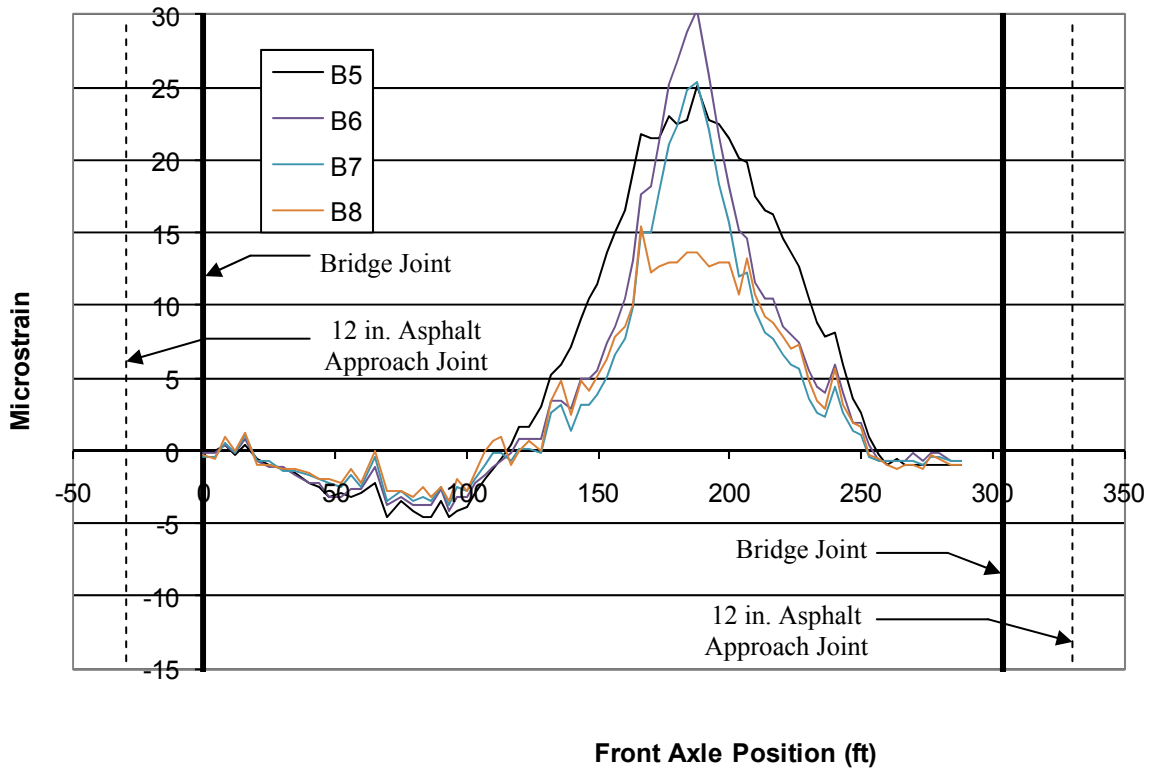
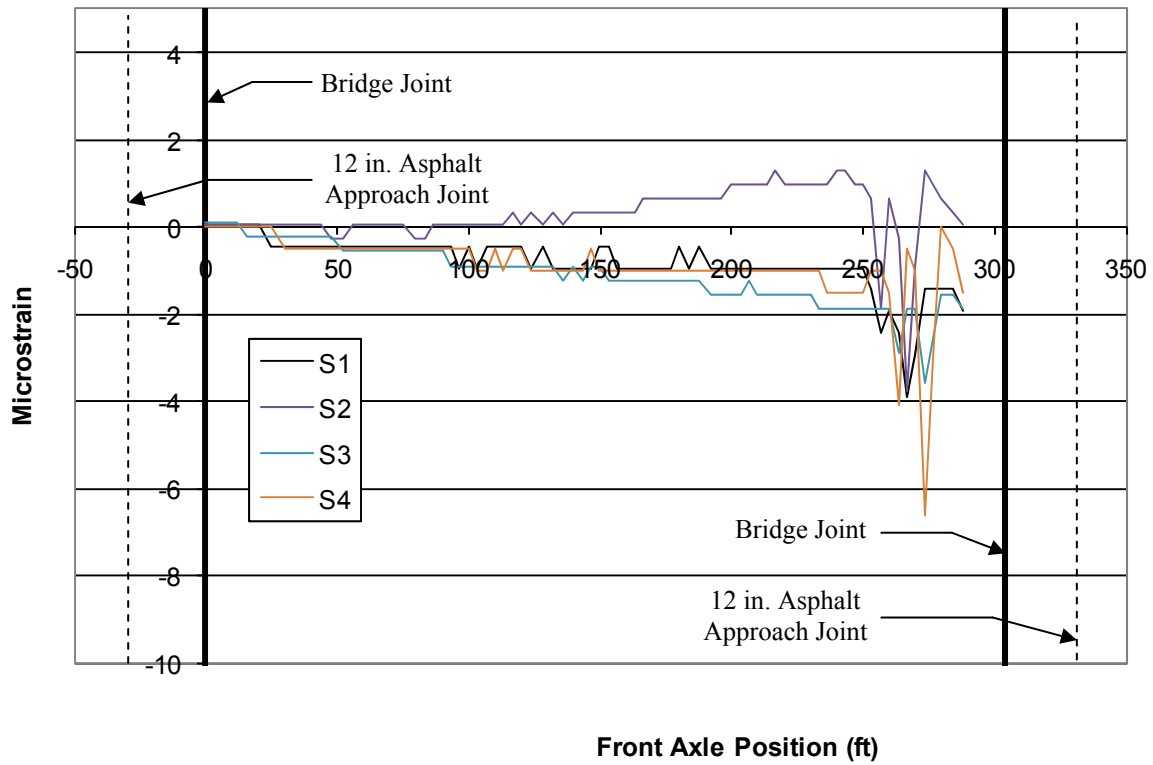
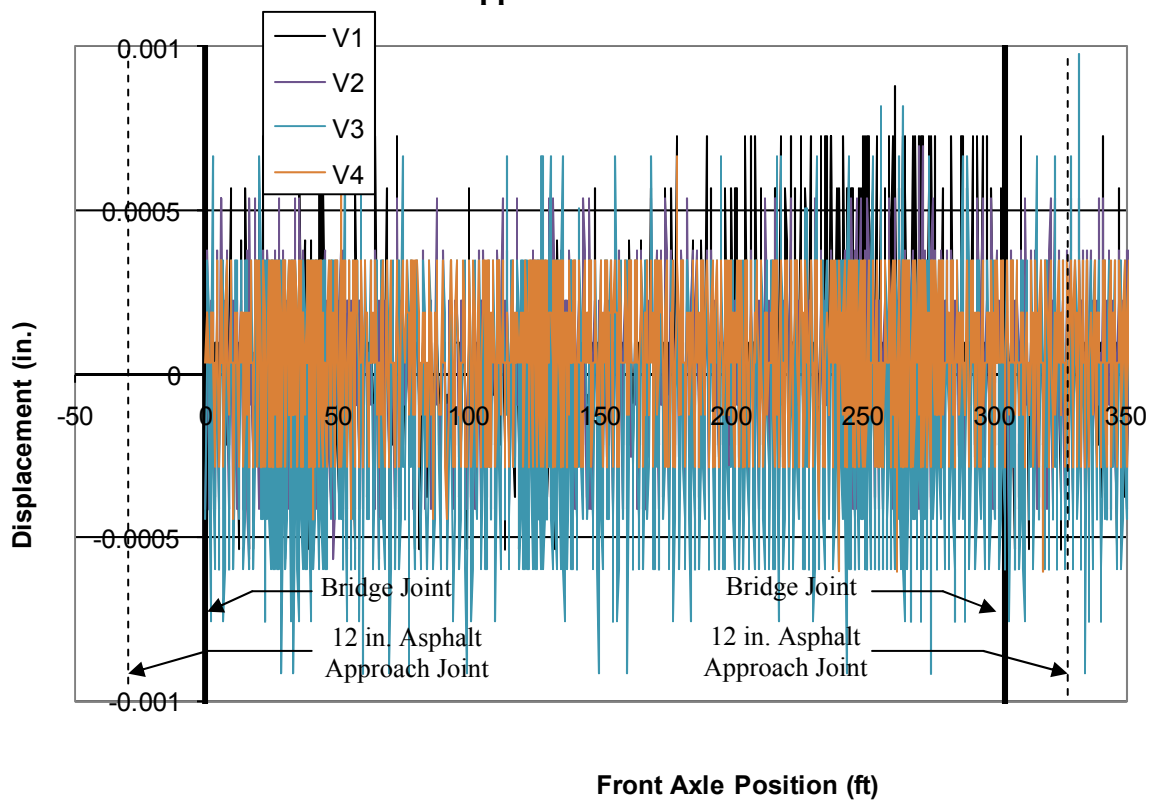
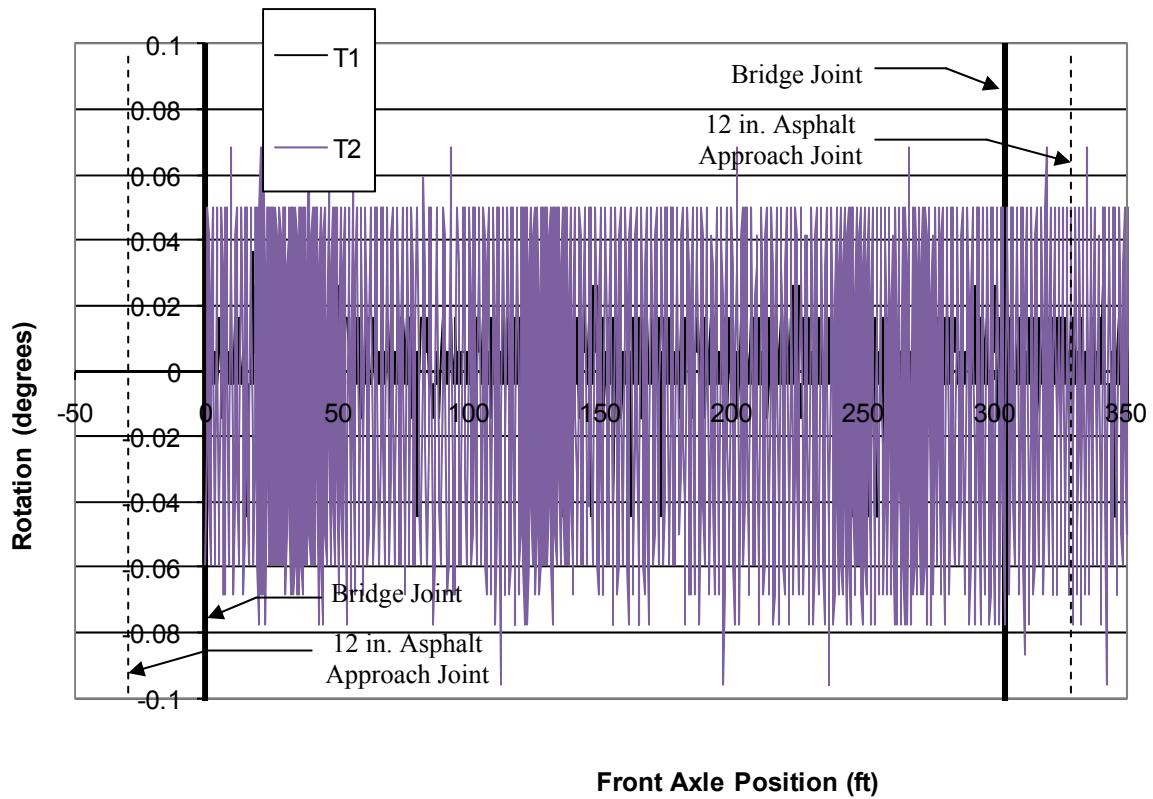
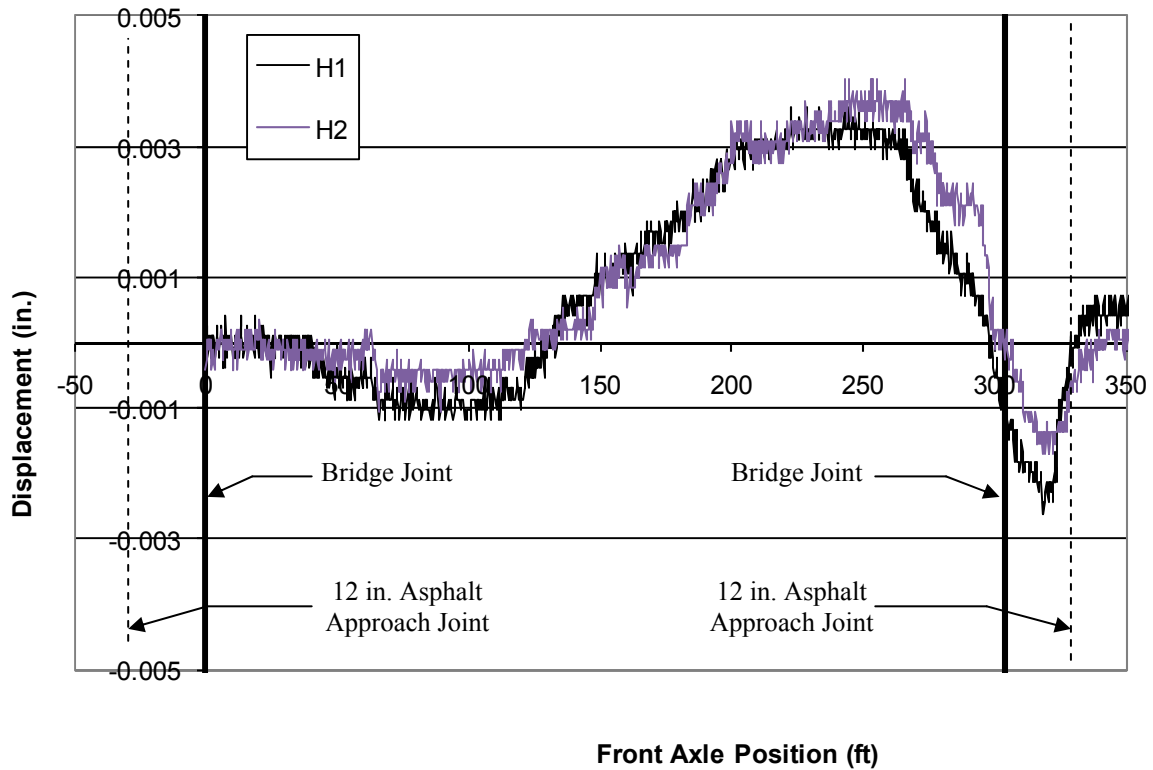
Figure 5.49. FRA 270-32.36 bridge live load testing results

As shown in Figure 5.49, the near girder end strain gages indicated very little end restraint occurring at the bridge bearings. This finding is further observed in the near midspan strain gages. In general, the measured girder strain levels are low with measured stresses under 1 ksi.

As in previously-described testing, very little measured slab strain and relative displacement indicated that the slab is behaving as a “unit.” This type of unified behavior is probably most impacted by the high degree of consistency in the support system stiffness.

As before, it was found the abutment did not rotate, but that it did have observable live load induced movement. This movement again has signs of strain sign reversal, indicating that the abutment is moving into and out of the supporting soil.

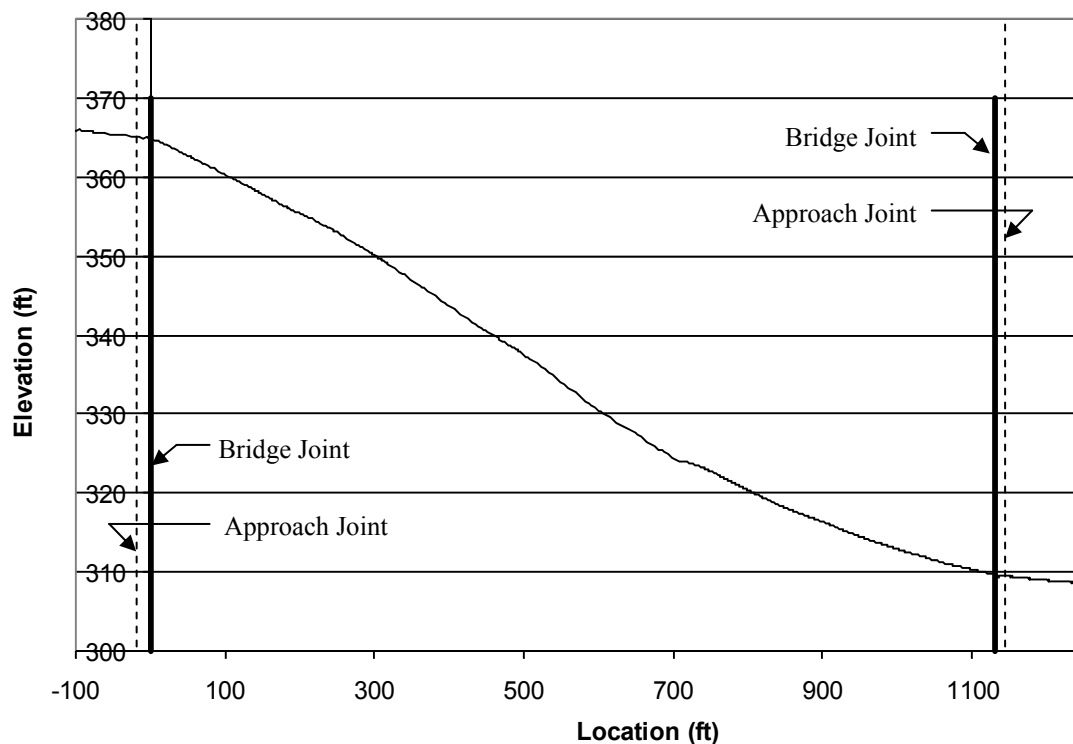
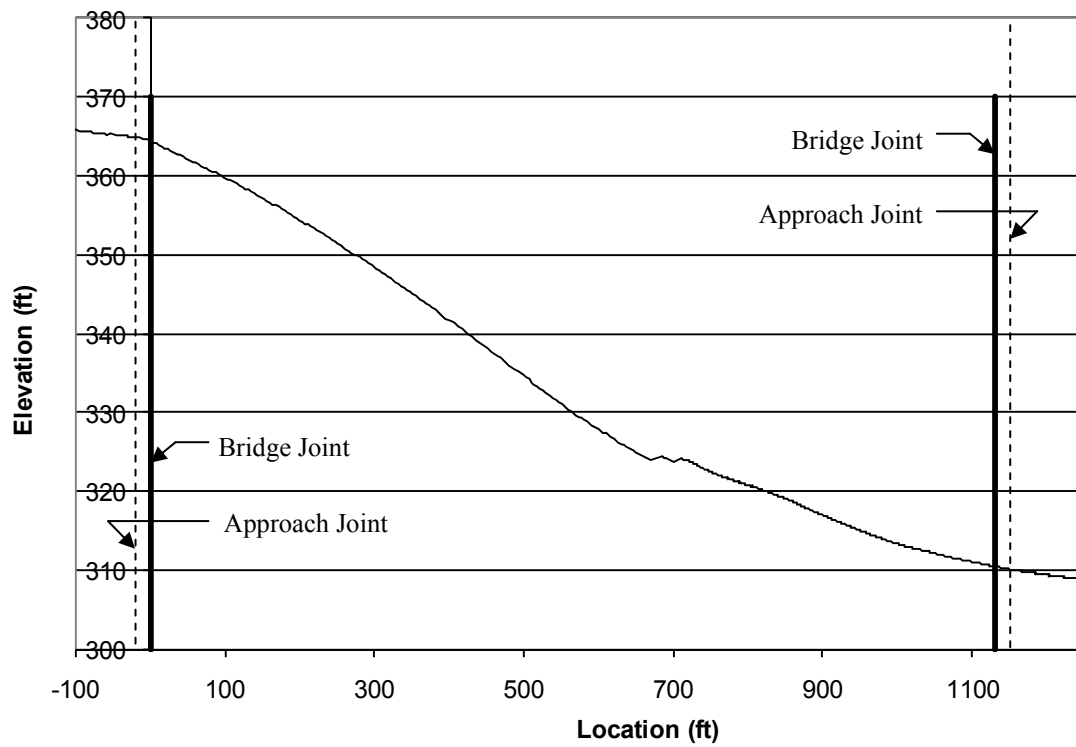
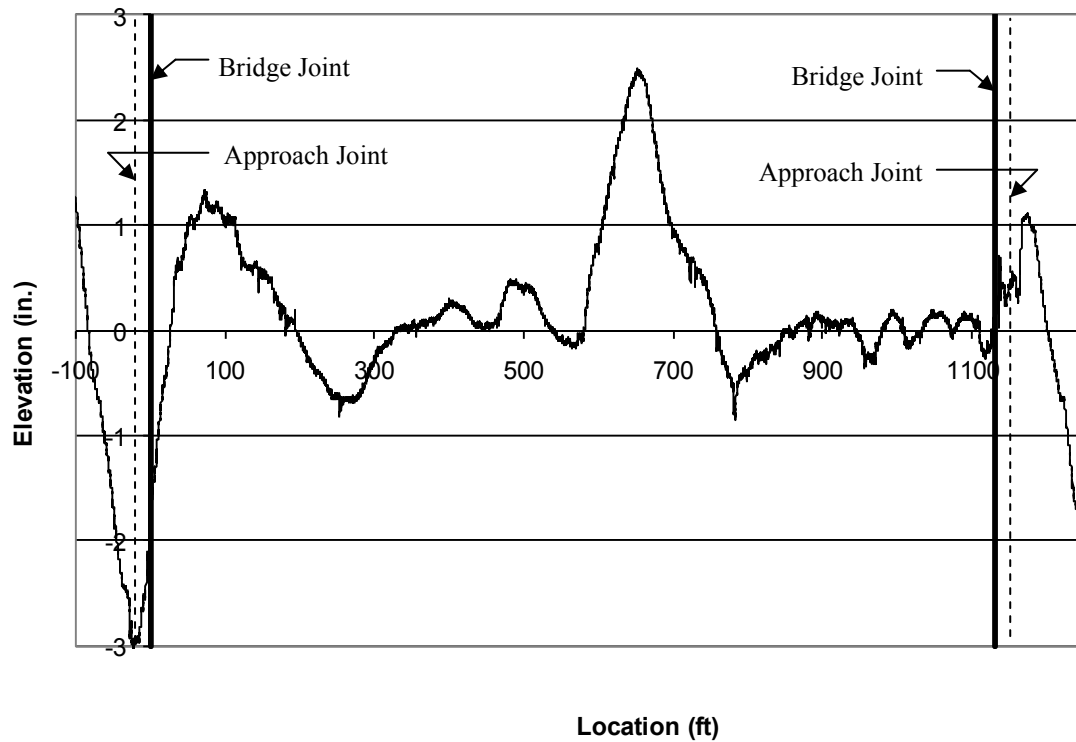
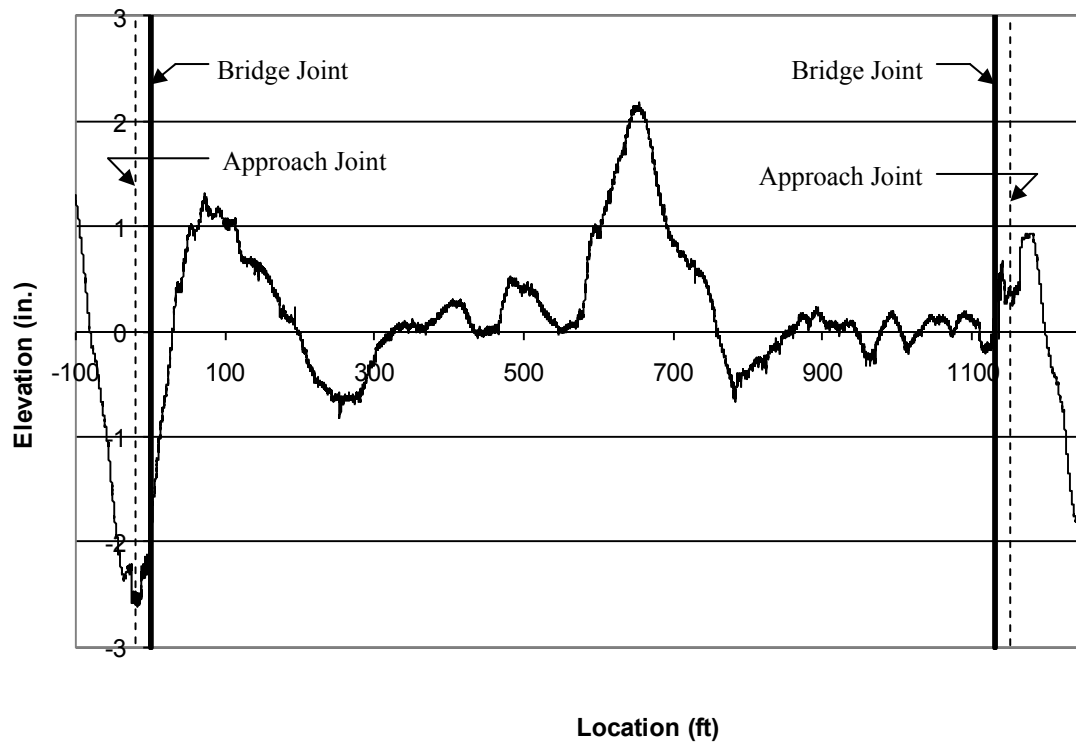
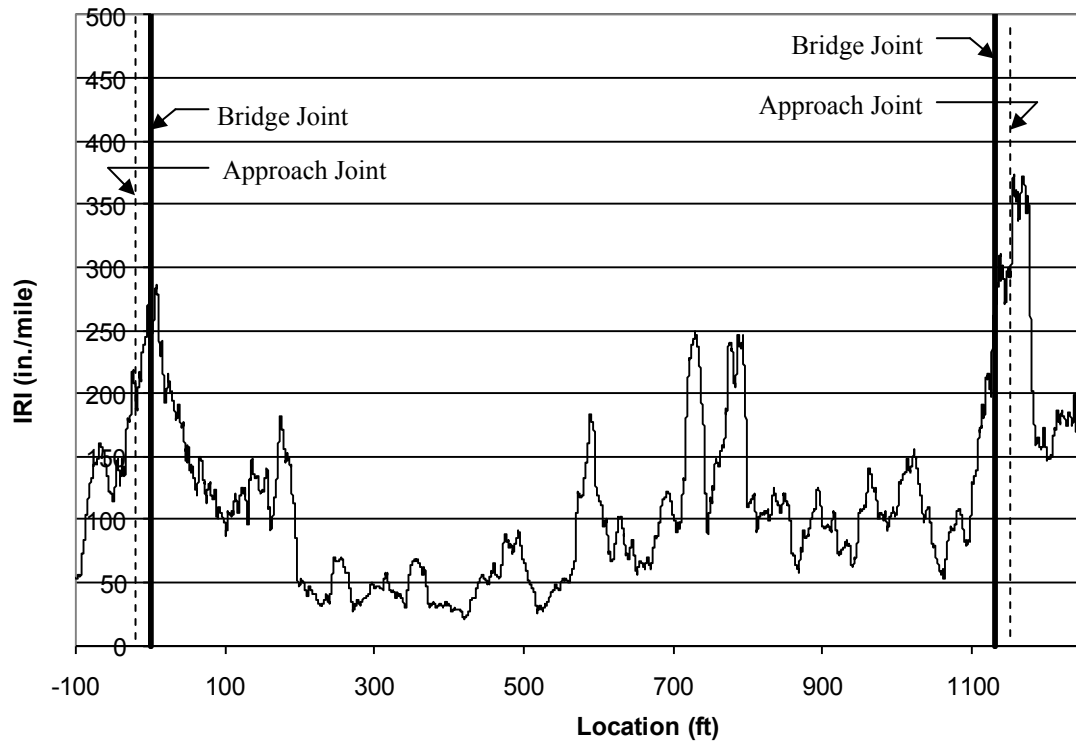
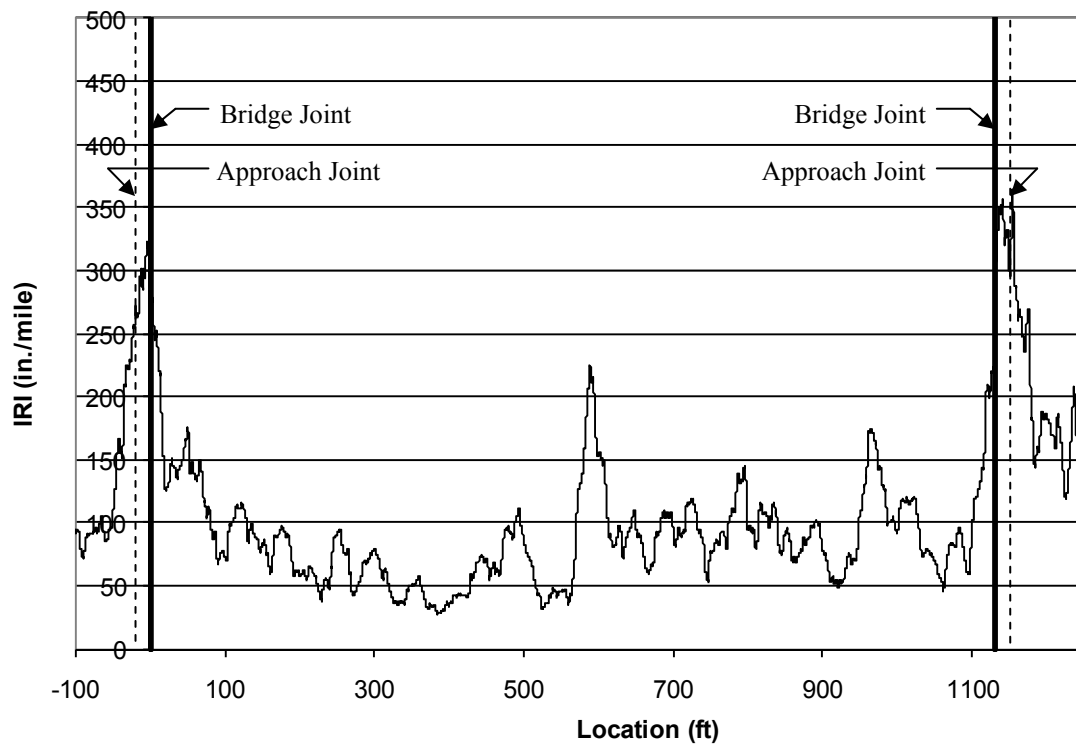
Figure 5.55. ERI 60-2.39 bridge geometric testing results

Figures 5.55a and 5.55b show the results of the laser-based survey. Generally, the survey results indicated a relatively consistent and gradually changing bridge profile. The only exceptions are at approximately 700 ft from the bridge entrance, as well as only slight discontinuities at each bridge end. (Note these are somewhat obscured due to the scale of the plots in the report).

The profiler and IRI data also indicate a relatively consistent surface with slight discontinuities at each end and at the 700 ft location. The FWD test results indicate a region extending approximately 25 ft from the bridge end where the support system is quite stiff. From 25 ft on, the support is less stiff but very consistent.

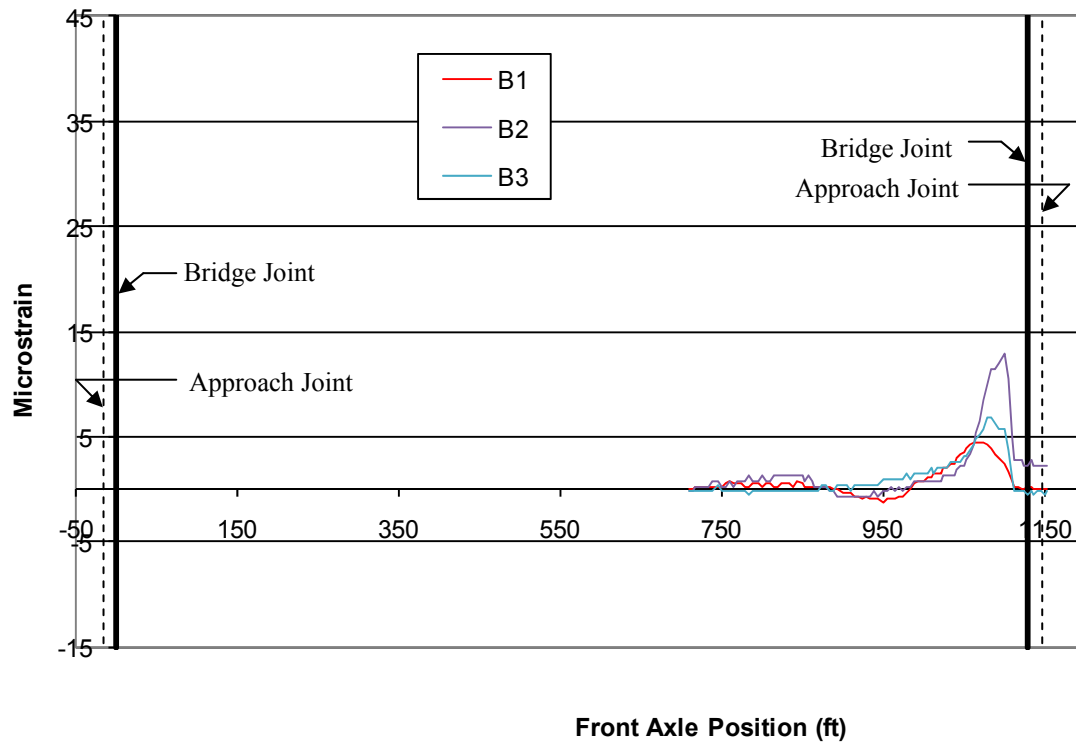
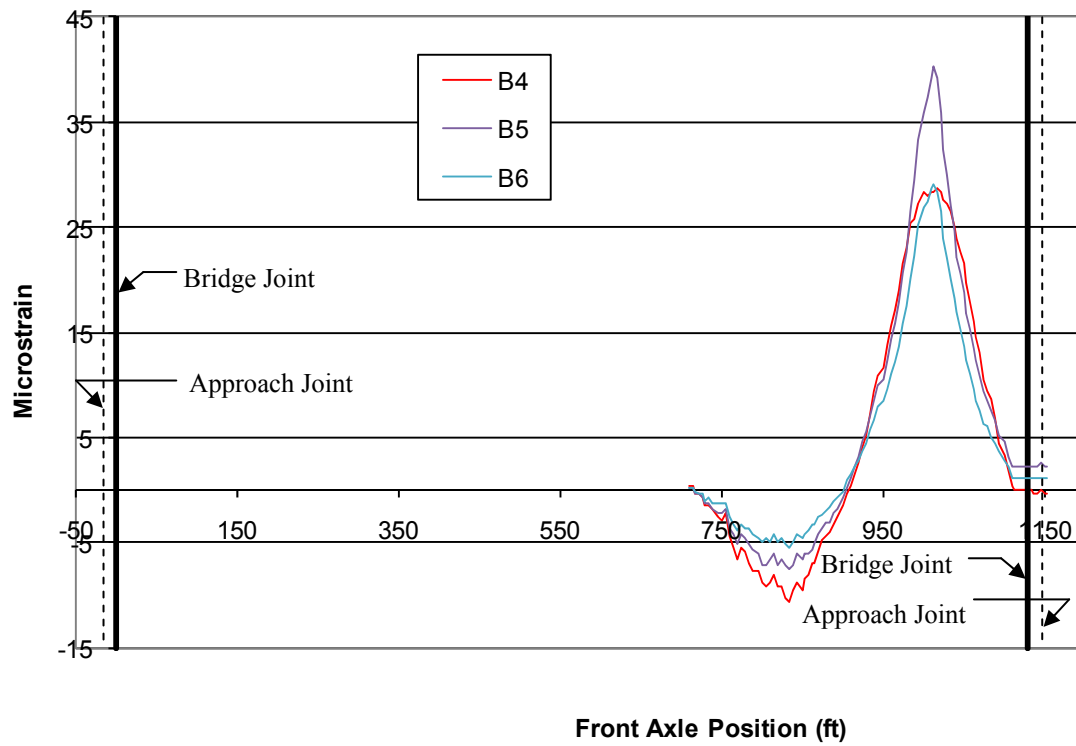
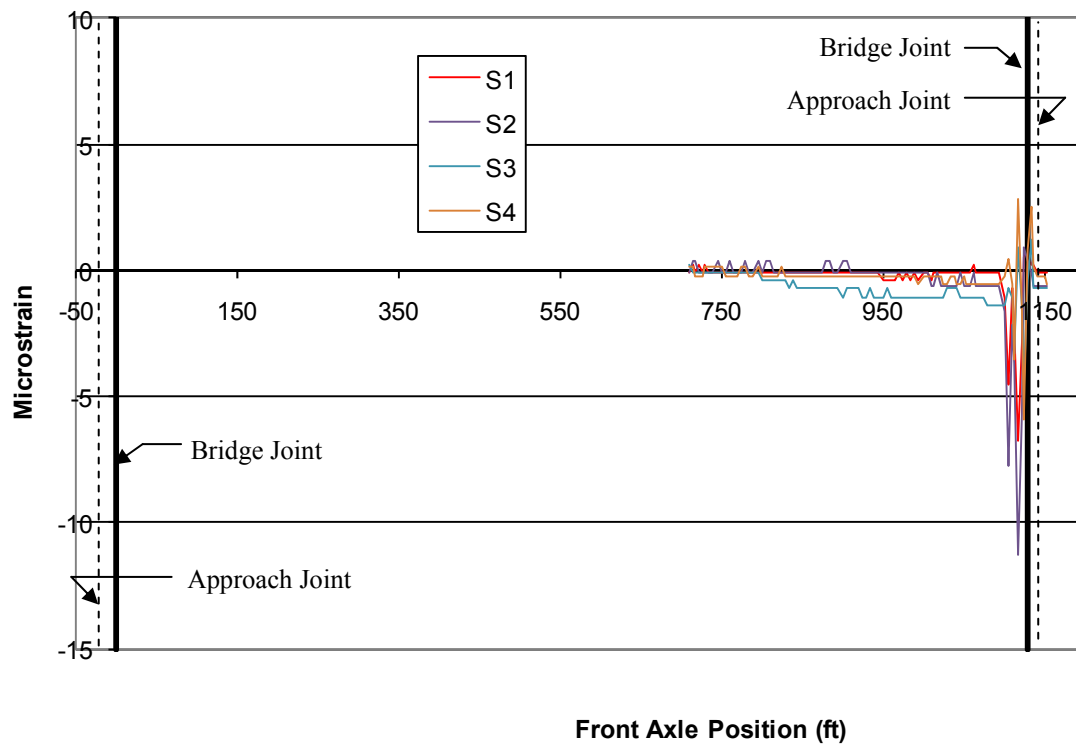
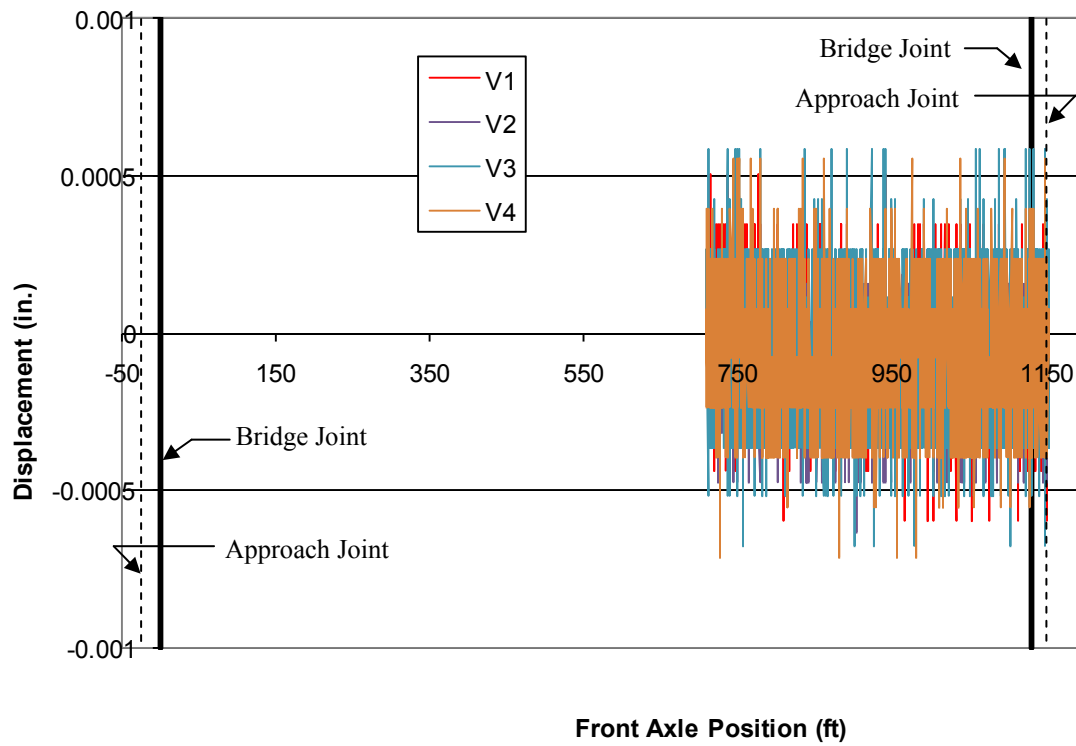
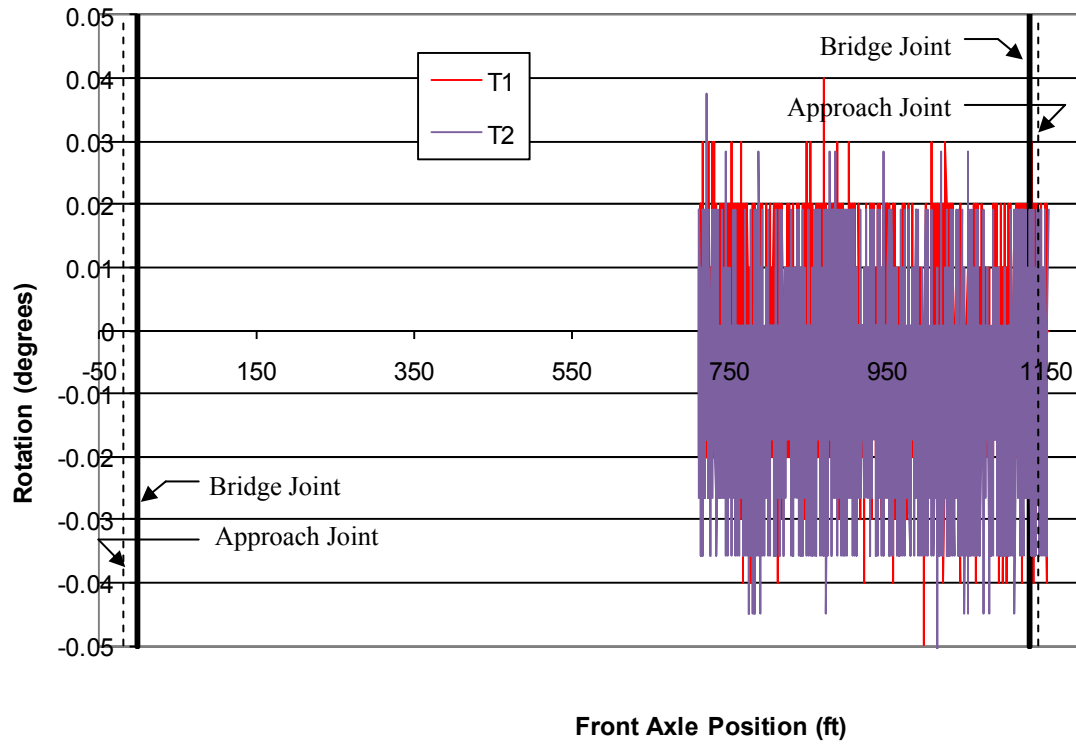
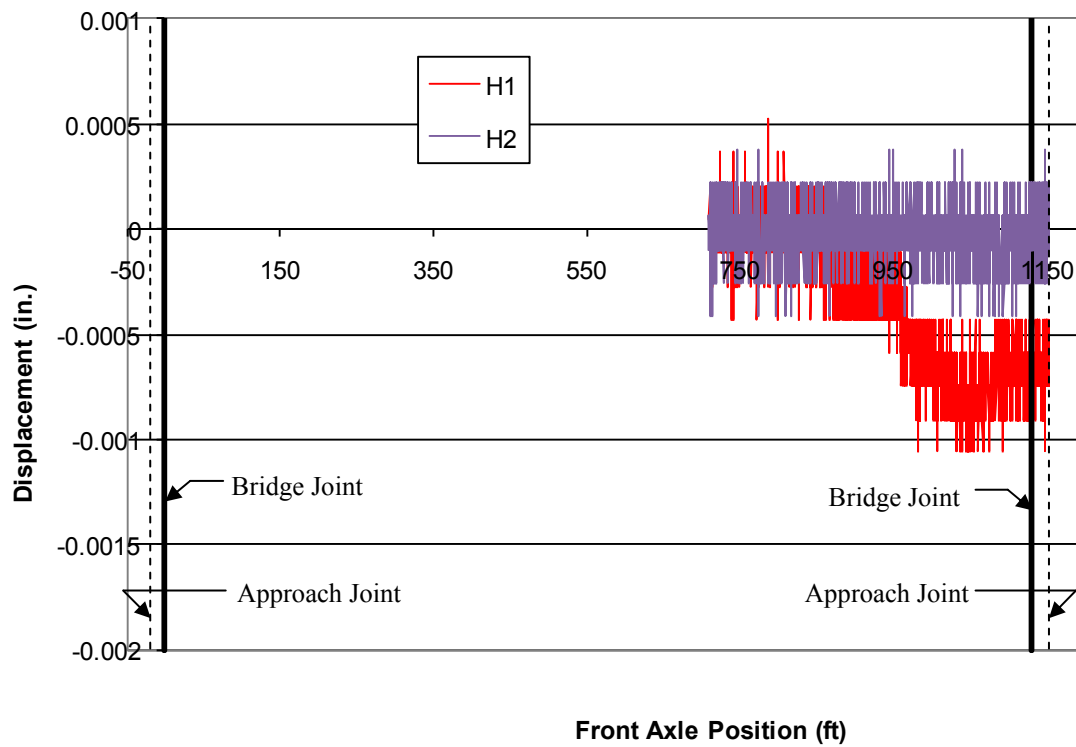
Figure 5.57. ERI 60-2.39 bridge live load testing results

As seen in Figure 5.57, the near girder end strain gages indicate very little end restraint; this behavior is further confirmed by the near midspan strain gages. In general, the stresses at all locations are high, relative to others tested as part of this work. However, the maximum recorded live load stress was just over 1ksi. The approach slab had larger measured strains than other bridges tested during this work. However, the measured strains were still relatively low. Also, relatively vertical displacement of the slab was found to be negligible.

During live load testing, the ERI 60-2.39 bridge abutment was observed to rotate when loaded. However, the rotations are considered to be small. Furthermore, like all other bridges tested, the abutment was observed to translate under live loads. Unlike the other bridges, the movement was only “away” from the soil and back to “neutral.”

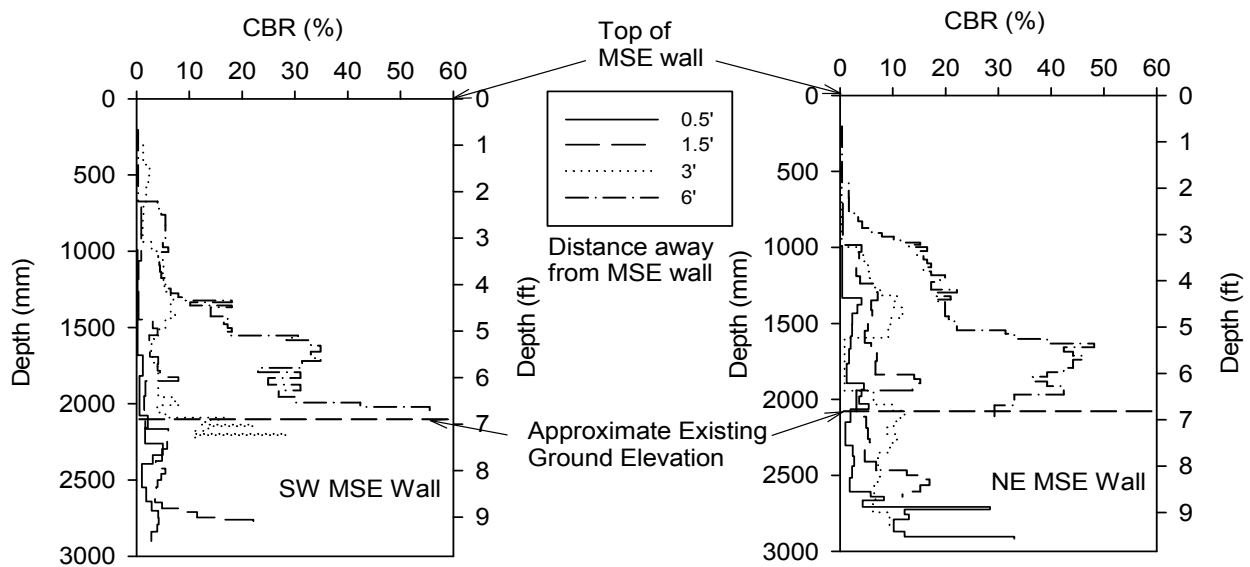
Figure 6.24. DCP-CBR profiles at selected distances away from the NE and SW MSE walls – Bridge #1

The CBR values ranged from 0 to 10% at 0.5 ft to 3 ft away from the MSE walls for the upper 6.6 ft of the backfill, which indicates variability and relatively low strength of the backfill material (See Figure 6.24). The tests performed at 6 ft away from the MSE showed higher CBR values at depths greater than about 4.9 ft. Because the DCP tests were conducted at the fill stage, no compaction had occurred in the upper 1.6 ft of loose lift. Figure 6.25 shows CBR values with distance away from the MSE for selected depths. Results show an increase in CBR value with distance from the MSE with depth.

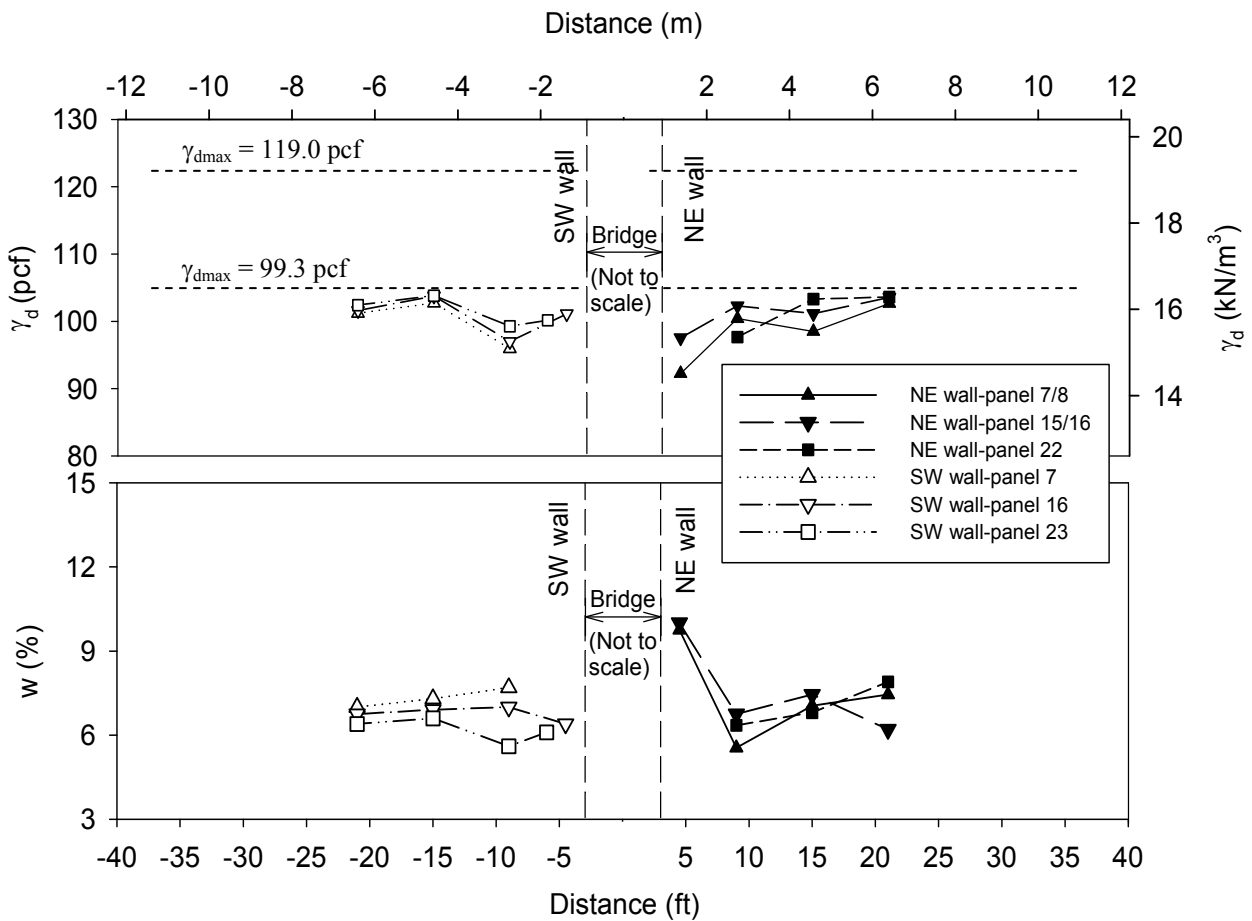
Figure 6.26. Moisture and dry density measurements at selected distances away from the MSE walls – Bridge #1

The dry density measurements of the backfill material at the SW wall and NE wall ranged from 95 to 105 pcf. The moisture content measurements were relatively constant for the measured locations, except for the tests conducted at 1.5 ft away the NE wall, which could be the result of that location having been watered just before the measurements were taken. Figure 6.26 shows the moisture contents, which ranged from 5 to 10% for the test locations.

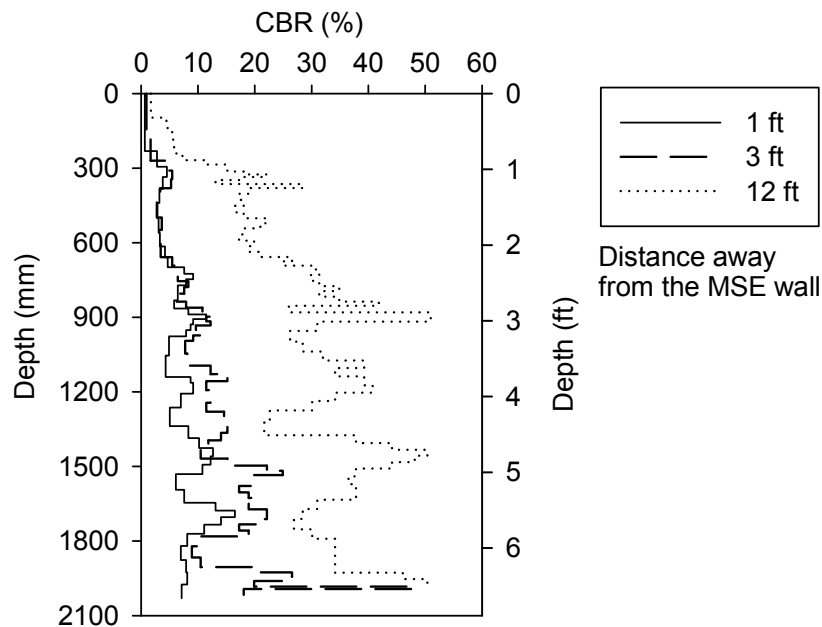
Figure 6.28. DCP-CBR profiles at selected distances away from the MSE wall – Bridge #2 (USCS: SW-SM)

DCP tests were performed at distances of 1 ft, 3 ft, and 12 ft away from the MSE wall. Between 1 and 3 ft away from the MSE wall, the CBR values did not change significantly; the test conducted at 12 ft away from the MSE wall showed a higher CBR value. The CBR values for the tests conducted at 1 ft and 3 ft away from the MSE wall ranged from 0.7 to 23% from the surface to 6.6 ft below the ground, and the DCP test conducted at 12 ft away from the MSE wall showed the CBR value ranged from 1.7 to 50%, which indicates a significant increase. DCP tests results are presented in Figure 6.28

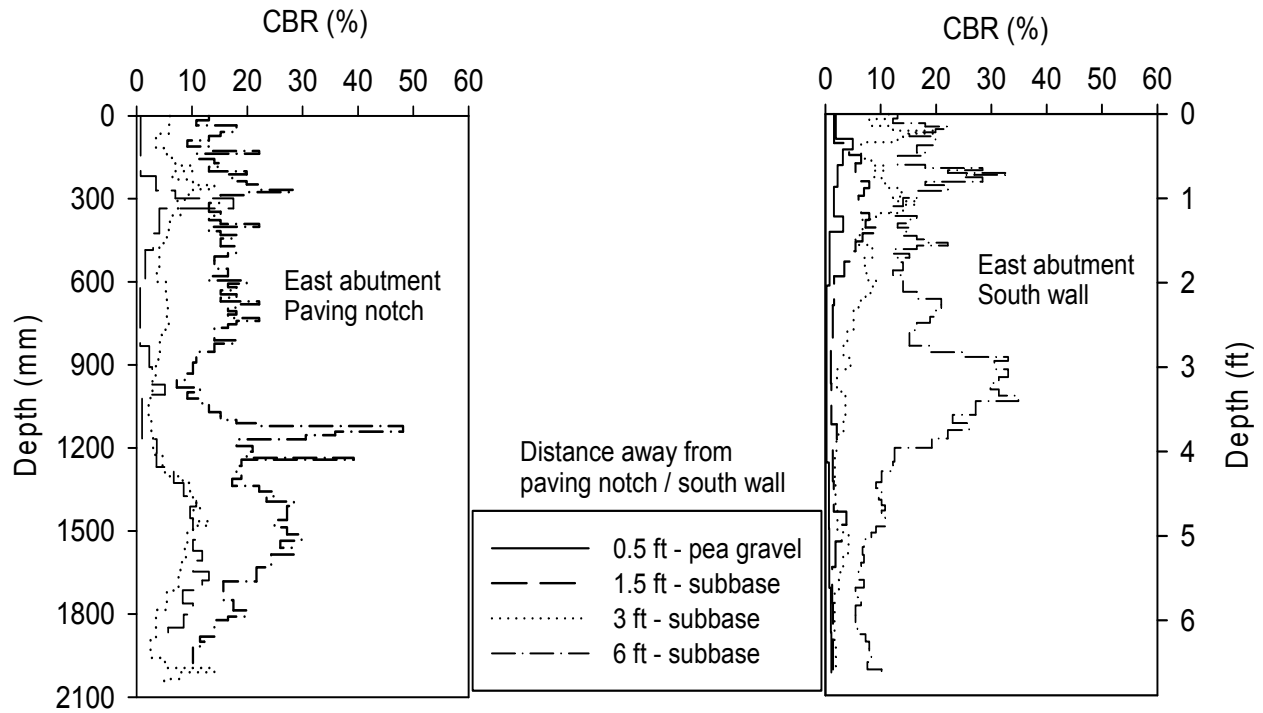
Figure 6.30. DCP-CBR profiles at selected distances away from south wall and paving notch at east abutment – Bridge #3

CBR values generally increased with distance away from the paving notch and the south wall (See Figure 6.30). There is a soft layer at about 3.28 ft below the surface along the tested lane perpendicular to the paving notch. The CBR values near the paving notch ranged from 1 to 15% at the distance from 1.5 to 3 ft away from the paving notch and, at 6 ft away from the paving notch, the CBR values ranged from 9 to 48%. The tests conducted along the lane perpendicular to the south wall returned CBR values that ranged from 0.2 to 20% within 3 ft of the wall and the CBR values for the test at 6 ft away the wall ranged from 5 to 35%.

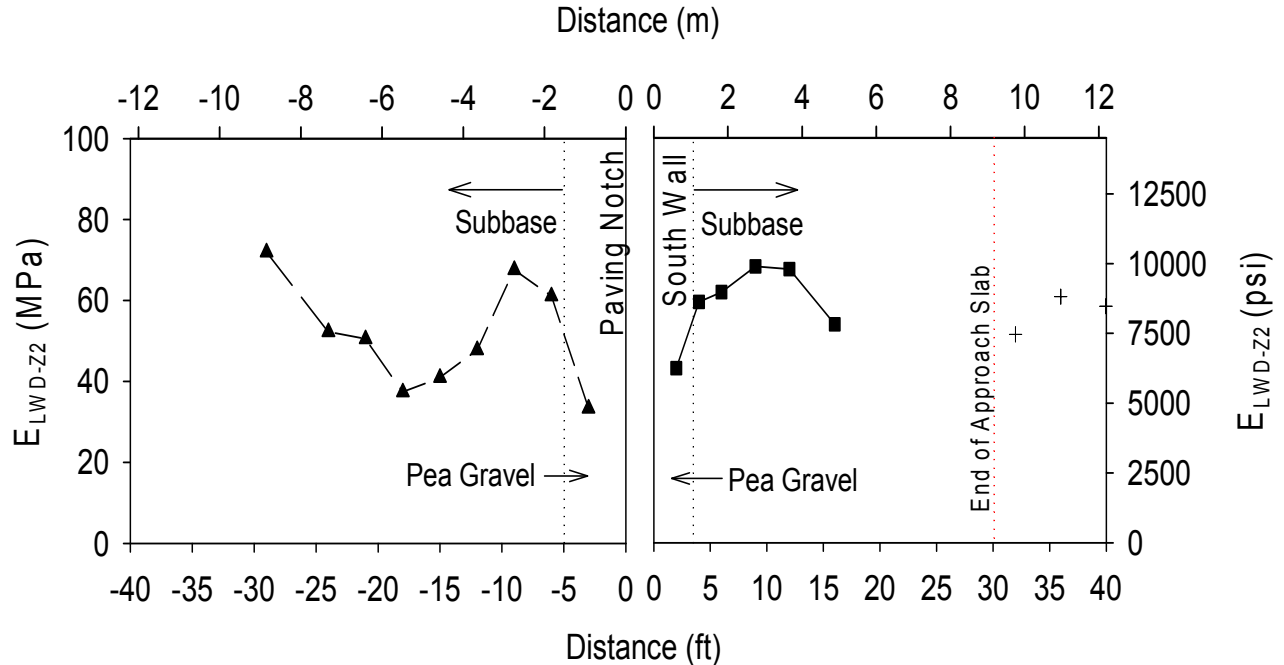
Figure 6.31. E_{LWD-Z2} measurements at selected distances away from paving notch and south wall on the east abutment – Bridge #3

Figure 6.31 shows the LWD modulus change at test locations away from the paving notch and the south wall. LWD tests were conducted at the same location as DCP tests, in general, and three tests were conducted at the location behind the end of the approach slab. For these test locations, the individual LWD modulus values ranged from 4,786 to 10,443 psi, and there was no significant difference between the test locations with sub-base or those without sub-base material. Figure 6.31 shows the modulus values with distance from the paving notch.

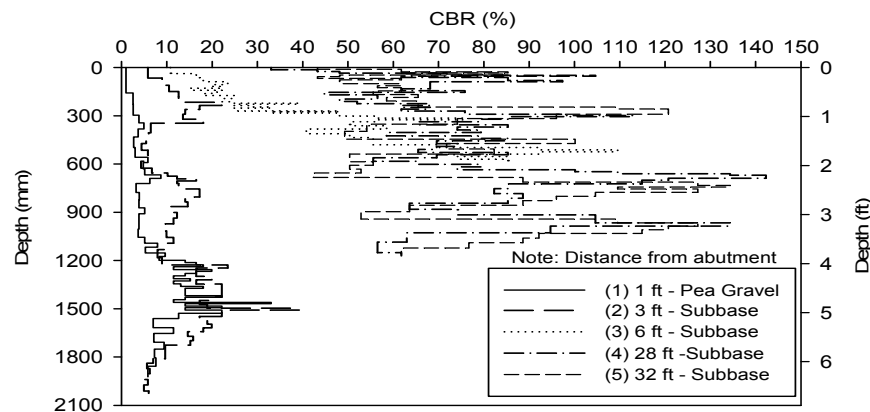
Figure 6.33. DCP-CBR profiles at selected distances away from the abutment – Bridge #4

DCP tests were conducted at four locations inside the approach slab at 1 ft, 3 ft, 6 ft, and 28 ft away from the paving notch and one test was conducted at 2 ft behind the end of the approach slab (See Figure 6.32). The CBR value generally increases with distance away from wall, and there is a stiff layer at a depth of 3.9 ft to 4.9 ft for the test location within 3 ft away from the wall (See Figure 6.33). The test conducted at 6 ft away from the paving notch indicates that the backfill started getting stiff from 1 ft below the surface and no significant changes of strength for the location near the end of the approach slab.

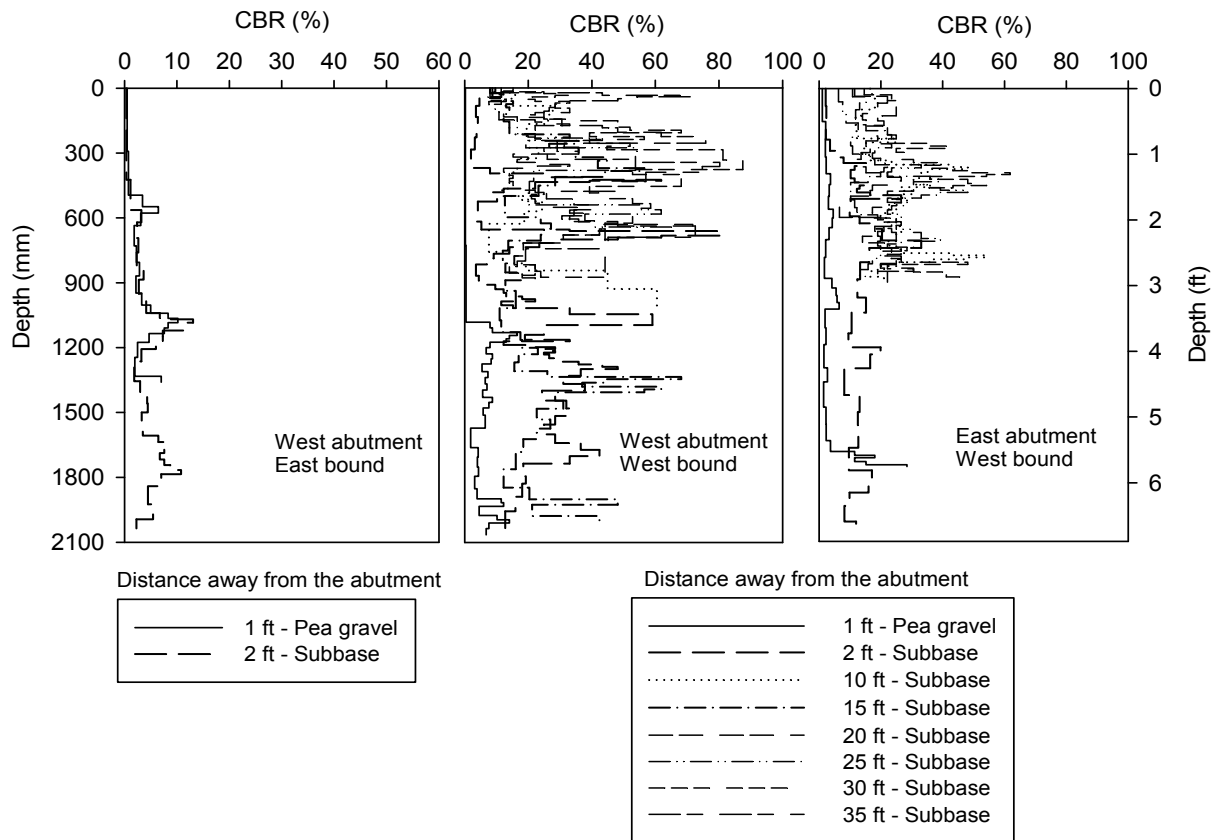
Figure 6.37. DCP-CBR profiles at test locations away from the east and west abutments – Bridge #5

The tests performed at the distances of 1 ft and 2 ft away the abutment provided similar CBR profiles along the west abutment eastbound lane. The CBR profiles for both west abutment and east abutment indicate the lowest strength occurred at 1 ft away from the abutment and then increase with distance away the abutment. LWD test results show that the modulus generally increases with distance away from wall and that the dry unit weight measurements also show a similar trend.

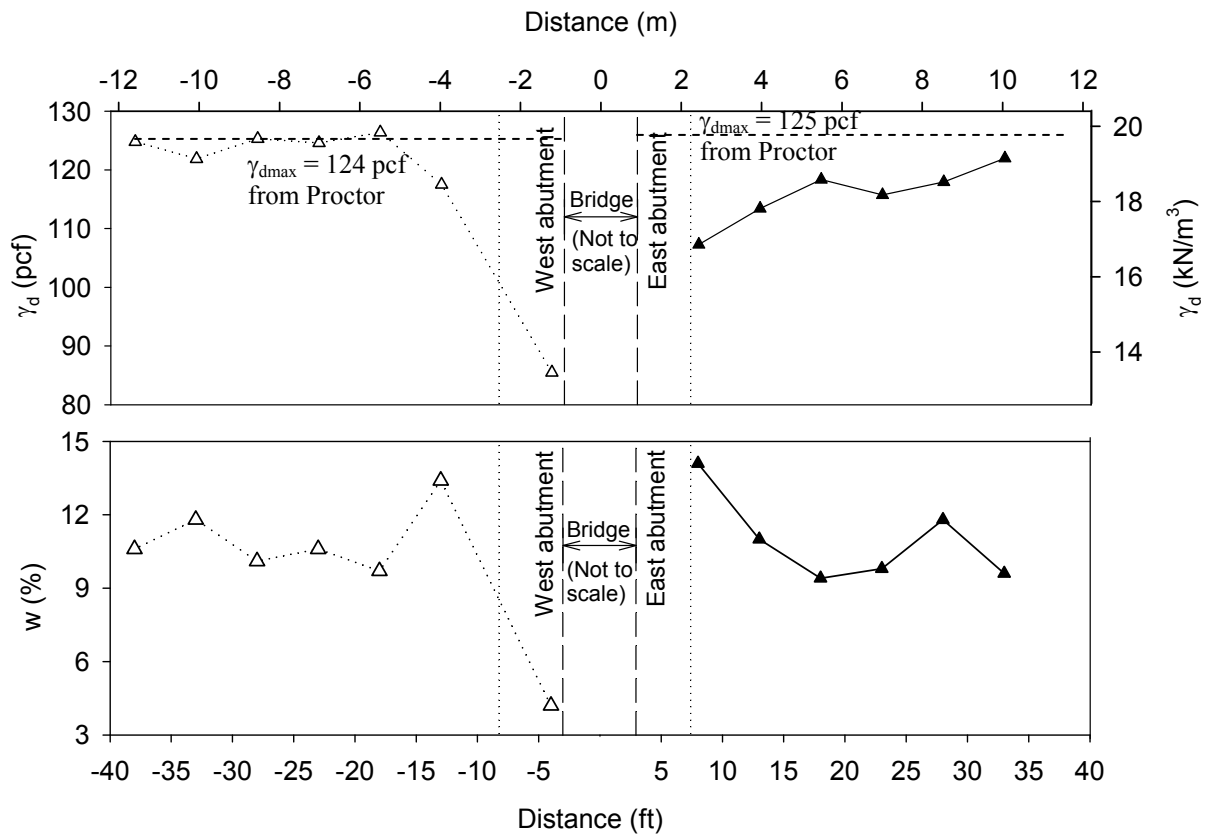
Figure 6.39. Moisture and dry density measurements at test locations away from the east and west abutments – Bridge #5

The moisture measurements near the west abutment indicate the lowest moisture content was next to the abutment and that, at further distances away from the abutment, the moisture content ranged from 9 to 12%. The results from the east abutment indicated the moisture content decreased with distance away from the abutment from 5 to 20 ft and within the range of 9 to 12%.

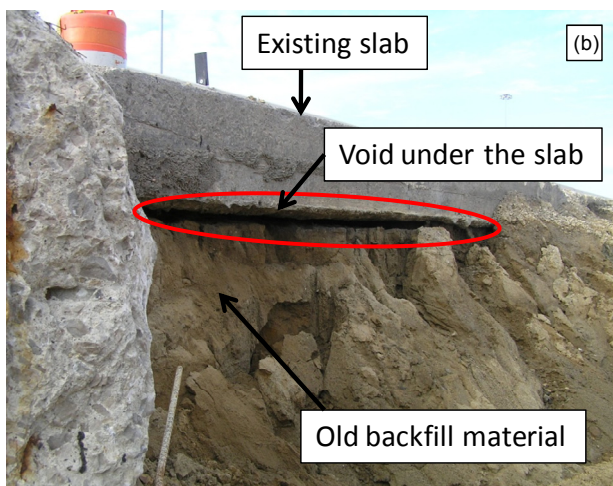
b. void under the existing slab and old backfill material
