Identification and Evaluation of Pavement-Bridge Interface Ride Quality Improvement and Corrective Strategies

Institute for Transportation

Report Number FHWA/OH-2011/1

January 2011

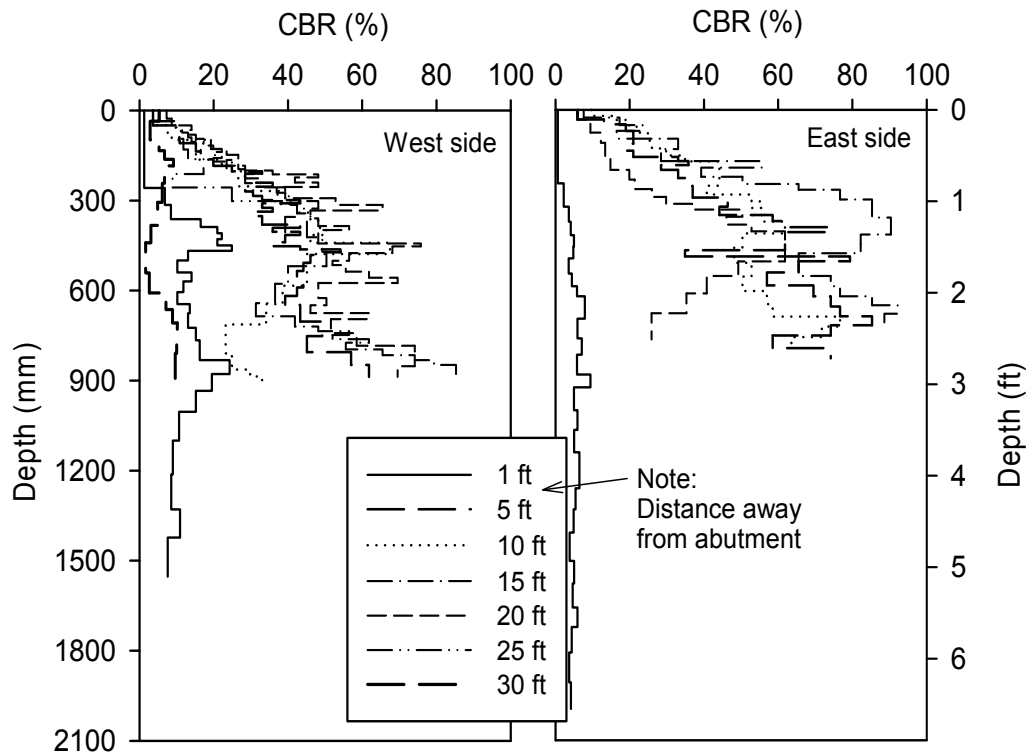
Figure 6.41. DCP-CBR profiles at test locations away from the south abutment for west and east lanes – Bridge #6 (USCS: GP-GM)

DCP tests were conducted on two testing lanes (west and east) at 1 ft away from the abutment and then at 5 ft intervals to 30 ft from the abutment. Figure 6.41 provides the DCP tests results in terms of CBR values for both west and east lanes. The CBR profile from the west lane shows that, at the same depth, CBRs increase with distance away from wall, but, with the distance of 25 to 30 ft away from the wall, the CBR values start to decrease. That may be caused by an existing wall near the end of the west lane. The DCP tests conducted on the east lane also give the similar conclusion.

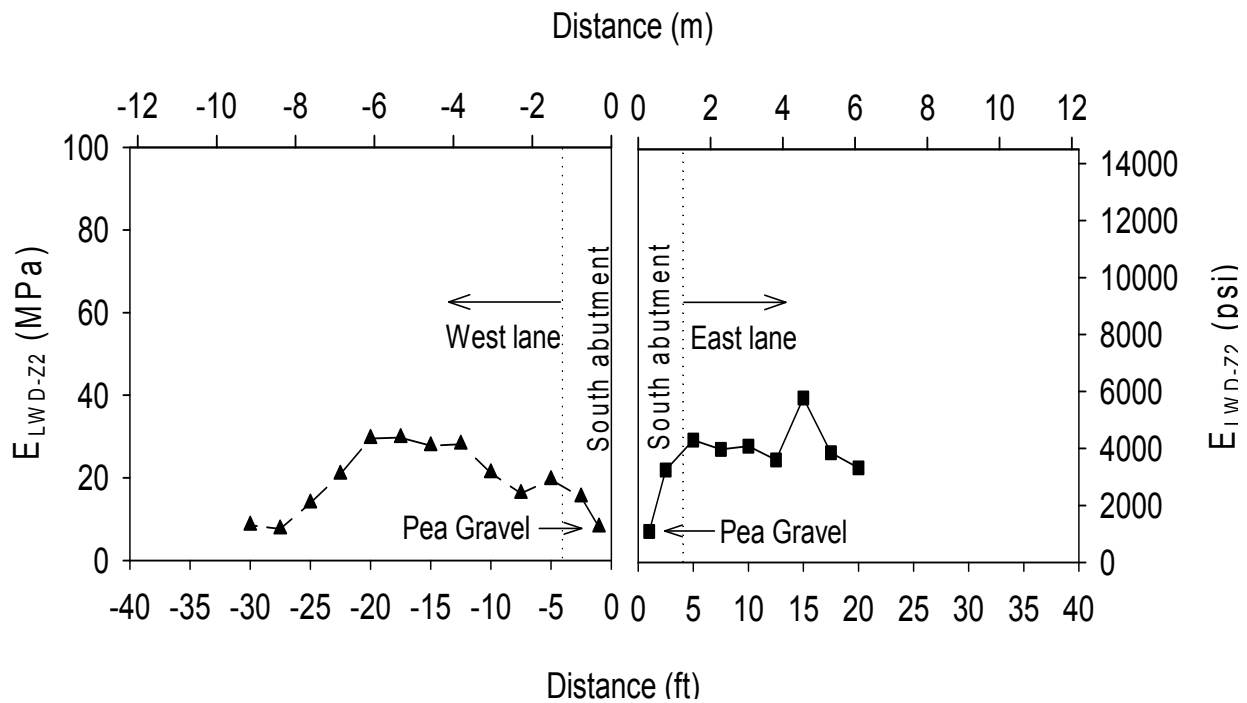
Figure 6.42. E_{LWD-Z2} at test locations away from the south abutment on east and west lanes – Bridge #6 (USCS: GP-GM)

LWD tests were performed on both the east and west testing lanes along the south abutment. Nine testing points were constructed on the east testing lane and thirteen points were tested along the west lane on the south abutment. Figure 6.42 shows that the E_{LWD-Z2} varies with distance away from the south abutment for both testing lanes. The LWD test results indicated that the modulus values at the middle part of the two testing lanes are higher than the E_{LWD} measured at the ends, and the modulus values from the two testing lanes show similar trends and the typical E_{LWD-Z2} range was 725 to 4,351 psi.

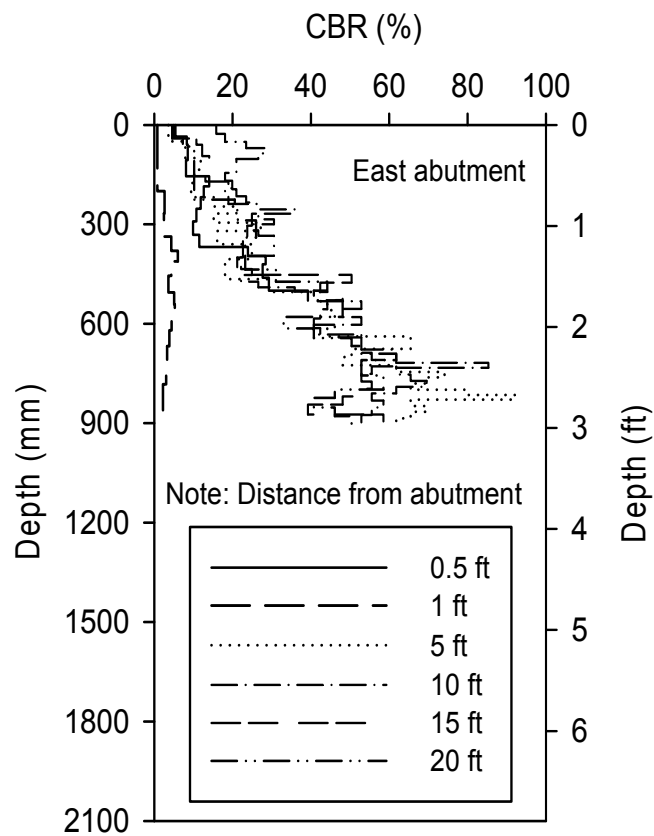
Figure 6.45. DCP-CBR profiles at test locations away from east abutment – Bridge #7

Based on the DCP-CBR profile, the measurements at 1 ft away from the wall indicated the lowest strength profile. The LWD test results indicate that modulus values for the backfill ranged from 725 to 5,076 psi.
