Low-Cost Rural Surface Alternatives Phase III: Demonstration Project

Final Report
April 2022

Sponsored by
Iowa Highway Research Board
(IHRB Project TR-721)
Iowa Department of Transportation
(InTrans Project 17-604)

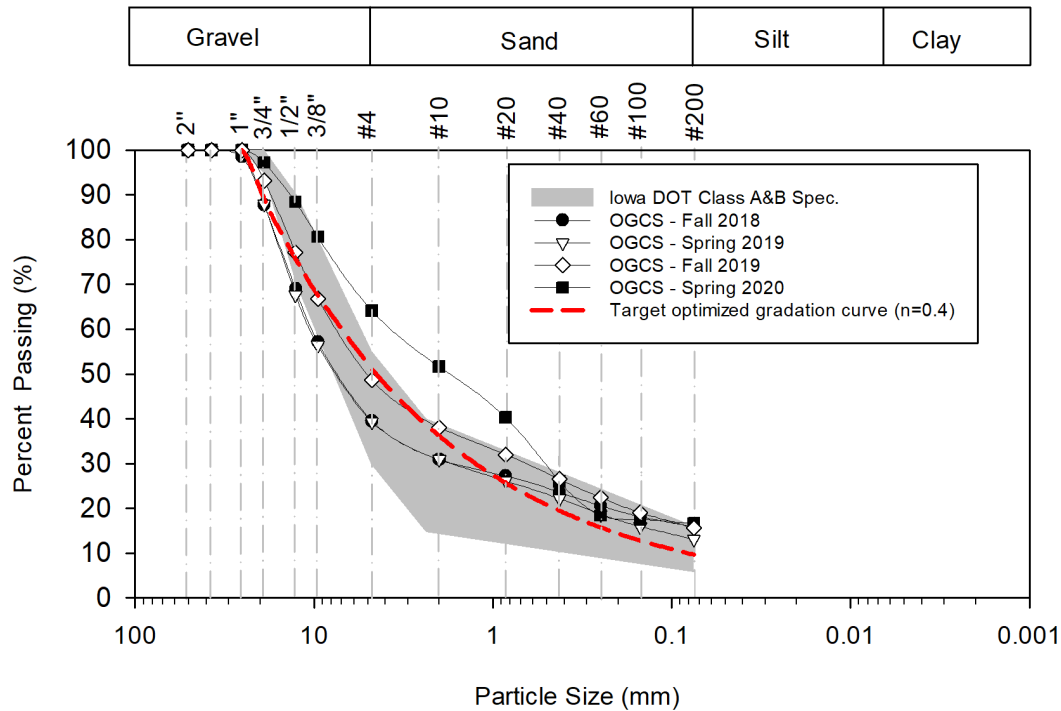
Figure 102. Particle size distribution curves for Hamilton County OGCS section

By spring 2020, the OGCS gradations in Howard, Washington, and Hamilton counties had started to migrate above the Iowa DOT Class A and B specification band in some particle size ranges, indicating that the effectiveness of this method is reduced after two to three years. However, this performance represents an improvement over the use of powdered bentonite as a binding agent, which was found in the previous IHRB project to lose effectiveness after only one year.

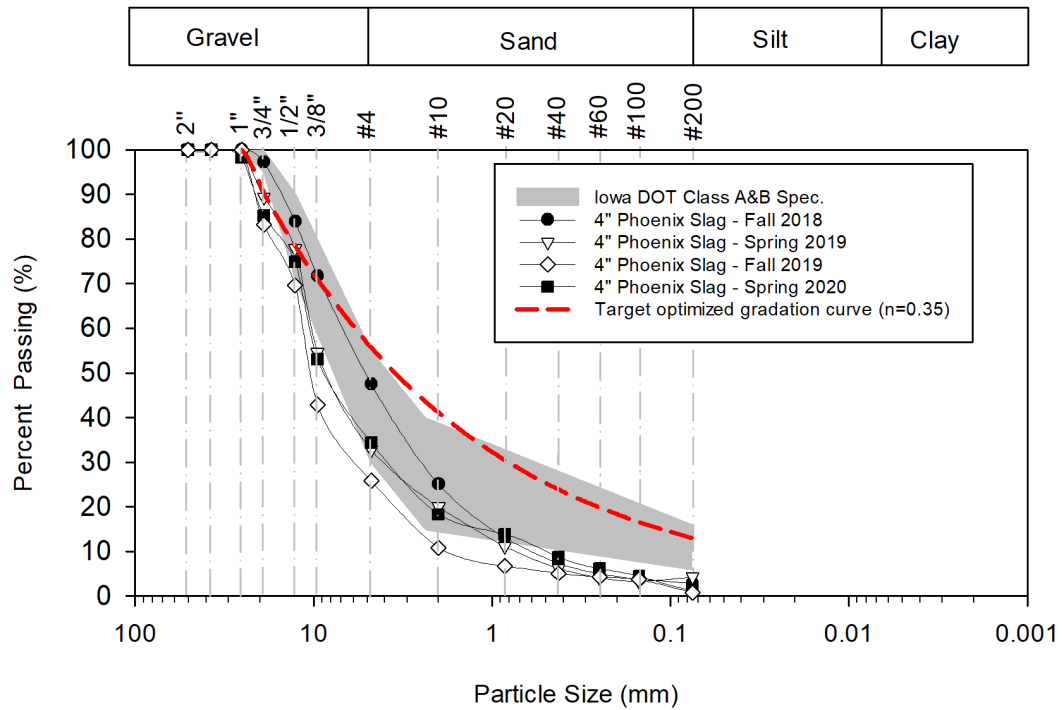
Figure 103. Particle size distribution curves for Cherokee County 4 in. Phoenix slag section

The two Phoenix slag sections in Howard County also became gap-graded by spring 2020, but this phenomenon was not observed for the Phoenix slag sections in Cherokee County, nor any other test sections. The Phoenix slag sections in Cherokee County fared better, showing much less change in gradation over time, with the 2 in. section becoming finer but remaining close to the Class A and B specification band (previous Figure 104) and the 4 in. section showing little gradation change in the fine sand range and only a slight increase in fines (previous Figure 103).

However, it should be noted that the spring 2020 slag gradations in Cherokee County include fresh crushed limestone surface aggregates that were placed without notice to the research team. An attempt was made to remove the limestone from the samples, but some particles remained and affected the spring 2020 gradation curves.

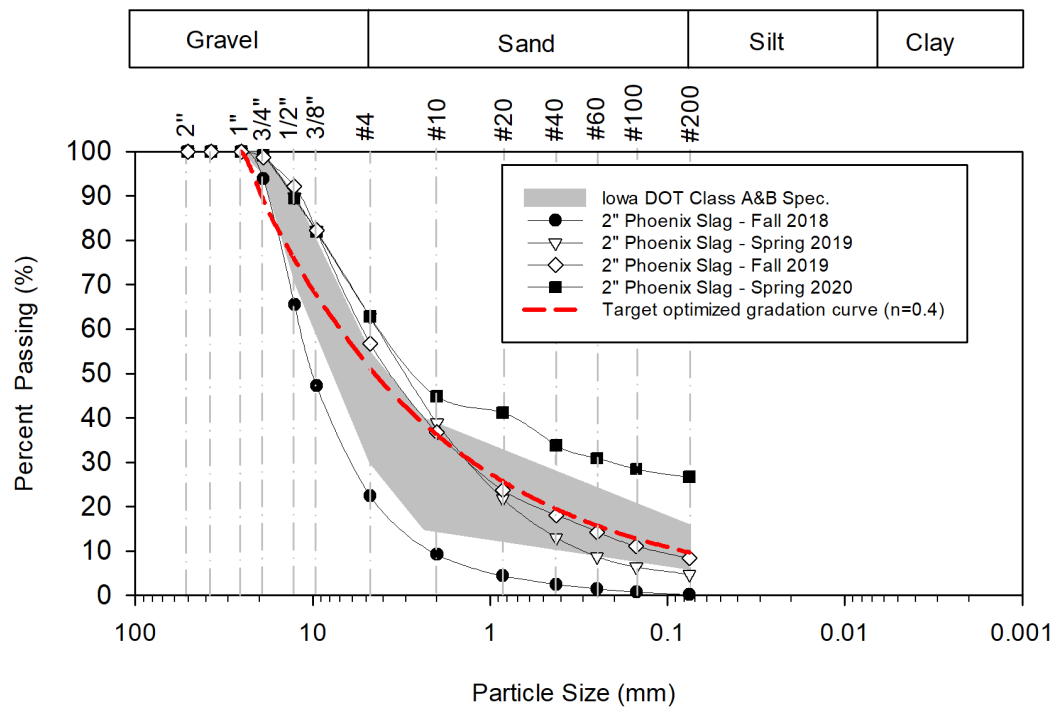
Figure 106. Particle size distribution curves for Howard County 2 in. Phoenix slag section

From 2018 to 2020, the particle size distributions for the Phoenix slag sections became finer because of abrasion due to heavy traffic loading, along with material loss due to raveling. In Howard County, the fines content increased significantly from 0% to 17% in the 4 in. Phoenix slag section over the project duration and from 0% to 26% in the 2 in. Phoenix slag section. The latter section ended up with a gradation curve in spring 2020 that was almost entirely above the Class A and B specification band (previous Figure 106).

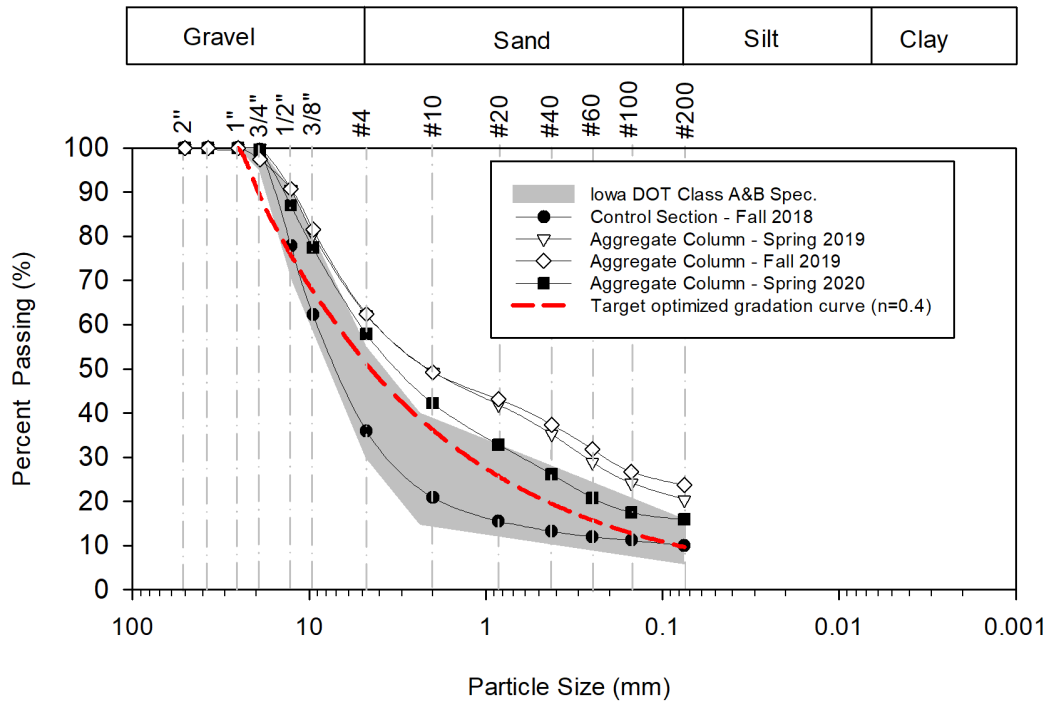
Figure 112. Particle size distribution curves for Howard County aggregate columns section

However, in Howard, Washington, and Hamilton counties (see Appendix E), the surface courses of the aggregate columns sections performed similar to their corresponding control sections. That is, their gradation curves indicated significant material loss and abrasion by migrating upwards well outside the Iowa DOT Class A and B specification band with time. As explained later in Section 6.3.2, an additional 1 in. of clean aggregate was spread over the Howard County aggregate columns section in fall 2019, which brought the gradation curve for the mixture of

existing and fresh aggregate back down toward the upper bound of the Class A and B specification in spring 2020 (Figure 112).

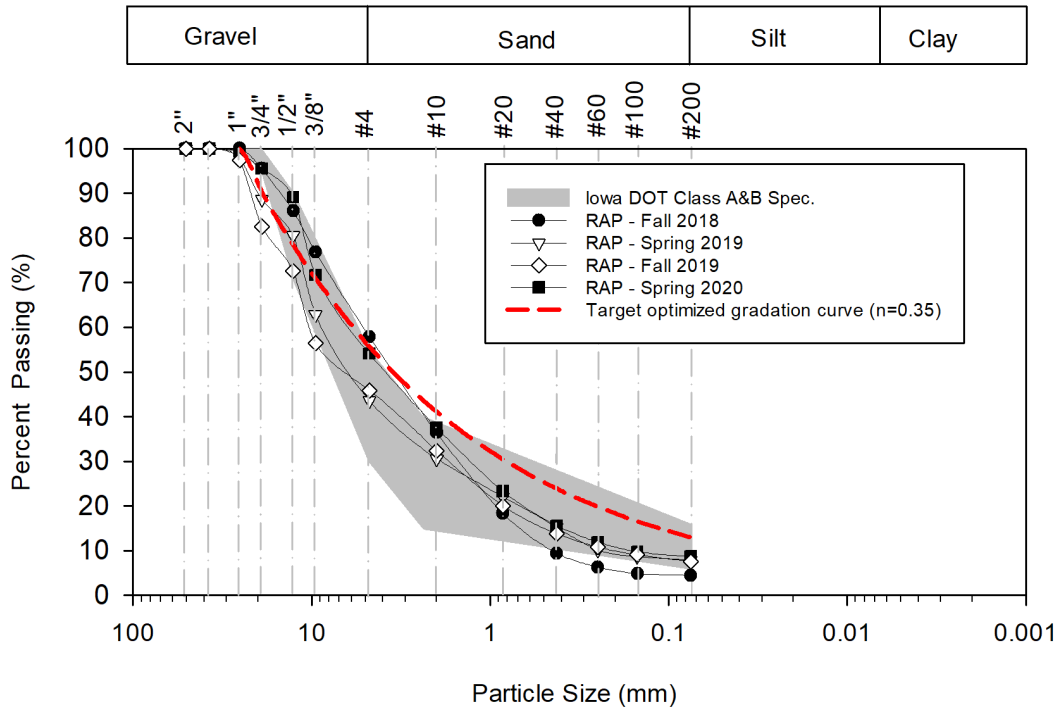
Figure 113. Particle size distribution curves for Cherokee County RAP section

The RAP sections in Cherokee and Howard counties used locally sourced materials and both started out in fall 2018 with gradations that were inside the Iowa DOT Class A and B specification band for sieve #20 and larger and below the specification band for sieve #40 and smaller. The RAP section in Cherokee County underwent slight changes in gradation but remained almost entirely within the specification band (Figure 113).

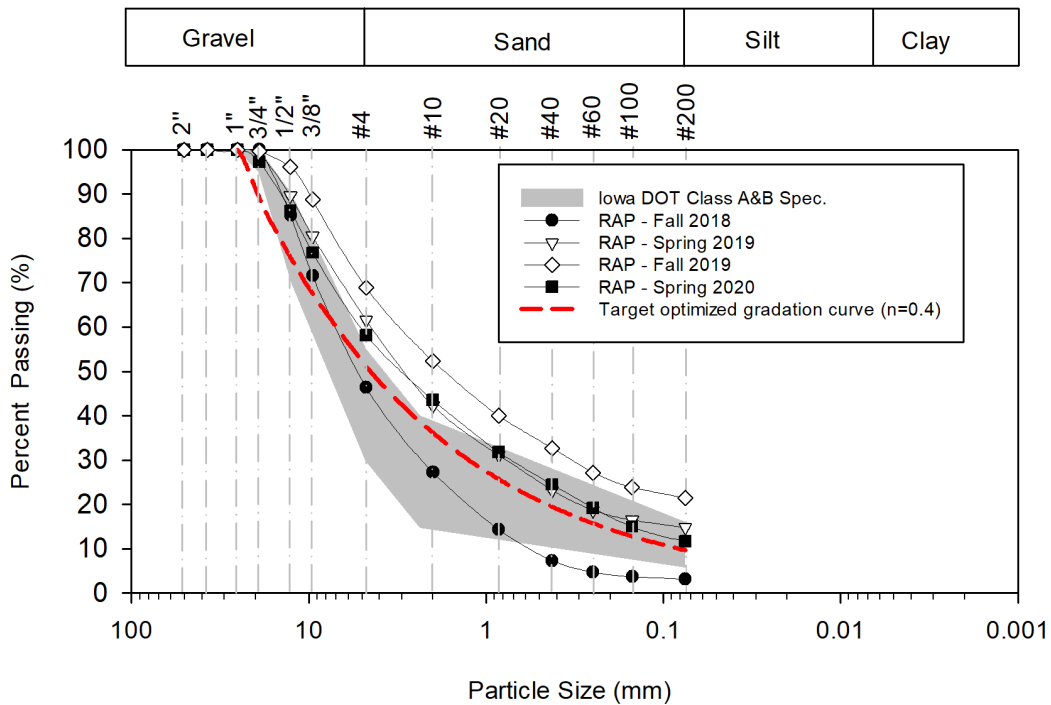
Figure 114. Particle size distribution curves for Howard County RAP section

In comparison, the RAP section in Howard County experienced more significant changes in gradation that ended up entirely above the specification band in fall 2019 (Figure 114).

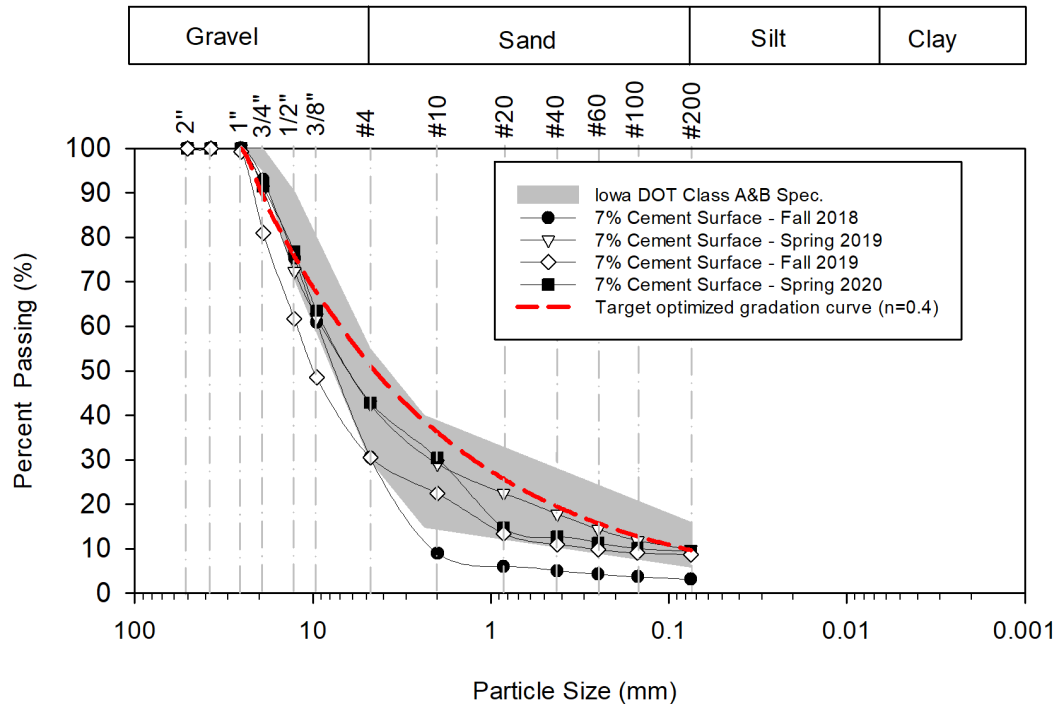
Figure 115. Particle size distribution curves for Washington County 4 in. cement-treated surface section

In Washington County, the 4 in. cement-treated surface section initially had a coarser gradation curve below the Iowa DOT Class A and B specification; but with compaction and abrasion from traffic breaking up the aggregate over time, the gradation became finer and remained almost within the specification band from spring 2019 to spring 2020 (Figure 115).

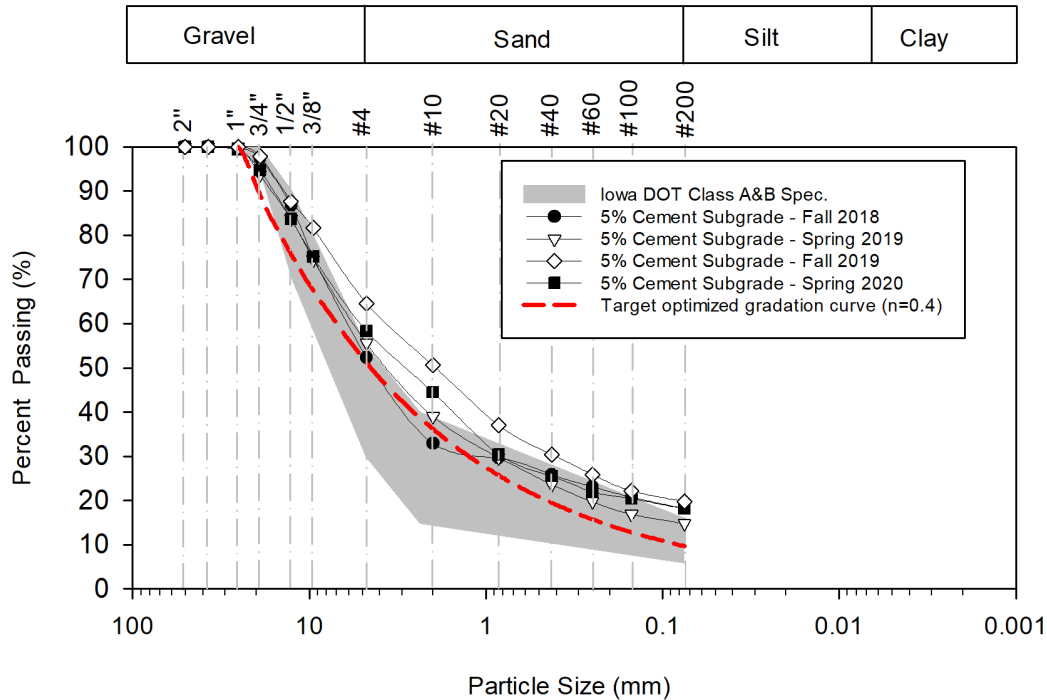
Figure 116. Particle size distribution curves for Washington County 12 in. cement-treated subgrade section

In spring 2020, an additional 26 tons of fresh aggregate were spread to cover potholes. In contrast, the initial gradation of the 12 in. cement-treated subgrade section in 2018 was almost entirely within the specification band, but migrated above the band in fall 2019 before decreasing by spring 2020 despite no fresh aggregate being placed on the section (Figure 116).

The decrease in the sand and fines fractions for this section in spring 2020 may be a result of dust generation in addition to abrasion from traffic loads creating sand-sized particles, which are then blown or washed off the relatively stiff surface by traffic and water.

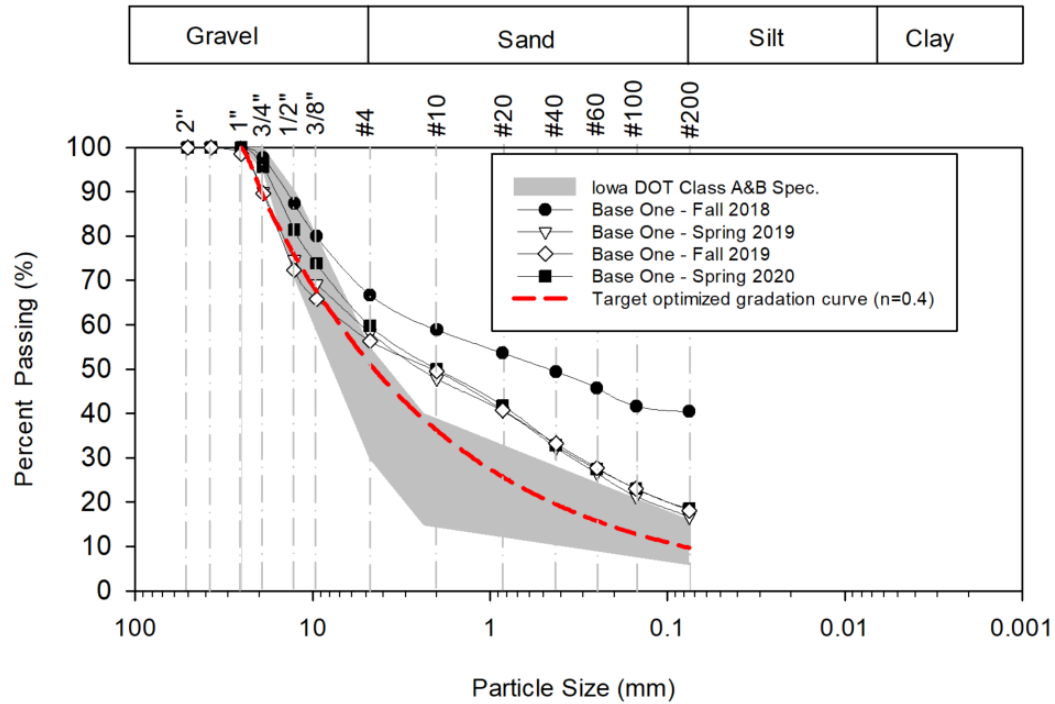
Figure 117. Particle size distribution curves for Washington County BASE ONE section

The BASE ONE section in Hamilton County (see Figure 120) exhibited a smaller overall change in gradation than the one in Washington County (Figure 117), but the latter changed very little over the last three testing periods and retained more gravel-sized particles within the gradation band. Interestingly, the BASE ONE sections in both counties ended up with gradations very similar to their respective control sections in spring 2020.

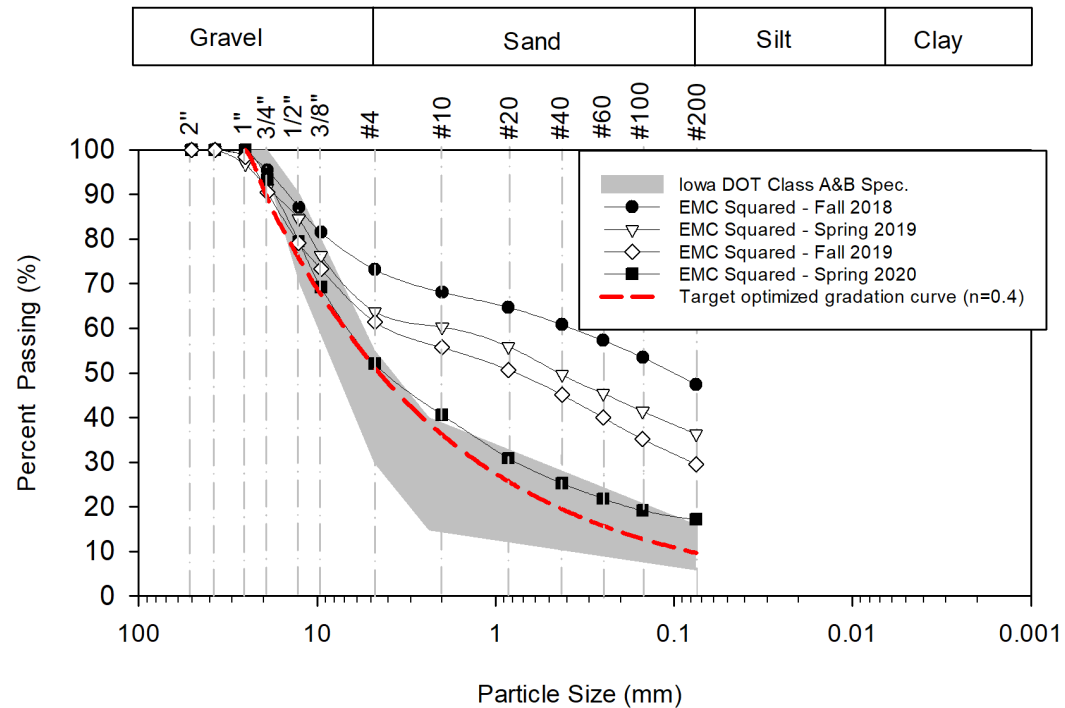
Figure 118. Particle size distribution curves for Washington County EMC SQUARED section

The EMC SQUARED section in Washington County (Figure 118) started out in fall 2018 with a very fine gradation but continually became coarser over time, with its gradation curve ending up almost entirely inside the specification band after maintenance aggregate was added in spring 2020. In Hamilton County where no maintenance aggregate was added, the EMC SQUARED section showed the opposite trend (Figure 121), starting out with its coarsest gradation close to the top of the specification band in fall 2018 and ending with its finest gradation far above the band in spring 2020. Even before the maintenance aggregate was added in Washington County, the gravel-sized portion of the EMC SQUARED section's gradation stayed much closer to the specification band in Washington County than in Hamilton County.

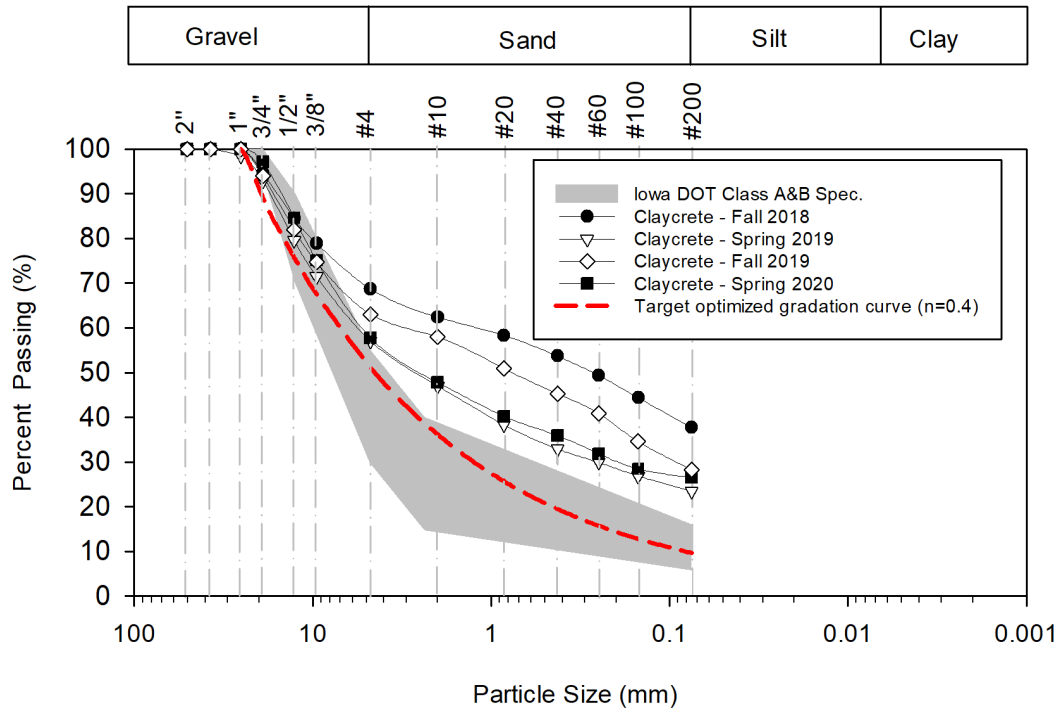
Figure 119. Particle size distribution curves for Washington County Claycrete section

The Claycrete section in Washington County (Figure 119) started out with its finest gradation in fall 2018 and generally moved toward a coarser one with time but remained above the specification band in the sand-sized range even after fresh aggregate was added in spring 2020.

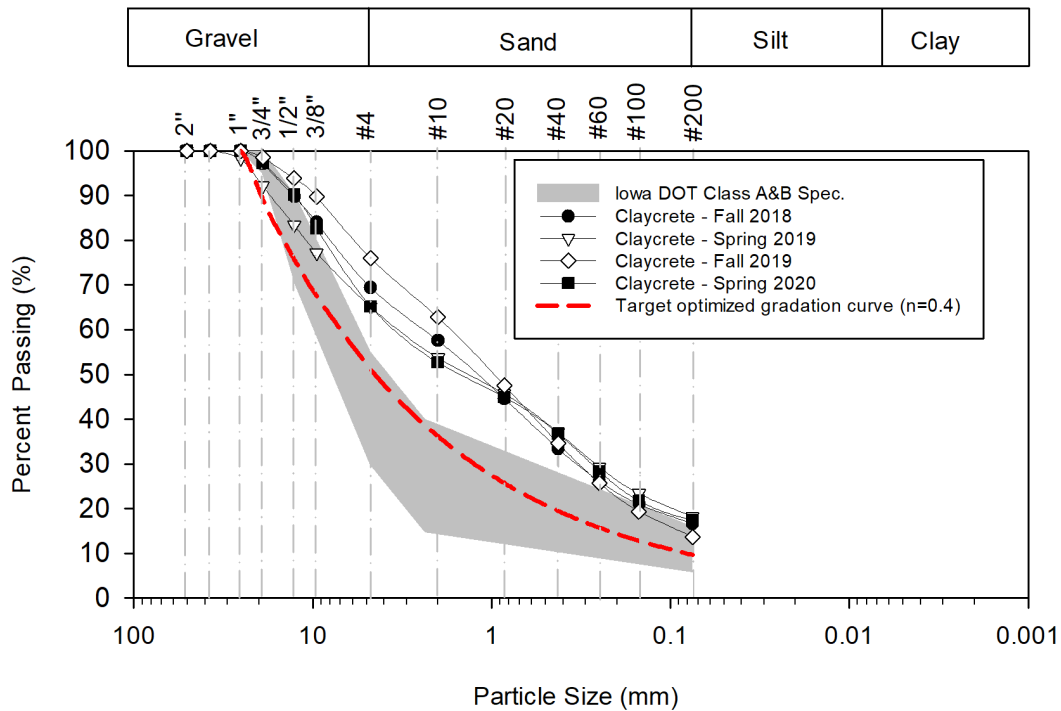
Figure 122. Particle size distribution curves for Hamilton County Claycrete section

In contrast, the gradation of the Hamilton County Claycrete section changed less over time but was further from the gravel-sized portion of the specification band than the Washington County gradation (Figure 122).

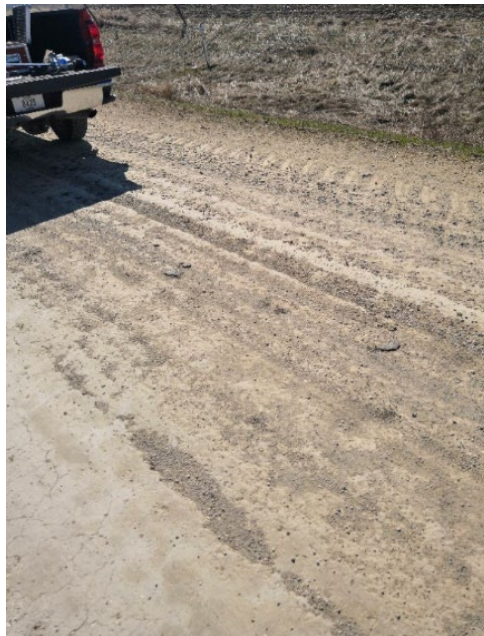
Throughout the study, the most common surface distress issues observed were rutting and potholes, with rutting caused by agricultural machinery on the road surface and shoulder being the most common issue in all counties. Examples of these conditions are shown in Figure 127 and Figure 128.

Figure 128. Rutting in Howard County OGCS section during spring 2020

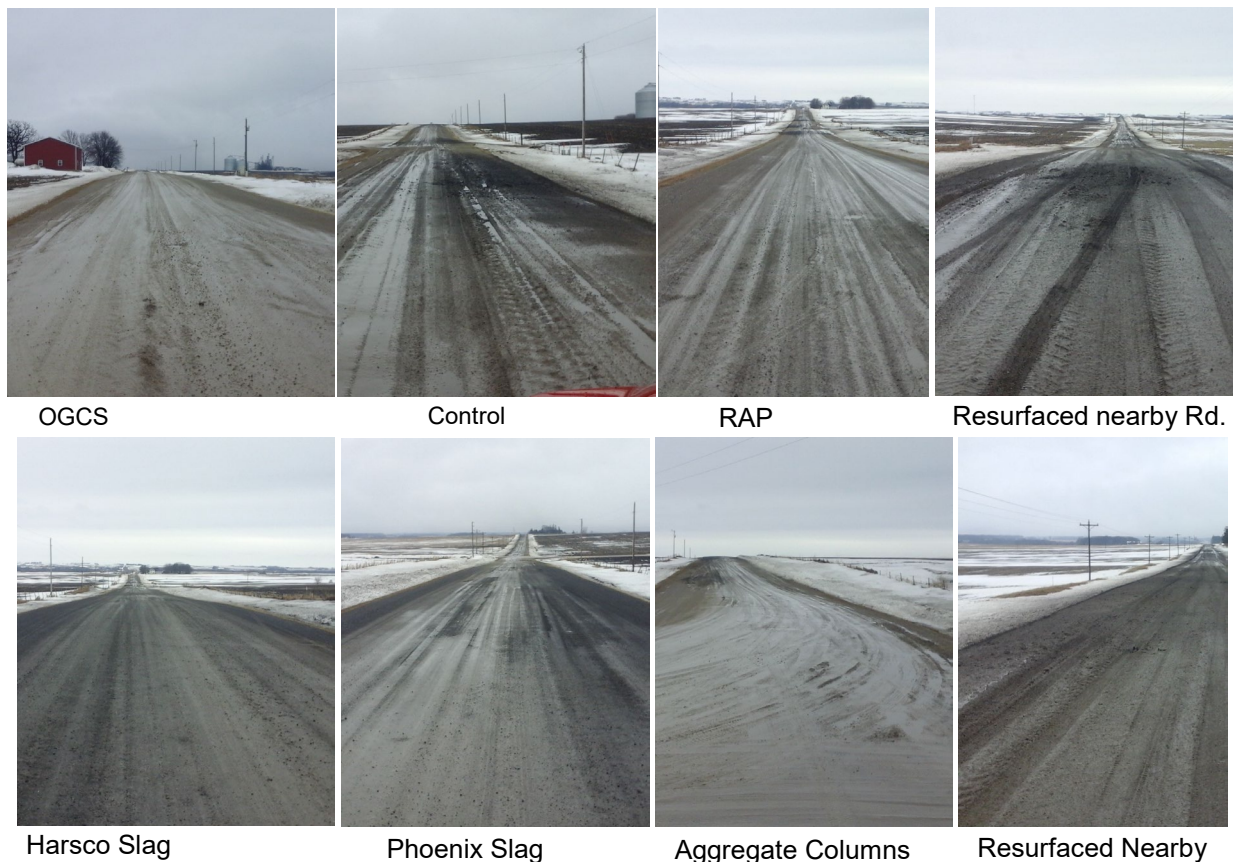
The stabilized Howard County sections also held up remarkably well in spring 2019 compared to both the control section and nearby roads that were recently resurfaced. At the time, some of the surrounding untreated roads were nearly impassable or closed due to significant damage and flooding from melting of snow followed by significant precipitation resulting in the worst road conditions seen in decades, while the test sections were in relatively good condition (see Figure 131).

**Figure 131. Test sections and recently resurfaced nearby roads in Howard County
March 14, 2019**
