Development of Cost-Effective Timber Bridge Repair Techniques for Minnesota

Minnesota
Department of
Transportation

Brent Phares, Principal Investigator
Bridge Engineering Center and
National Center for Wood Transportation Structures
Iowa State University

Research Project
Final Report 2015-45A

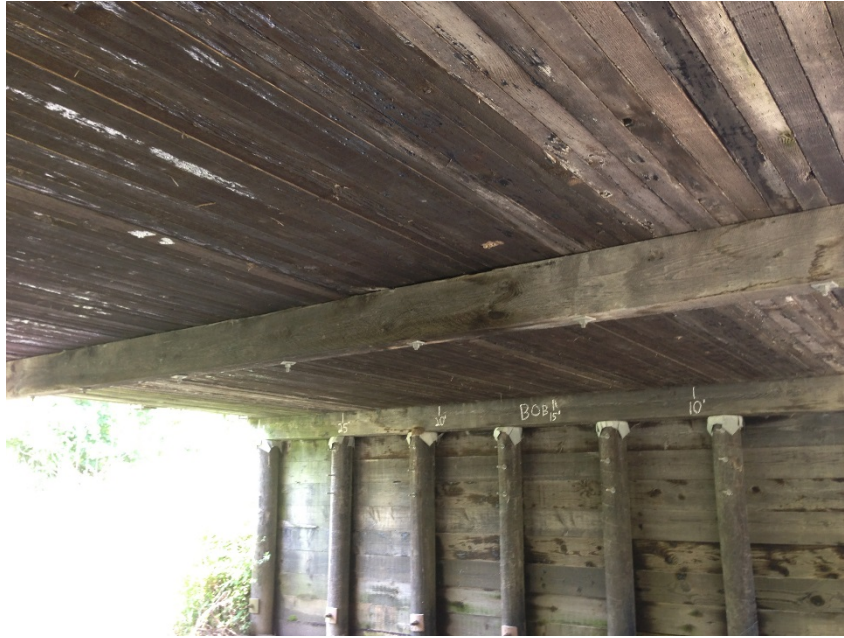
Figure 2-1 Typical timber slab bridge

Figure 2-1 and Figure 2-2 show a typical slab bridge and stringer bridge, respectively.

Slab bridges can be identified by the closely spaced, nail- or spike-laminated dimension lumber placed in the longitudinal direction of the bridge. The lumber attached in this manner not only makes up the primary superstructure of the bridge but also the deck.

Similar to concrete jacketing, pile encapsulation, like that shown in Figure 2-1, uses readily available materials and county work forces to complete the fairly simple construction.

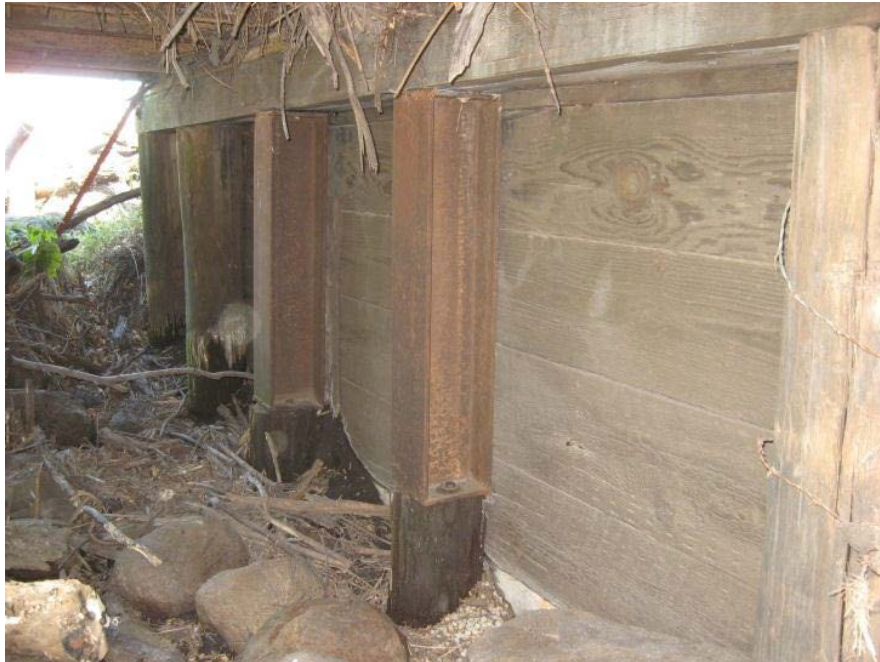
Figure 3-2 Posted piles using steel W shapes

A method of posting used in Iowa is shown in Figure 3-2 (Dahlberg et al. 2012).

Here, W shapes take the place of deteriorated portions of the pile. The method requires that the pile be cut below the area of deterioration at a sound, non-deteriorated location. It is at this location where a steel member is placed between the top of the remaining pile and the pile cap above and then lagged into place at both the top and bottom.

This posting method requires precision that may not always be achievable in the field. The steel must be fabricated to exactly fit the area between the remaining pile portion and pile cap. Moreover, full bearing between the pile and post or post and pile cap is rarely seen. One method to help alleviate the problem of non-fitting steel members was introduced by researchers at Iowa State University (Dahlberg et al. 2012). The method created the ability to vertically adjust the steel member to fit in a desired location using leveling nuts and a threaded rod, which are attached to angles that are lagged to the pile (see Figure 3-3).

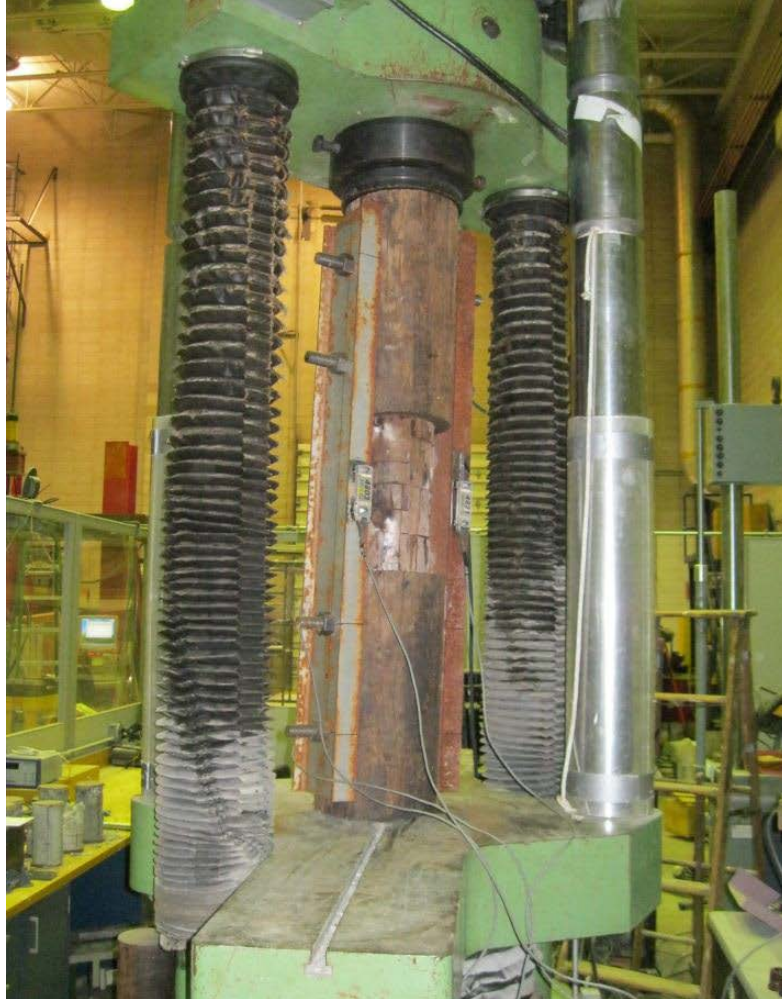
Figure 3-7 Pile strengthened with steel sisters

A repair method for piles with localized degradation that utilizes steel “sisters” to bypass the suspect area was investigated at Iowa State University (Dahlberg et al. 2012). The researchers showed that attaching steel “sisters” using steel through bolts at sound locations above and below the deteriorated portions effectively restored the desired capacity of the pile. Figure 3-7 shows the repair method during compression testing.

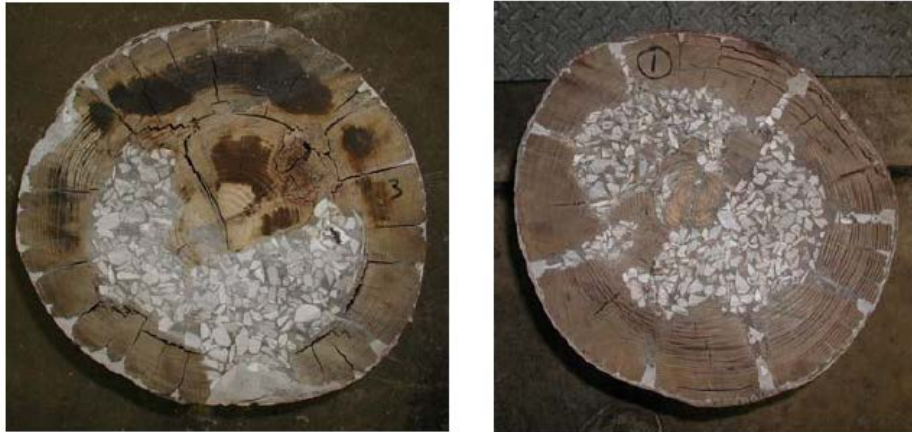
Figure 3-17 Cross-sections of epoxy- and aggregate-repaired piles

A method of repairing piles with aggregate and epoxy was developed and evaluated in Oklahoma (Emerson 2004). As is the case in many states, piles in Oklahoma experience significant fungal deterioration, which often results in only the exterior shell of the original pile remaining. Significantly decayed portions of the pile are removed while the remaining portions are re-treated to prevent future fungal decay. Epoxy and aggregate are then used to replace the decayed core, after which the pile is wrapped with fiber reinforcement for confinement of the wood/epoxy/aggregate core. It was found that without the confinement, the epoxy/aggregate mix separated from the wood. The compression strength of all specimens repaired in this manner was found to exceed that of the American Wood Council *National Design Specification (NDS) for Wood Construction* (1997 edition) design values and average compression strengths published in

the Forest Products Laboratory's *Wood Handbook—Wood as an Engineering Material* (1987 version) for wood species typically used for timber piles. Cross-sectional views of repaired piles are shown in Figure 3-17.

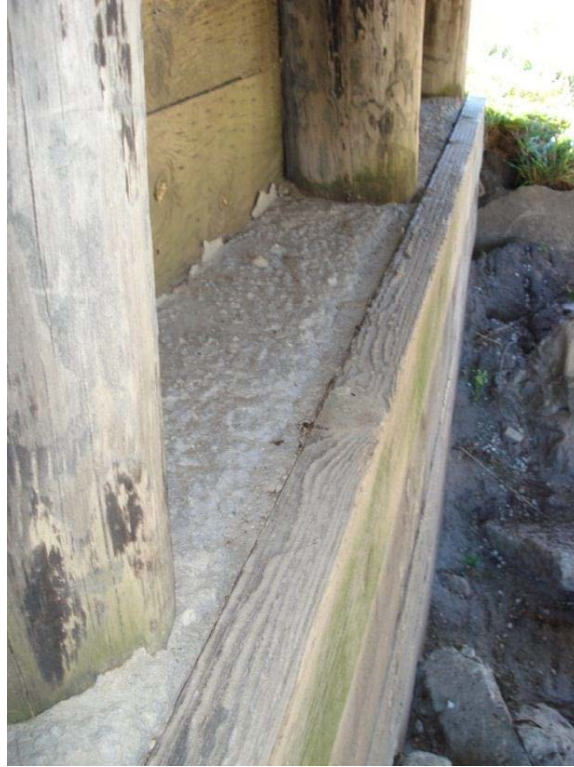
Figure 3-19 Timber planking and concrete encapsulation

Pile encapsulation is a method of pile repair and strengthening that has been used occasionally in Iowa and likely other locations as well, although this was not confirmed in Dahlberg et al. 2012. This method can be simply and effectively used at abutment and pier locations if the piles are of similar size and in relatively good alignment with each other. Multiple timber planks are fastened to each face of the piles at pier locations and on the span-side face at abutment locations. The planks form a crib that contains cast-in-place concrete between each of the piles (see Figure 3-19).

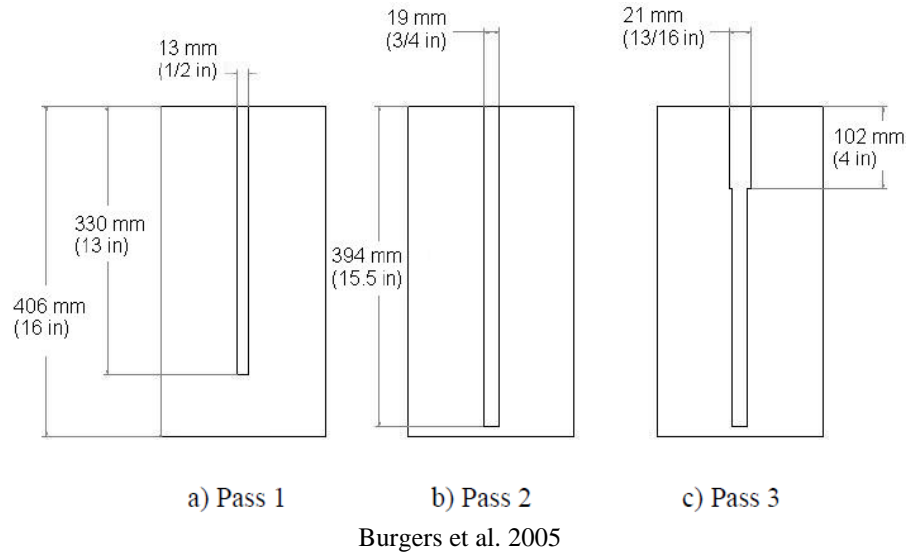
Figure 3-27 Method of drilling for shear spike insertion

Holes are created by first drilling a pilot before proceeding with a larger-sized bit and finally augering the first several inches for ease of insertion (see Figure 3-27).

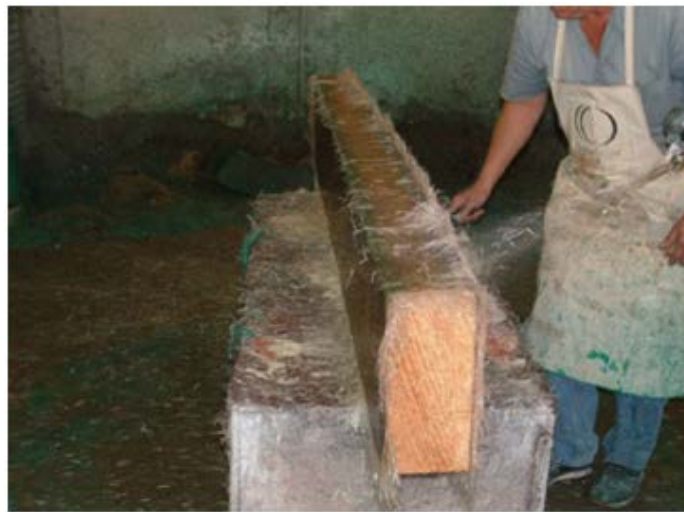
Figure 3-28 Sprayed fiber-reinforced polymer

The practice of sprayed fiber-reinforced polymer (SFRP) has been proven in laboratory studies to increase the load-carrying capacity of timber beams (Talukdar and Banthia 2010). One significant finding revealed that the added strength was dependent on the type of treatment used on the beam. Interestingly, it was shown that SFRP was more effective on creosote- (which is oil-borne) treated timber beams than those treated with Boracol (which is water-borne). In the case of the Boracol treated specimens, the strength increased almost 17 percent for most specimens. Whereas, for the creosote-treated specimens, the strength increased between 30 and 50 percent, with the range being attributable to the type of primer used prior to SFRP application. Figure 3-28 shows the application of SFRP on a timber beam.

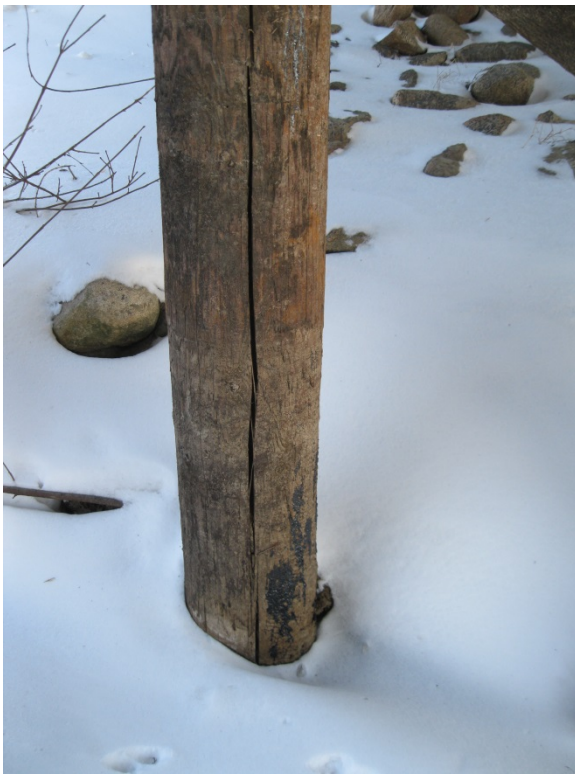
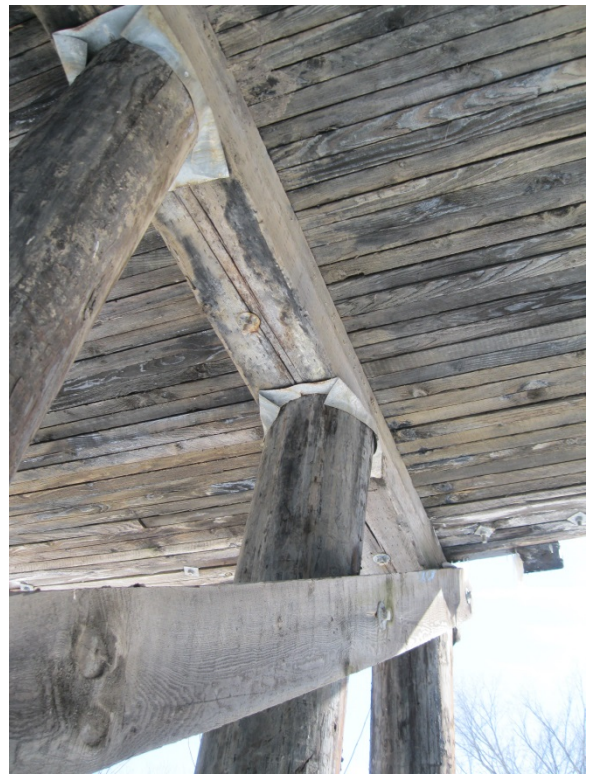
Figure 5-1 Timber substructure deterioration in Aitkin County, Minnesota

The ages of the timber bridges within the inventory of Aitkin County range from 7 to almost 60 years. Many of these bridges were constructed in the 1970s and 1980s and are typically spike-laminated slab-span construction. Frequently, the substructure elements and, more specifically, the timber piling at these bridges is what controls the overall condition state (see Figure 5-1).

a) Large check in pile at waterline

b) Large checks in pile cap

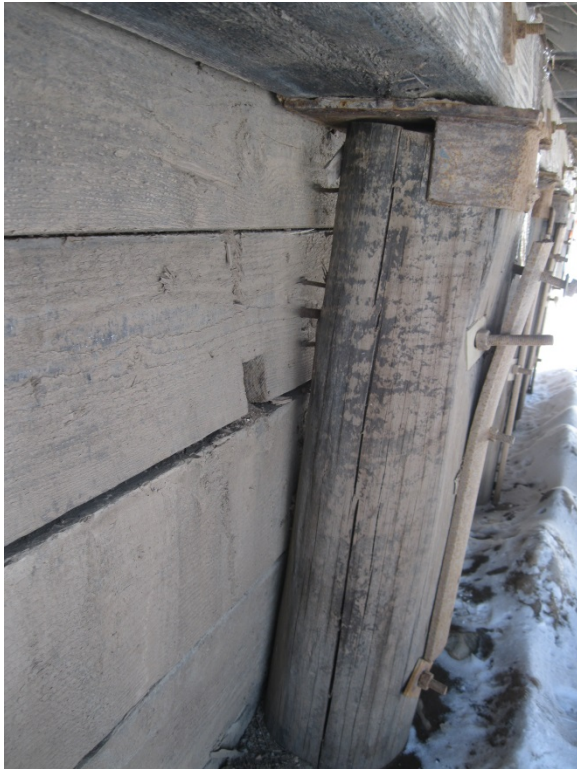
a) Pile rotation

The issues that the county is seeing that are common to timber bridges most often include deterioration and movement of substructure elements. One issue that is seen frequently is pile cap and pile rotation, especially at abutment locations. Although the cause is not completely known and is most likely a combination of several factors (backfill materials, freeze/thaw cycles, etc.), the effects are bulging backwalls, rotating piles, and subsequent separation of the piles and pile caps (see Figure 5-2a).

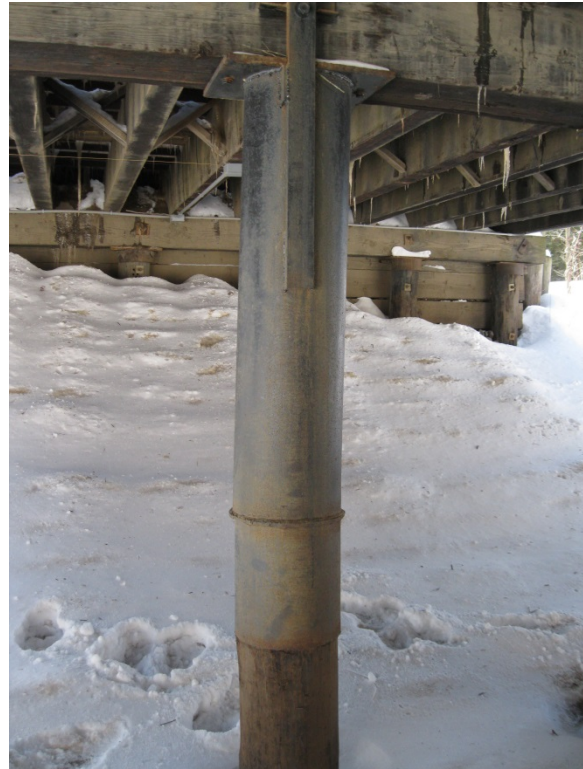
b) Steel replacement of timber pile

Because bearing is lost between the piles and pile caps, shims are required to reestablish a positive connection. Furthermore, section loss in piles and pile caps is of concern at many locations. At times, piles have been repaired by removing a portion of the pile and replacing with a steel member (see Figure 5-2b). These repairs appear to be effective, yet not intended for a long-term repair (as in intended for a short-term repair until full removal of the bridge or a more extensive repair is completed.)

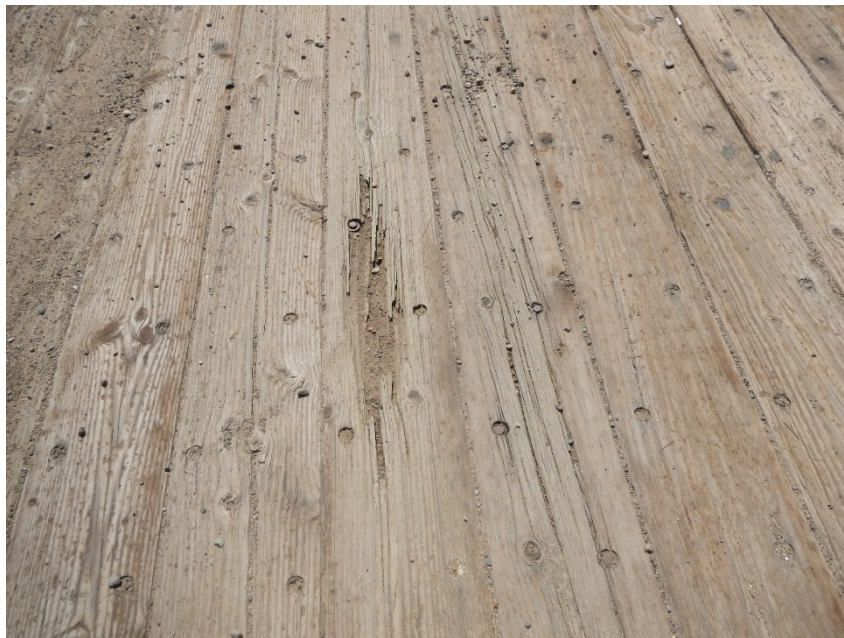
Figure 6-1 Timber deck without wearing surface in apparently good condition overall

Decks without wearing surfaces are certainly subject to abrasion from direct vehicle impact, but have the benefit of drying more quickly after rain or snow events. This quick drying ability might be the most advantageous characteristic of these decks given that prolonged contact with moisture is regularly the cause of deck deterioration. Commonly, the vehicular traffic is minimal on these bridges and therefore the cumulative effects of abrasion do not require deck repair or replacement at a high frequency. Figure 6-1 shows an example of a timber deck without a wearing surface. Some abrasion and deterioration is seen, but the deck appears to be in good condition overall.

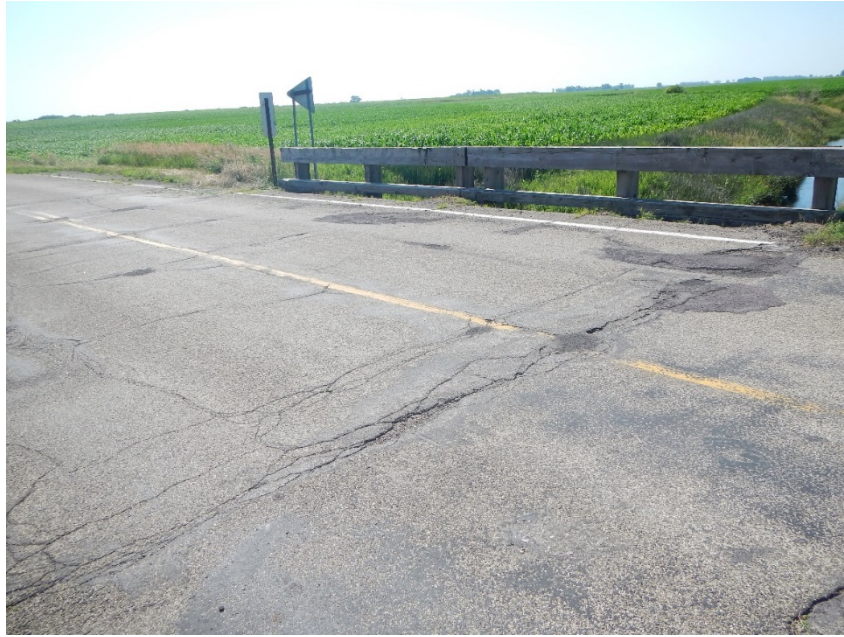
Figure 6-2 Cracking of asphalt wearing surface

An asphaltic wearing surface that covers the entire deck can both protect the timber deck below from vehicle impacts and shield the timber deck from moisture. Unfortunately, asphaltic wearing surfaces are prone to cracking and rarely remain water tight as shown in Figure 6-2.

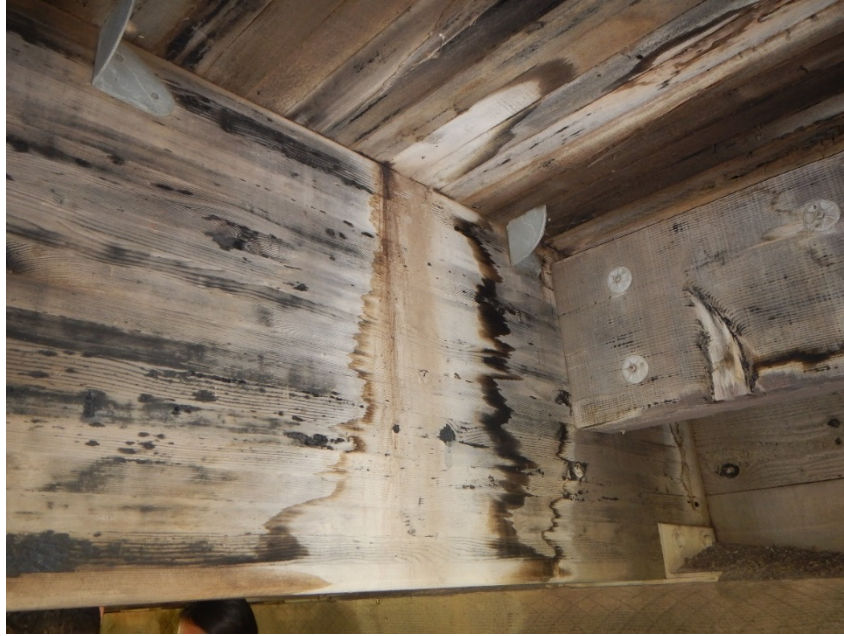
Figure 6-3 Localized deck drainage through asphaltic wearing surface

In these cases, water penetrates the wearing surface and gains access to localized areas of the timber deck and stringers below, thereby increasing the chance for decay to occur (see Figure 6-3).

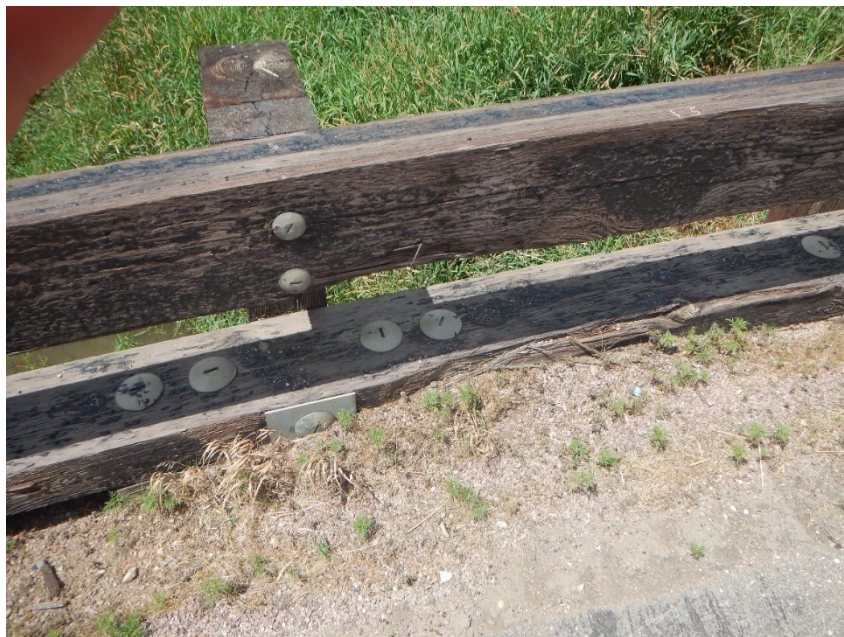
Figure 6-4 Deck debris accumulation at deck edge

Additionally, debris has a tendency to accumulate near the edges of the deck on the road surface, which hinders water runoff leading to greater moisture content at the edges of the deck than that at the center of the bridge. This, too, increases the chance for decay to occur. Figure 6-4 shows an example of deck debris accumulation where the debris has effectively blocked the scupper at the bottom rail and deck.

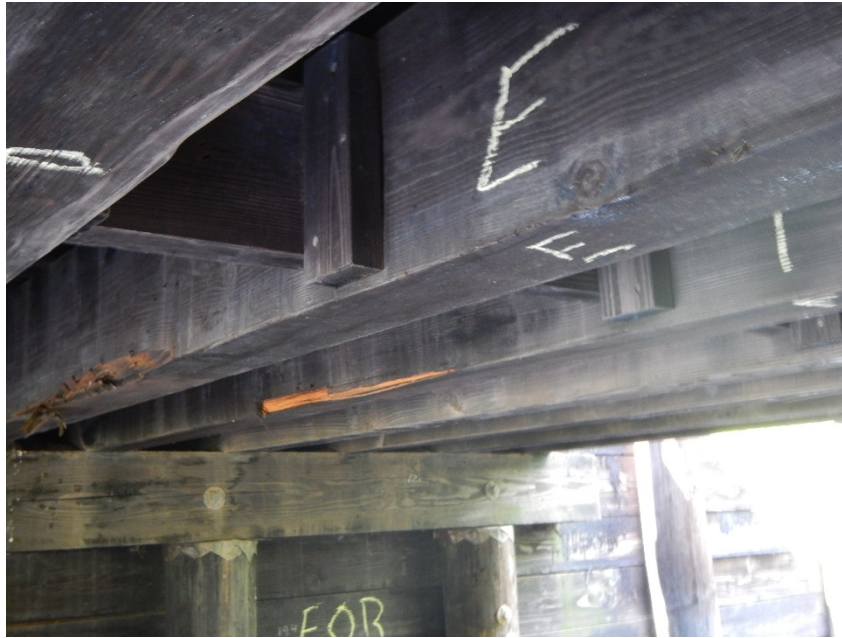
Figure 6-5 Stringer damaged by debris strike

Several reasons, including overloading, debris strikes (see Figure 6-5), and insect infestation cause deterioration of timber superstructures.

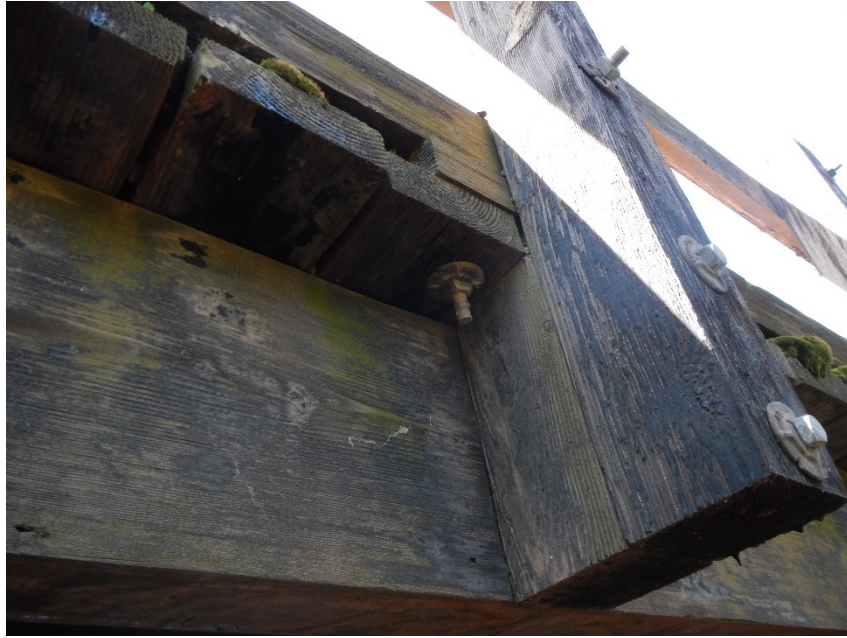
Figure 6-6 Staining and vegetation growth

Even so, the condition of timber bridge superstructures is often a direct reflection of the wearing surface type and performance given that its ability to either shed water or dry out quickly affects the duration of water exposure of the superstructure elements. Elements where staining or discoloration, vegetation, or even odor are present indicate areas frequently exposed to moisture (see Figure 6-6).

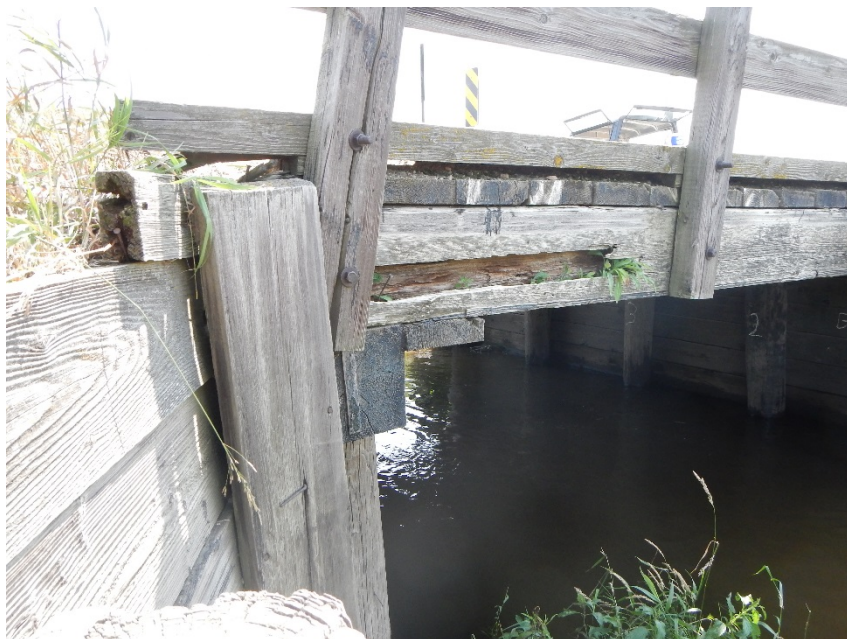
Figure 6-7 Moderate decay along face of exterior girder

An increase or decrease in moisture content can result in fluctuations of the modulus of elasticity and cause shrinkage and swelling. Furthermore, moisture exposure can lead to sagging or crushing as shown in Figure 6-7 or even cracking and checking, as shown in Figure 6-8, which are a higher degree of deterioration and one requiring remedial action.

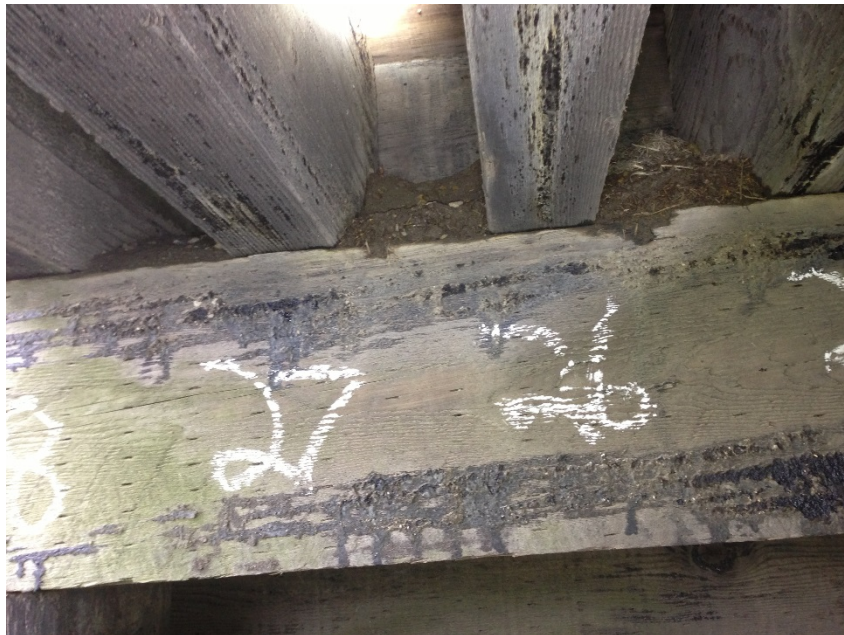
Figure 6-9 Debris accumulation between stringer ends and pile cap

As shown in Figure 6-9, soil and gravel can accumulate at abutment and pier cap locations of bridges where the decks allow their pass-through.

The accumulated debris can trap moisture against the ends of the stringers, thereby increasing the chances for deterioration. Given that the ends of the stringers bear the weight of the superstructure, a deteriorated beam where the internal structure is lost or badly decomposed will almost invariably crush.

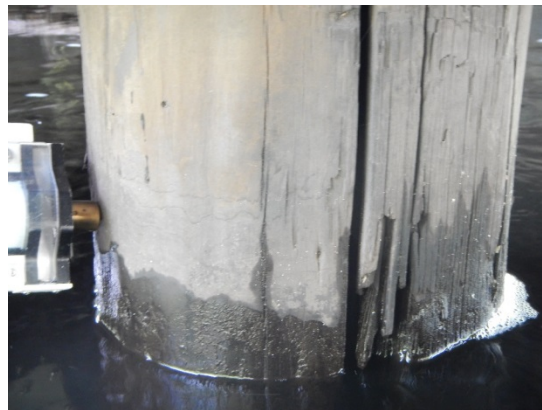
Figure 6-10 Pile splitting at the waterline

In almost all cases of physical deterioration (e.g., debris strikes), the resulting damage breaks down the protective preservative barrier and allows entry of biological decay mechanisms. In Minnesota, this is realized most prevalently in timber piles subjected to ice or floating debris in the channel and where the moisture exposure is cyclical (where the water elevation rises and falls along the piles creating cycles of wet and dry conditions). The continual cycling provides sufficient water to maintain a high moisture content and enough oxygen to promote fungal growth. Good examples of this phenomenon are shown in Figure 6-10 and Figure 6-11.

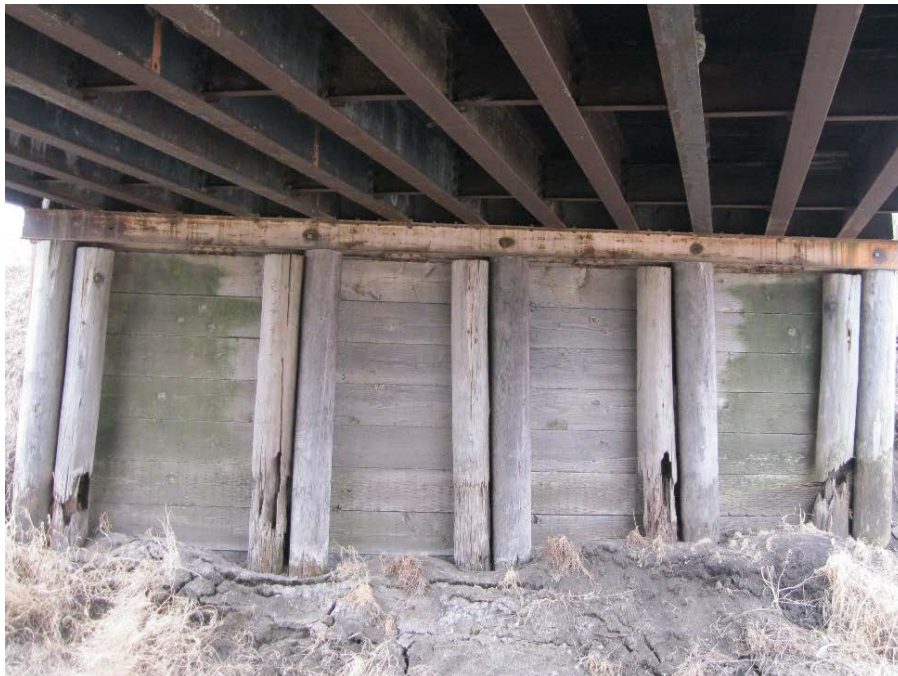
Figure 6-12 Severely decayed timber piles at abutment

Overloading can result from a few severe loads or continuous heavy loads. Furthermore, as timber piles deteriorate and their structural capacity is lost (as shown in Figure 6-12), the demands on adjacent piles increase. For this reason, loads that were once able to cross the bridge without risk of overloading may accelerate pile deterioration.

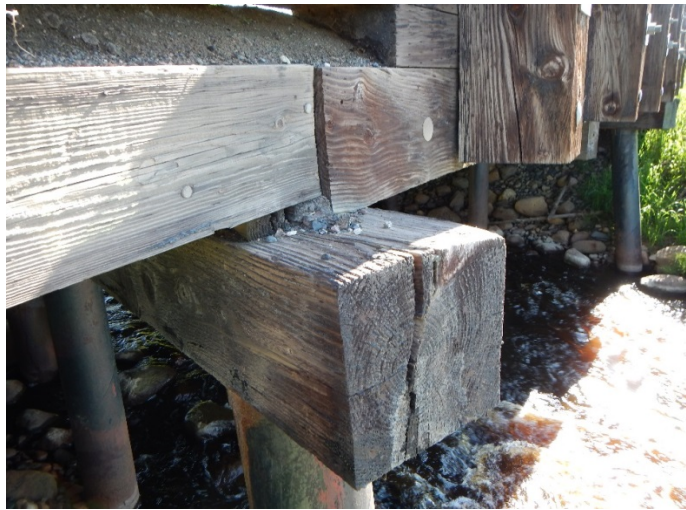
Figure 6-13 Advanced checking in pile cap

As is shown in Figure 6-13, large checks and cracks are commonly seen in unprotected pile caps and tend to be the result of end grain exposure and/or the deck leaking directly onto the

horizontal surface of the cap. Over time, these checks and cracks can result in significant loss of structural capacity and require repair and/or replacement.

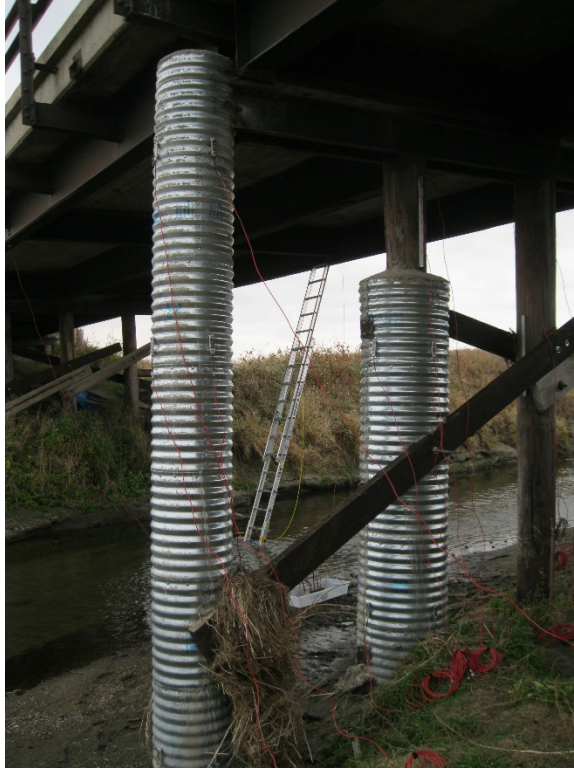
Figure 7-1 Concrete jacketing in CMP

Concrete jacketing takes on several different forms but fundamentally incorporates a cast formed by concrete around the deteriorated timber pile to reinforce weakened sections. The concrete cast can be formed using corrugated metal pipe (CMP), flexible forms, or split fiberboard forms. The addition of a reinforcing cage within the cast and/or shear connectors between the pile and cast can be included, but is not necessarily required. This decision is left to the engineer and may be dependent on the severity of the deteriorated area.

Advantages of concrete jacketing are the abilities to use readily available materials and county maintenance crews and equipment. The simple construction methods can be completed with little training and at minimal cost. As an example, Figure 7-1 shows one method of concrete jacketing.

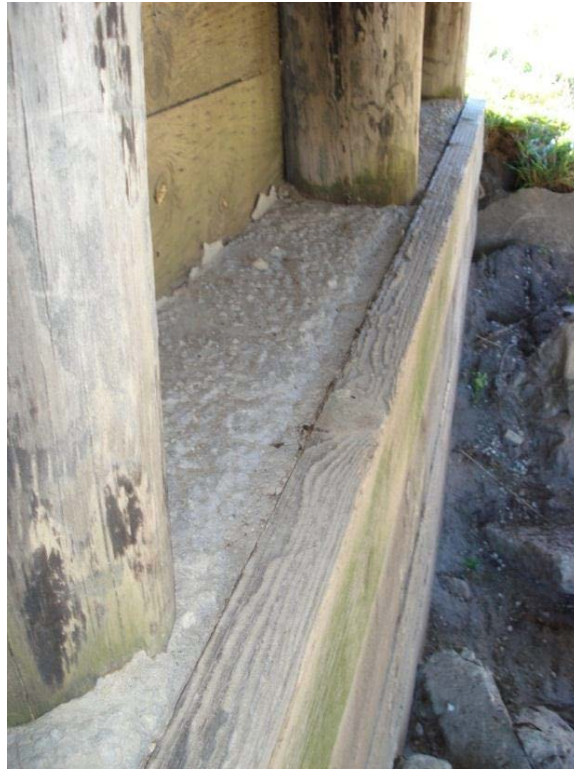
Figure 7-2 Pile encapsulation with timber planks and concrete

Encapsulating a group of piles gives the advantage of load distribution between piles and the concrete between piles. Along with the timber planks spanning the faces of the piles, the concrete between the piles provides additional lateral support and effectively reduces the length of the pile. With proper shear connectors installed between the piles and concrete, the concrete between piles acts to restore the overall bearing capacity of the pier or abutment.

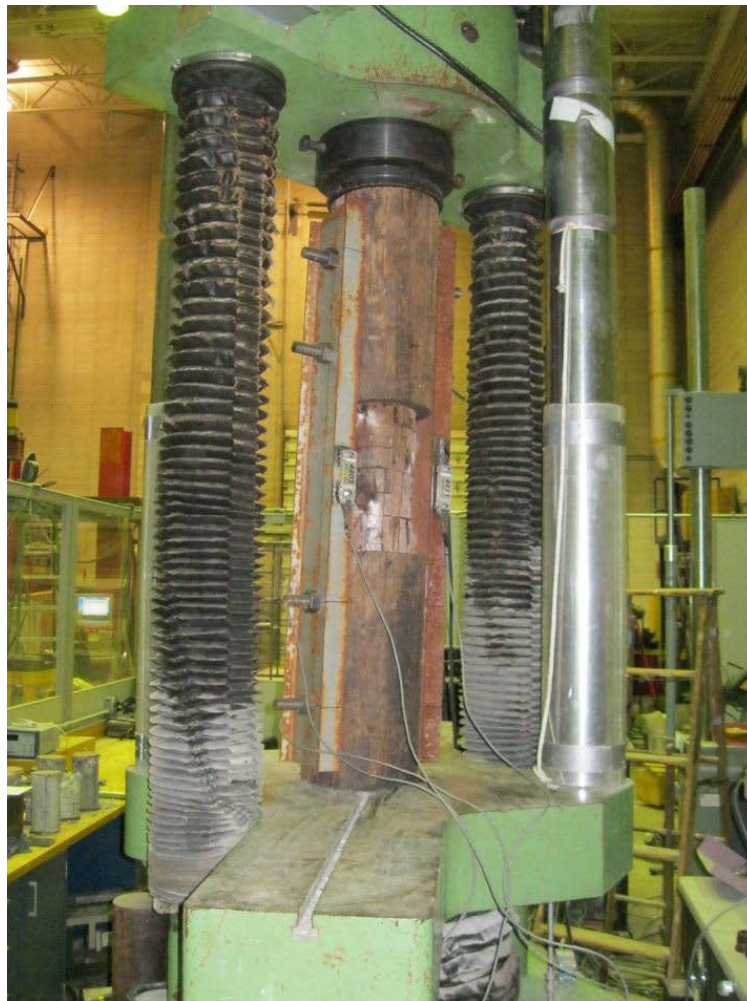
Where a portion of the timber member is so deteriorated that it must be replaced, a splice can be constructed using similar concepts to the scabbing or sistering methods. The splice joints, like deteriorated portions, must be spanned to sound material where the scab or sister can be properly attached. Figure 7-3 shows an example of a sistered pile.

Figure 7-3 Sistered pile with channels and through bolts

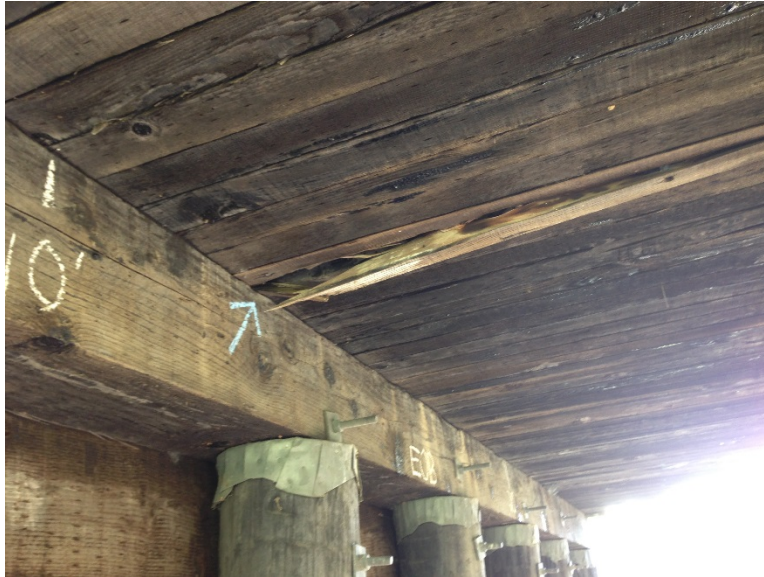
Localized areas of deterioration or damage in laminated bridge decks, like that shown in Figure 7-4, can be repaired through patching. It is a procedure that can be accomplished with readily available materials and county work forces.

Figure 7-4 Localized deterioration and damage in laminated timber deck

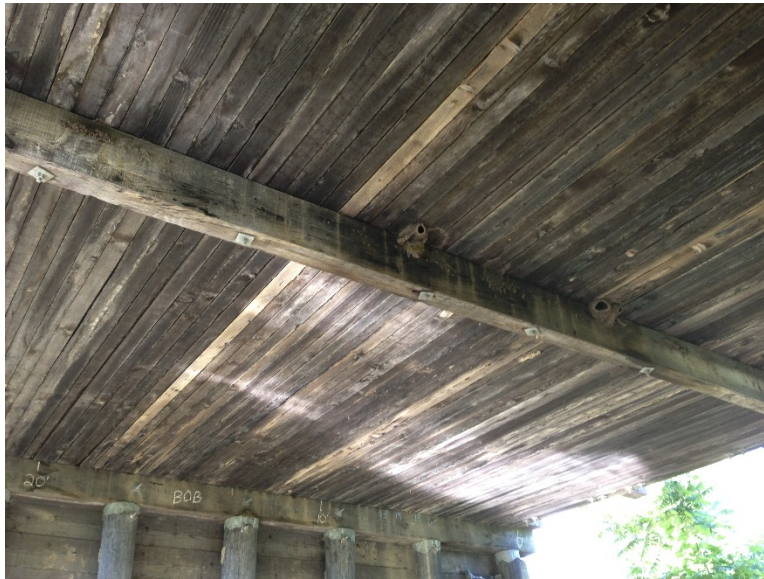
This method is used to repair a dowel-laminated deck (which is also known as a Wheeler deck), as shown in Figure 8-1, that has an area or areas of deterioration extending to either partial depth or full depth.

Figure 8-1 Repair of laminated decks

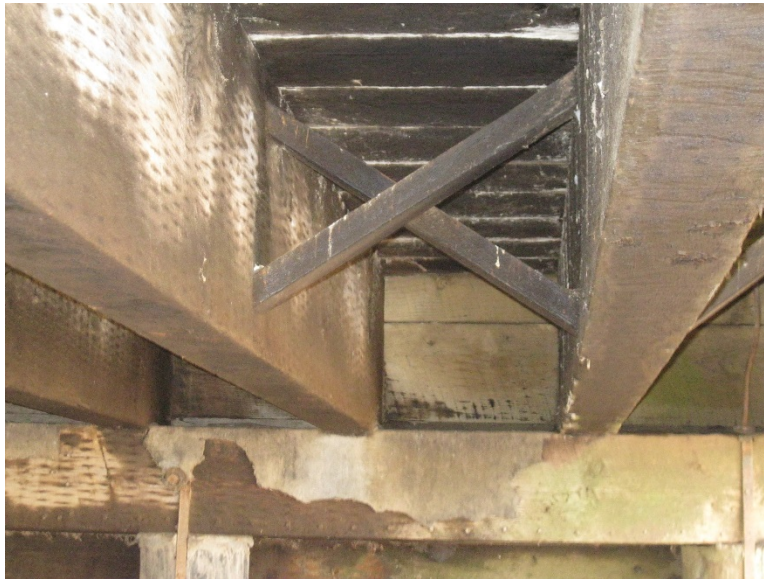
This method is used to strengthen timber stringers or girders that have localized minor to moderate deterioration that has weakened the overall strength of the member at the ends or along the span. See Figure 8-9.

Attach steel members to timber stringer or girder using through bolts or lag bolts.

Figure 8-9 Strengthening of individual timber stringers

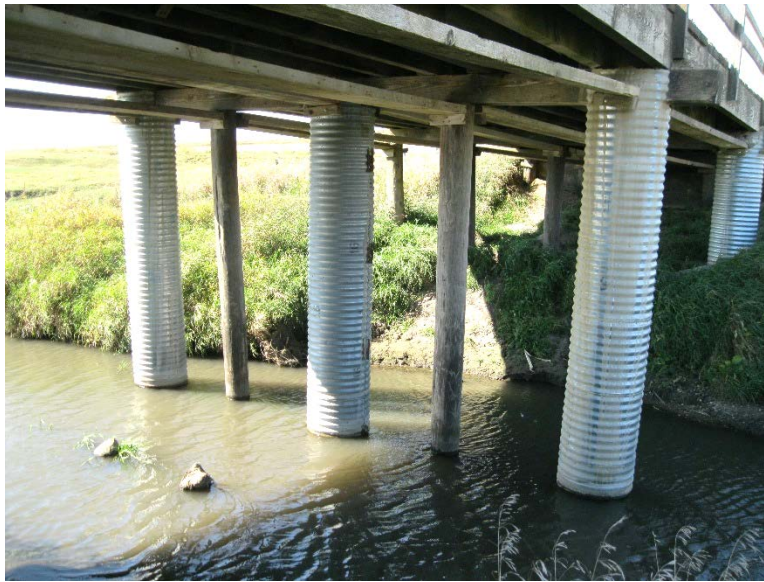
Timber piles are partially encased within a concrete-filled steel shell as shown in Figure 8-16.

Figure 8-16 Addition of pile jackets

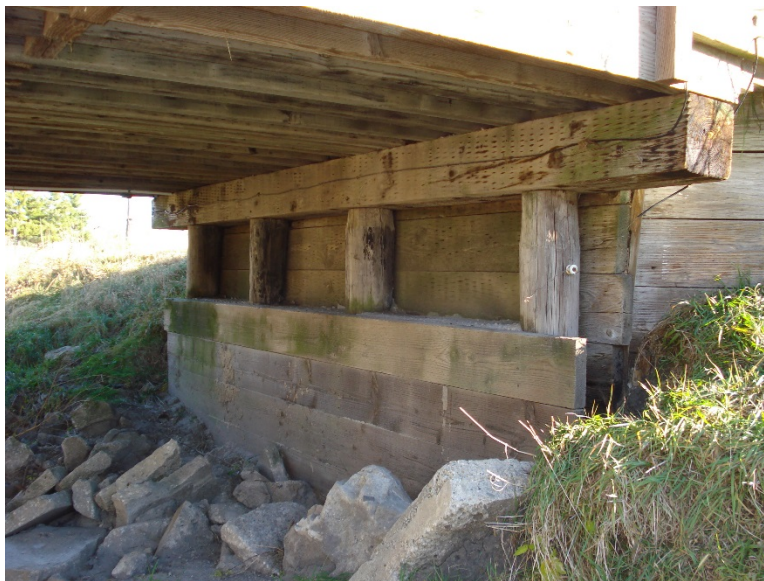
A group of piles, within which deterioration/damage is present on multiple piles, is encapsulated in a reinforced concrete grade beam, tying each pile together and strengthening the overall pile group as shown in Figure 8-18.

Figure 8-18 Pile encapsulation at abutment

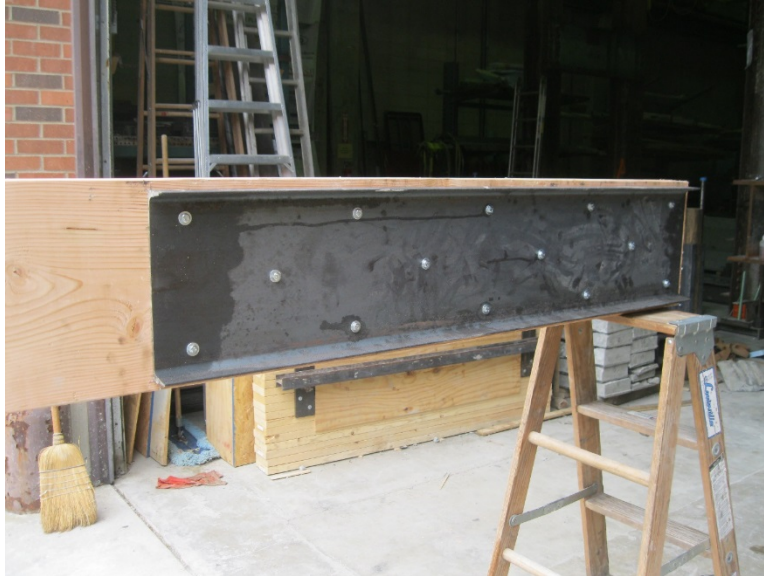
Figure 11-2 Stringer sister half-scale model

Several topics were covered including an overview of the condition of Minnesota's timber bridges, types of timber bridges, common decay mechanisms, advanced inspection tools, repair methods, and cost estimation. In addition, attendees had the opportunity to participate in a hands-on demonstration of advanced inspection tools and observation of half-scale repair models, shown in Figure 11-1 through Figure 11-5.

Solid sawn or glued-laminated stringers/girders can be strengthened for shear or bending by sistering steel channels to each side of the member spanning beyond the area of decay or deterioration.

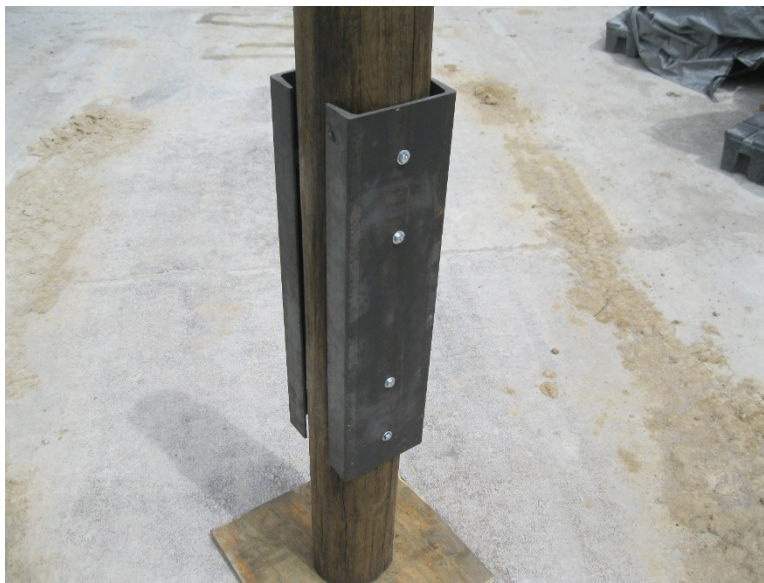
Figure 11-3 Pile channel reinforcement half-scale model

The first of the three pile repairs involves the use of two steel channels with welded cleats sistered to opposite sides of a slightly modified timber pile. The steel provides a load path by which applied loads can be transferred from above the area of deterioration to the area below.

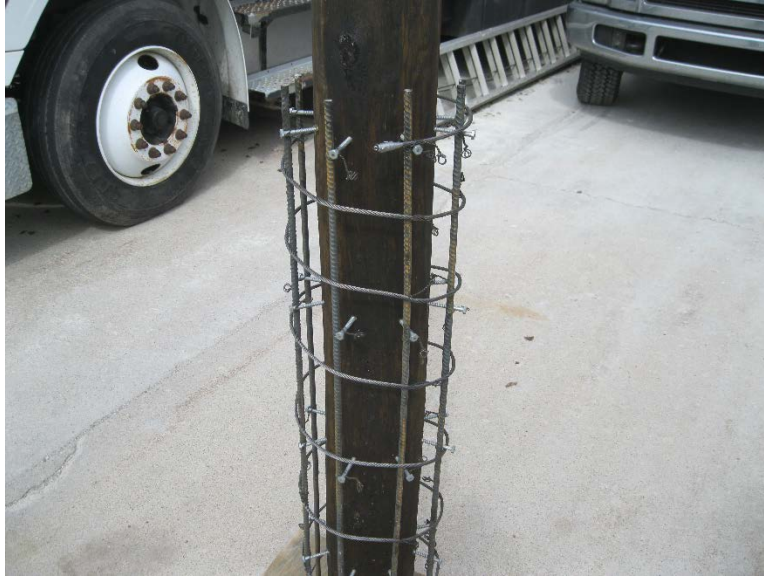
Figure 11-4 Pile jacket half-scale model
